Olympus Target - Damage from Heat

March 20, 2011

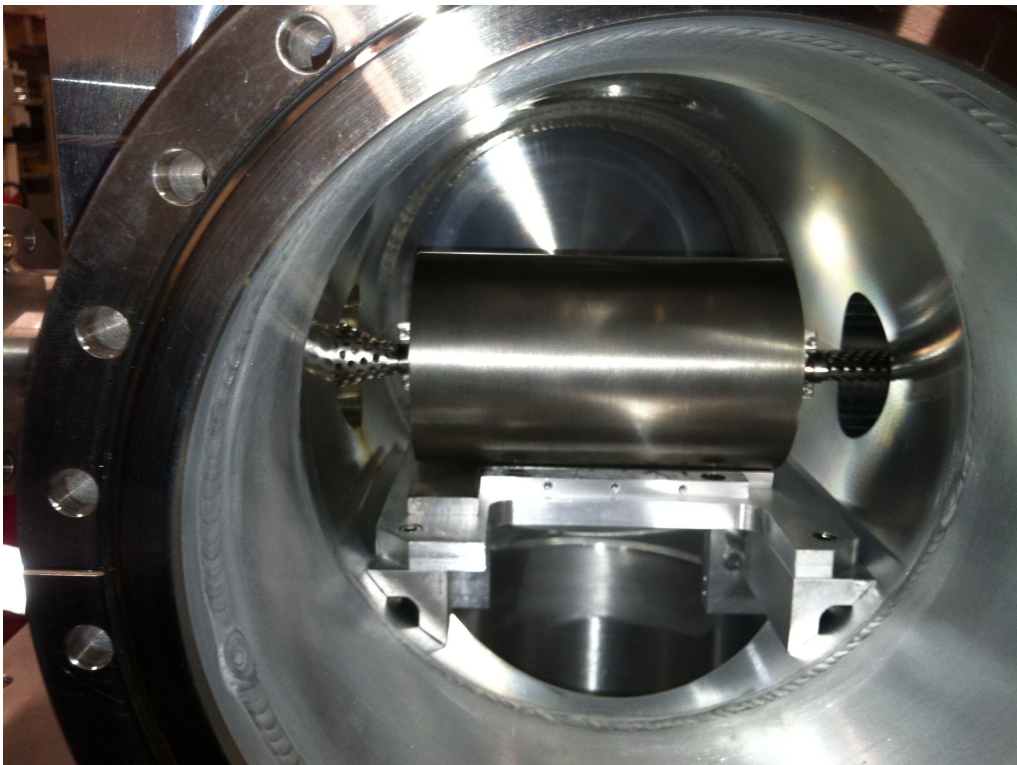
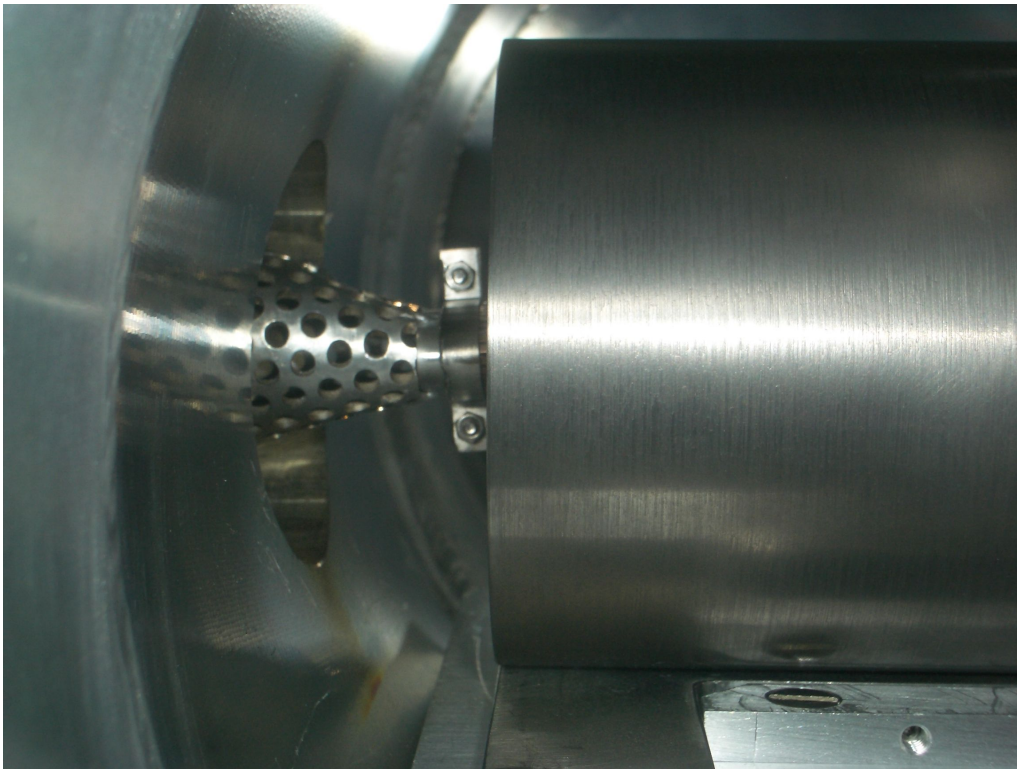
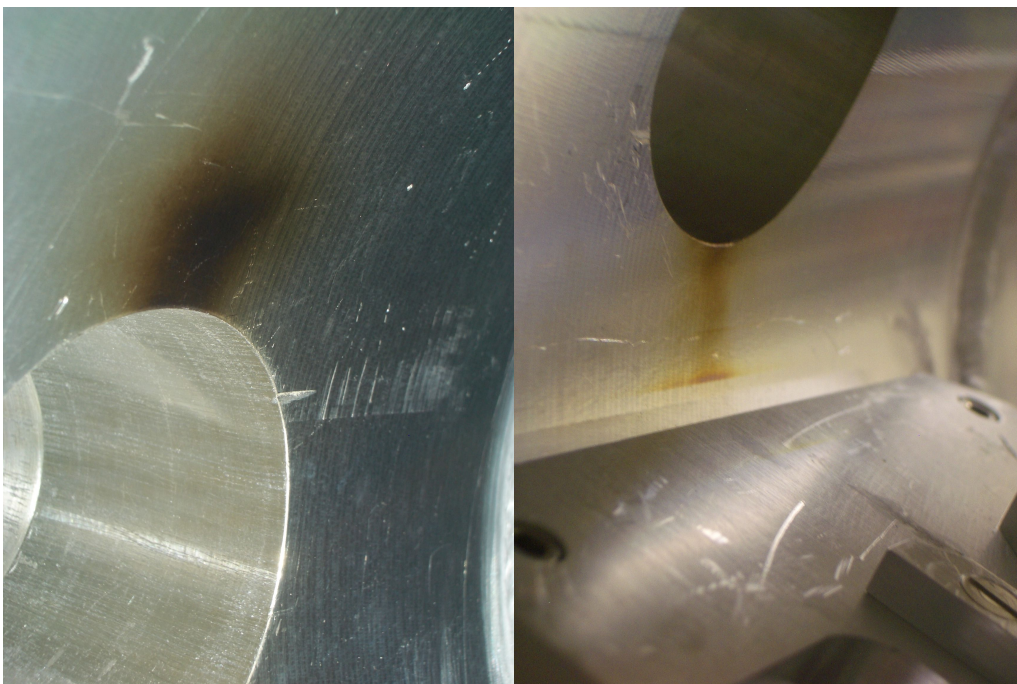
2.1 Images 23, 42, 79, 81

Strong discoloration above/below the upstream wakefield suppressor on the chamber wall upstream of the target in front of the collimator. The discoloration does not rub off. It continues slightly into the bore. Lower part shows a distinct line. This line may indicate a shadowing of the source by an edge, however, it is not clear which. The discoloration continues on the base of the collimator plate and stops where the plate was covered by the collimator assembly.

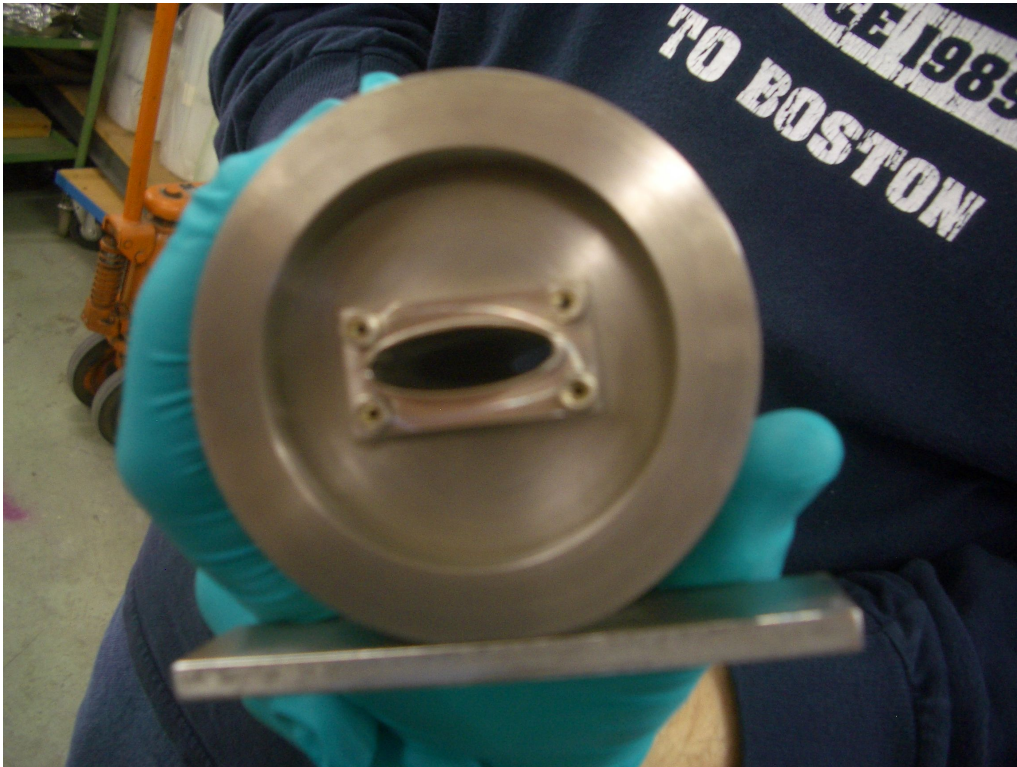
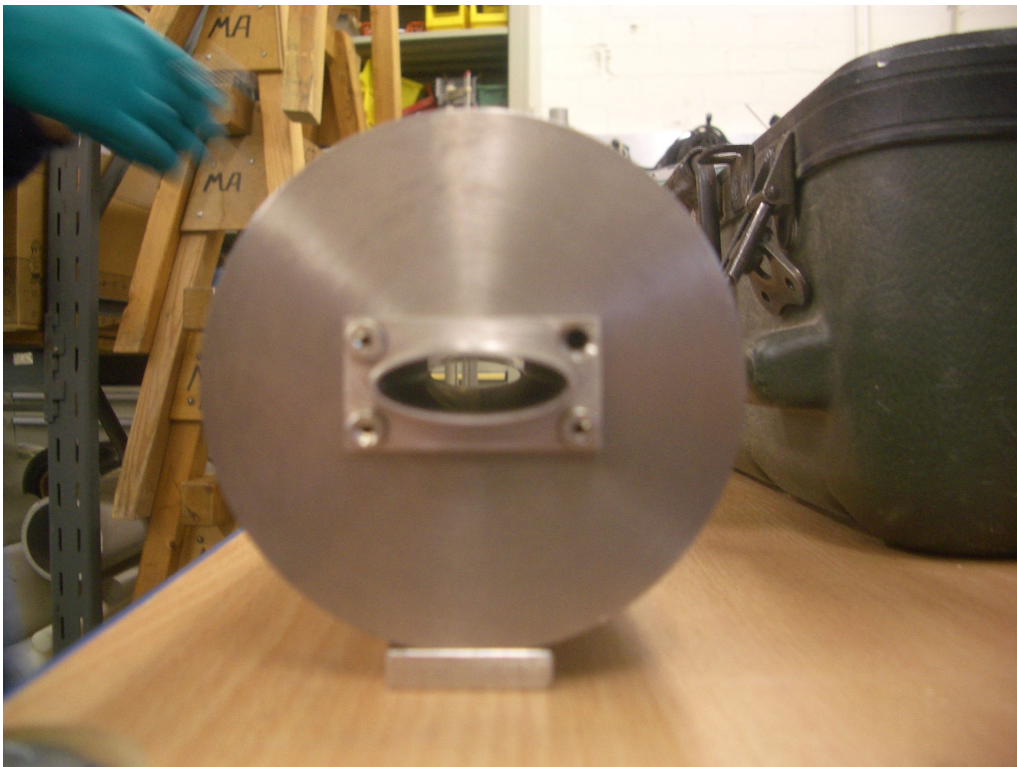
2.2 Images 71,72

There is no damage visible on any side of the collimator

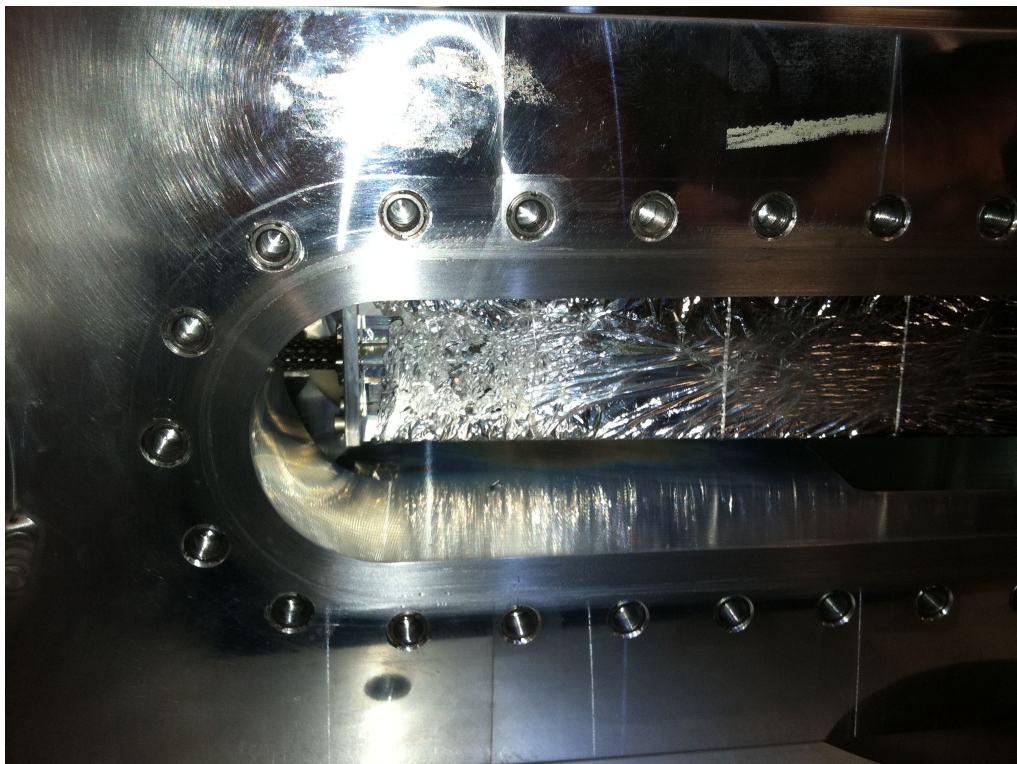
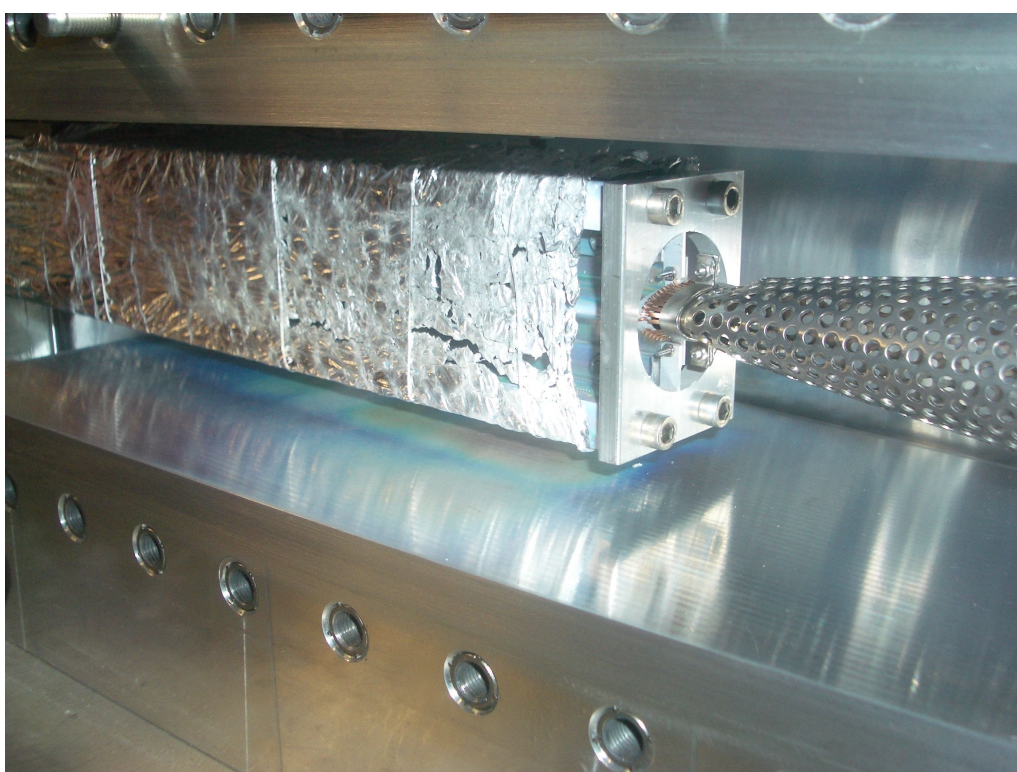
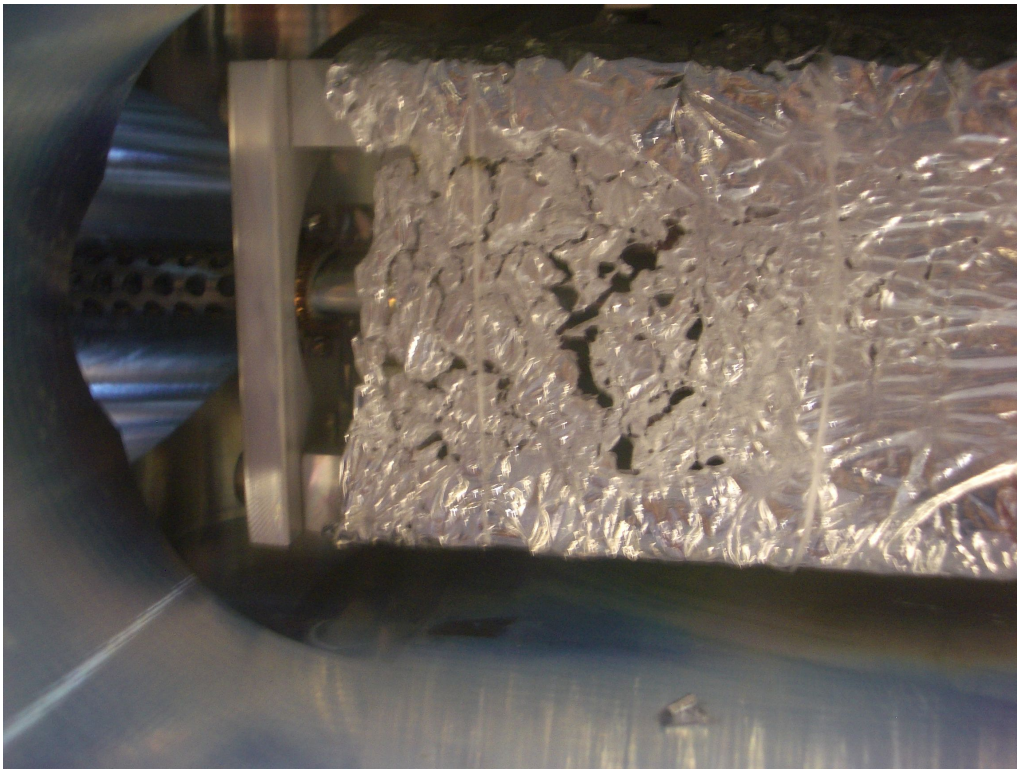
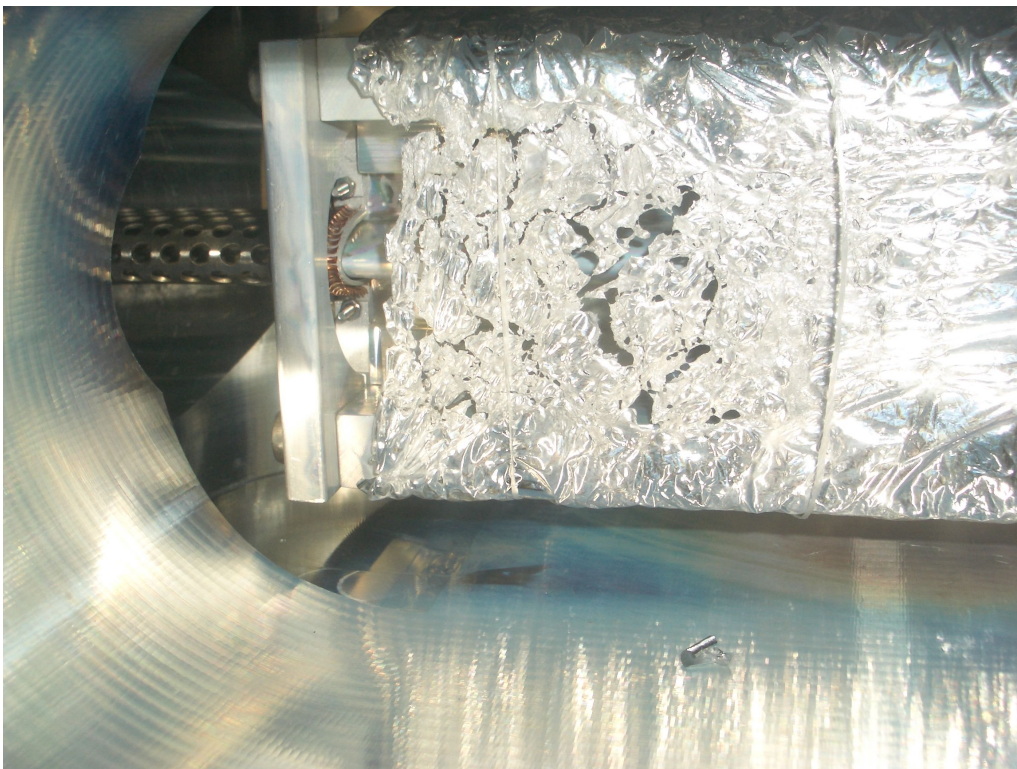
3.1 Images 27, 47, 51, 52

Superisolation was melted on both ends of the cell, on both sides. Damage is worse between aluminium struts, indicating that heat was not conducted through the struts. Also, damage seems to be symmetric in the up/down direction. Is the heat coming from the cell via radiation? I think that is unlikely, as the conductance of the cell wall to the aluminium should be better, and target sensors never showed so high temperatures.

One can see discoloration of the aluminum below the cell, maybe residue from the superisolation.

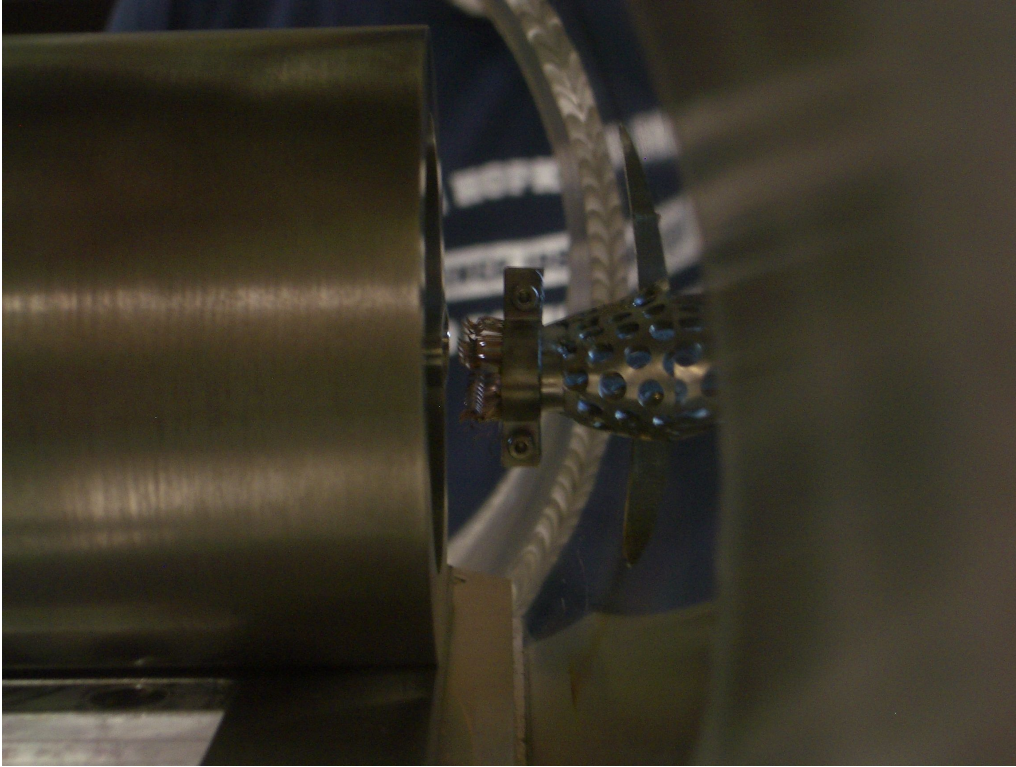
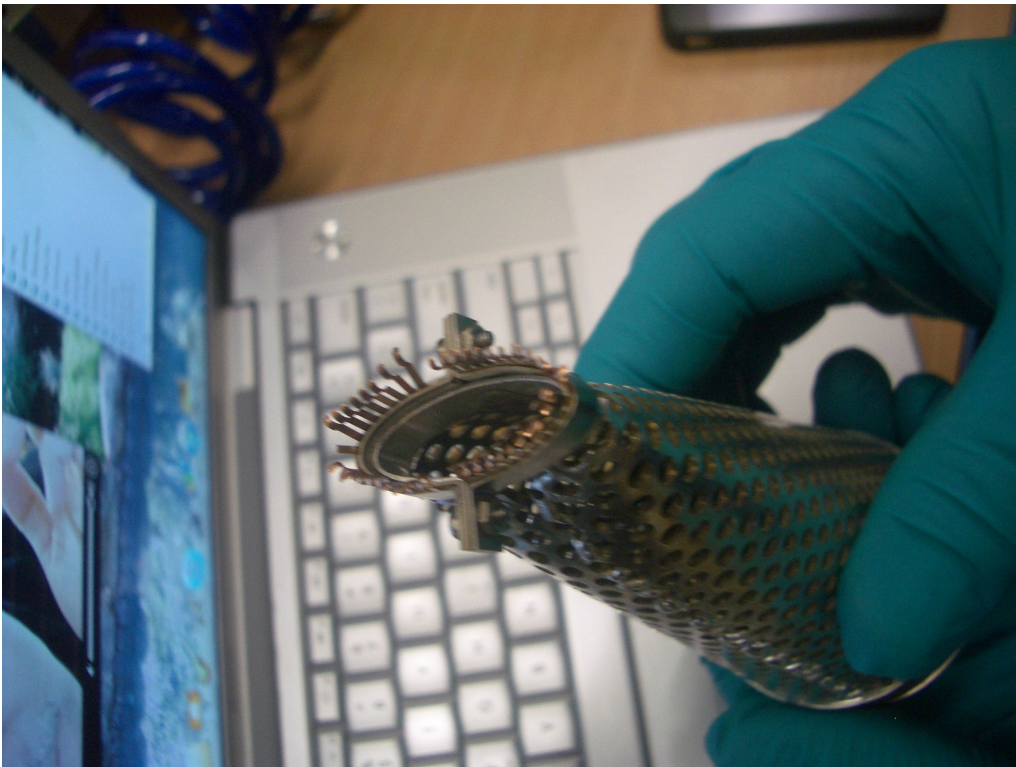
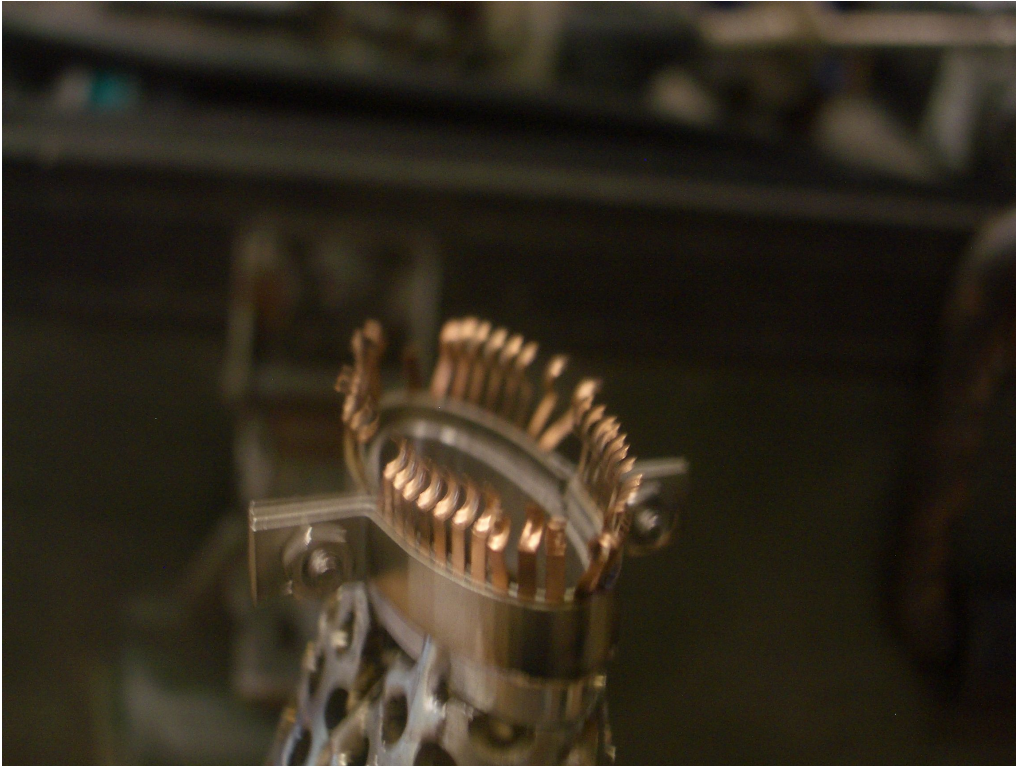
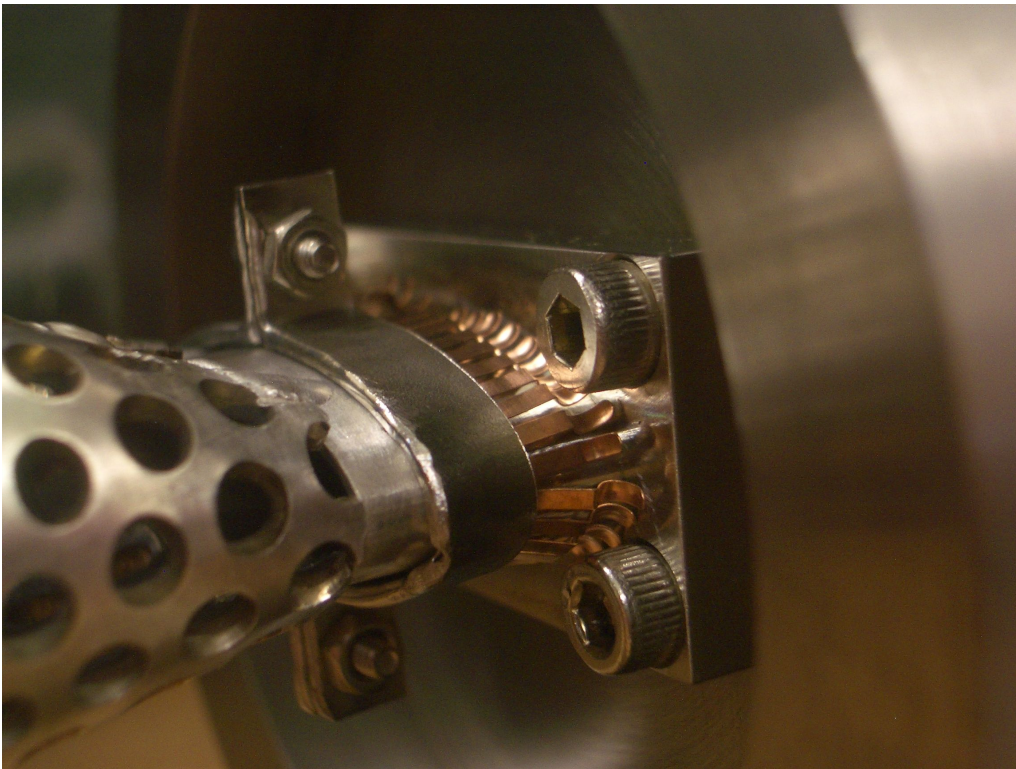
4.1 Upstream wakefield suppressor. Images 68, 76, 77, 83

Fingers bend out of shape, outwards. Some people saw discoloration upward/downward inside the suppressor.

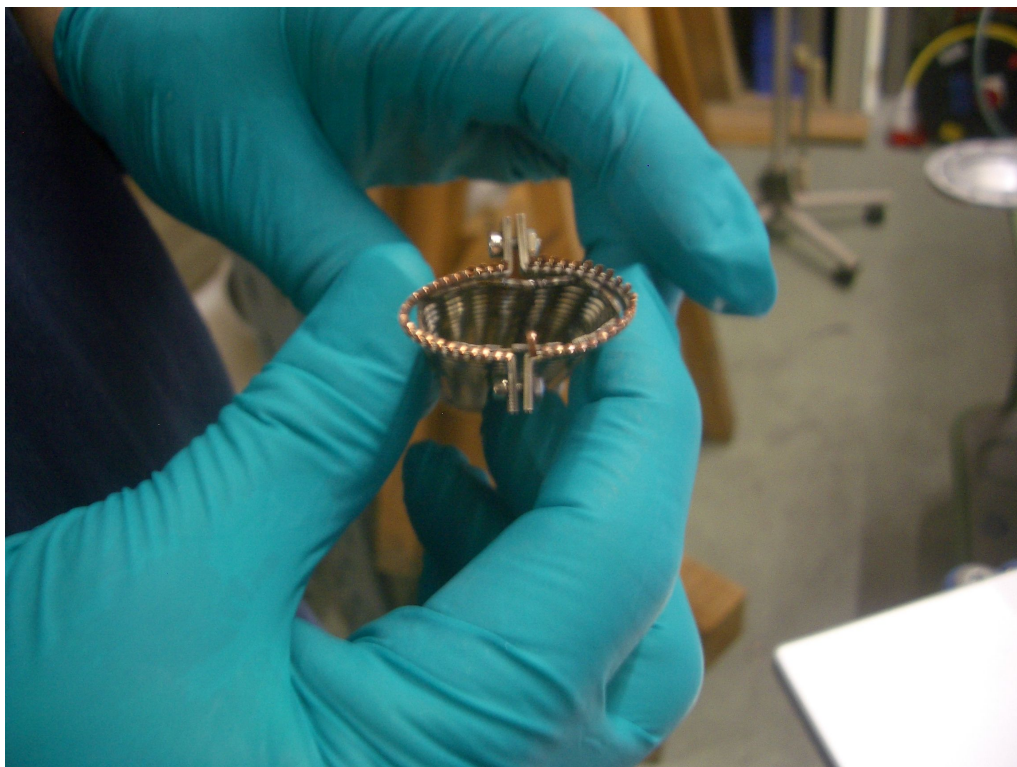
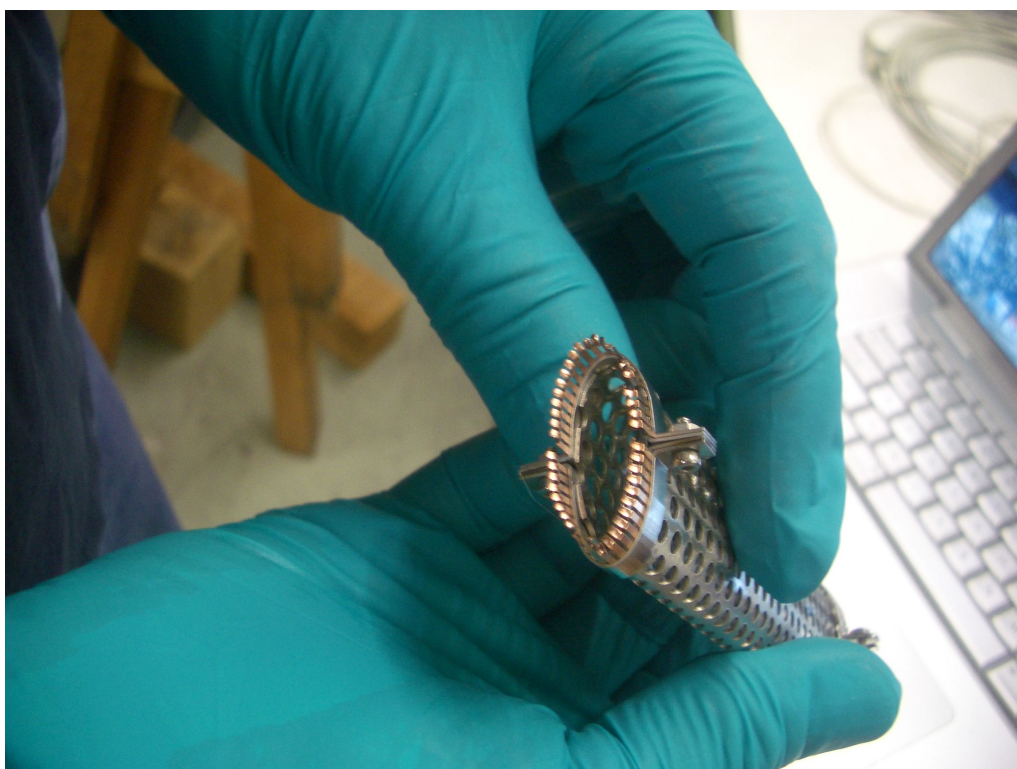
4.2 Connection Collimator to cell. Images 73, 74

Looked fairly good, but some fingers missing or completely bend.

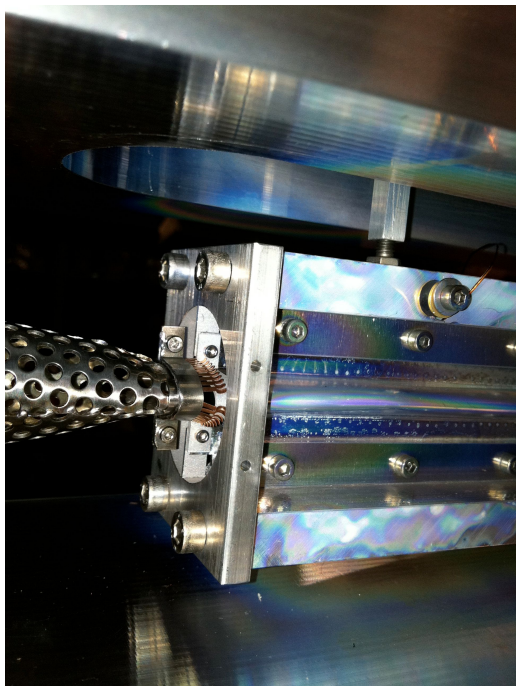
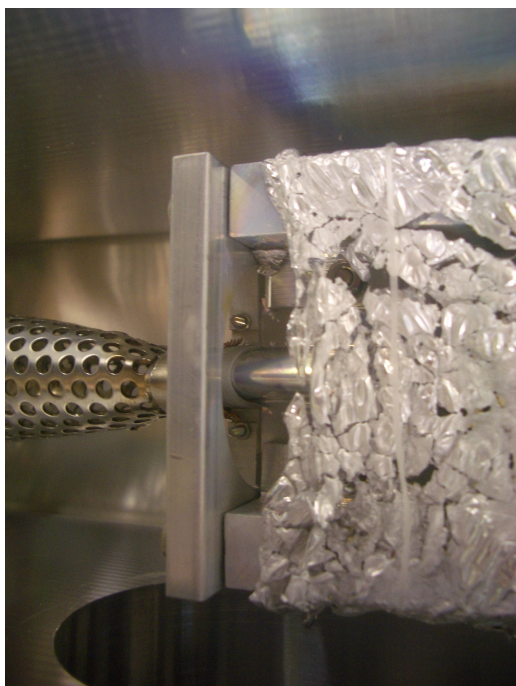
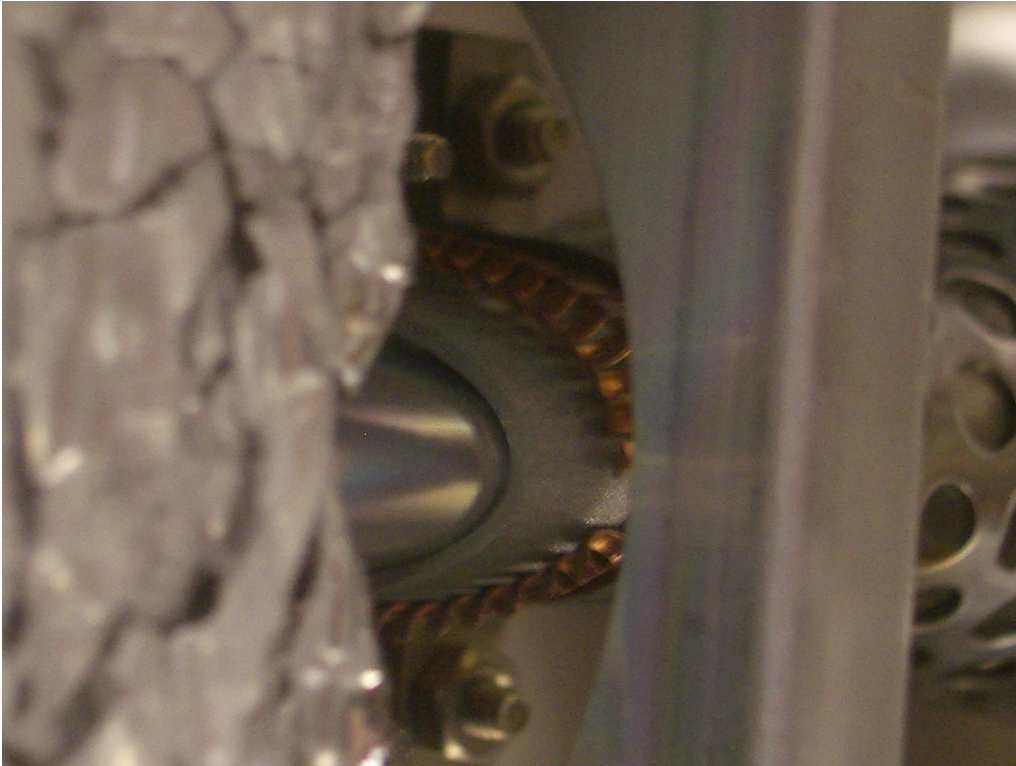
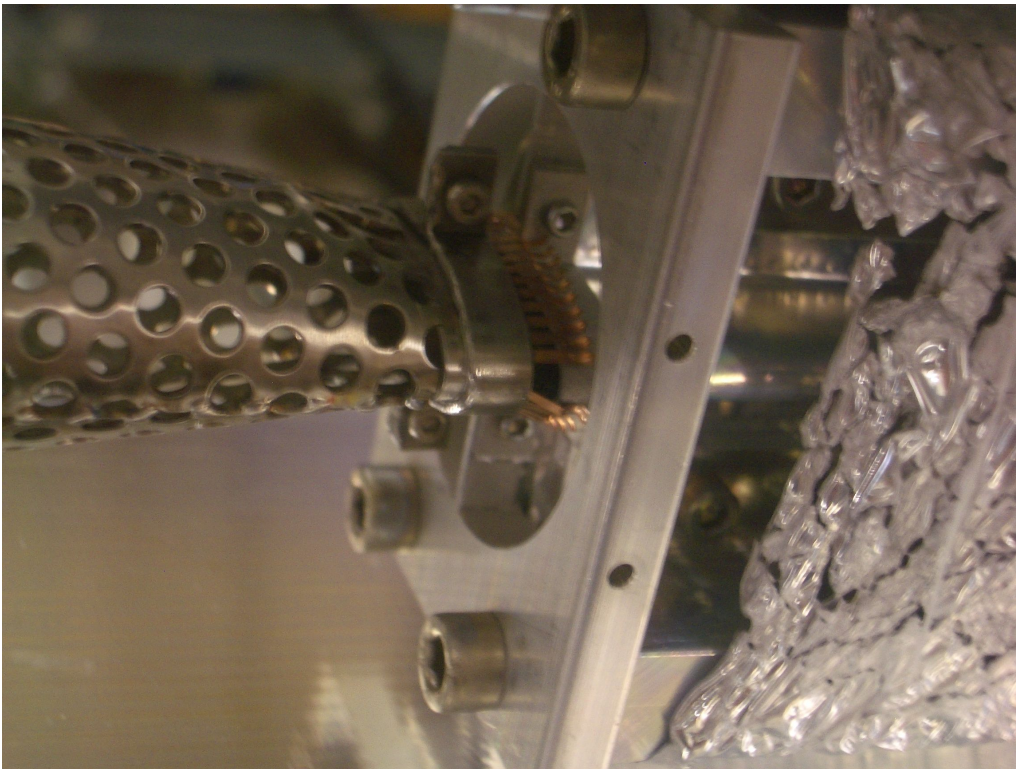
4.3 Downstream wakefield suppressor. Images 31, 54, 56, 60

Fingers do not make contact in upper part of the cell.

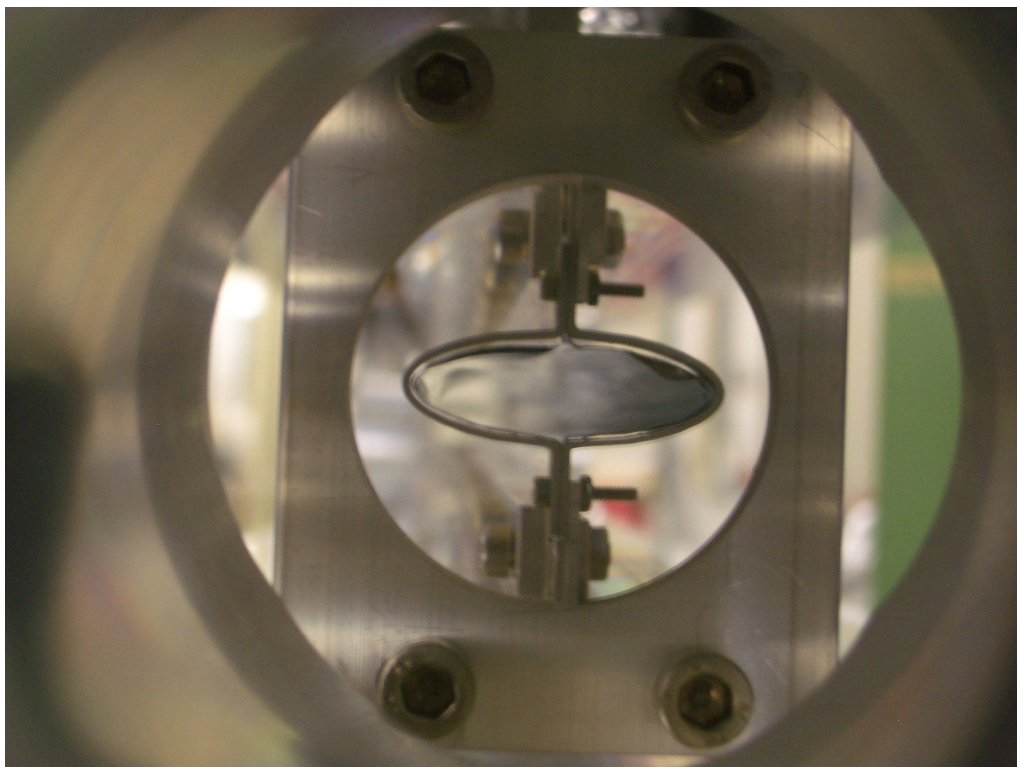
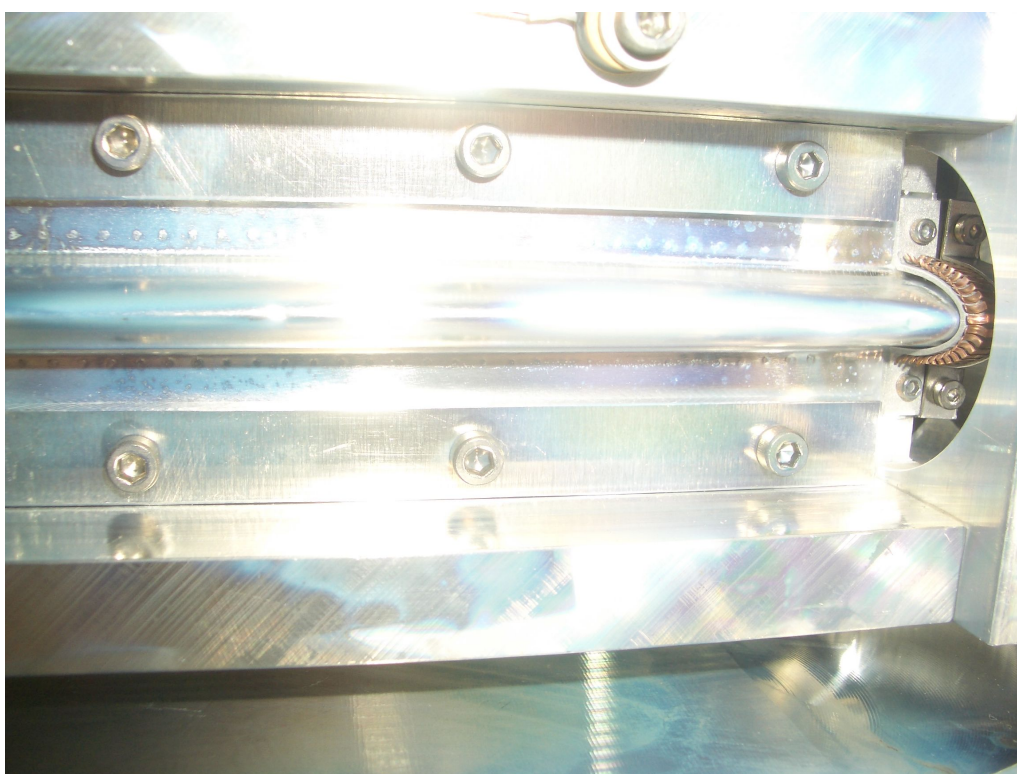
5.1 Upstream end. Images 16, 64

Cell wall not attached to the aluminium ring anymore.

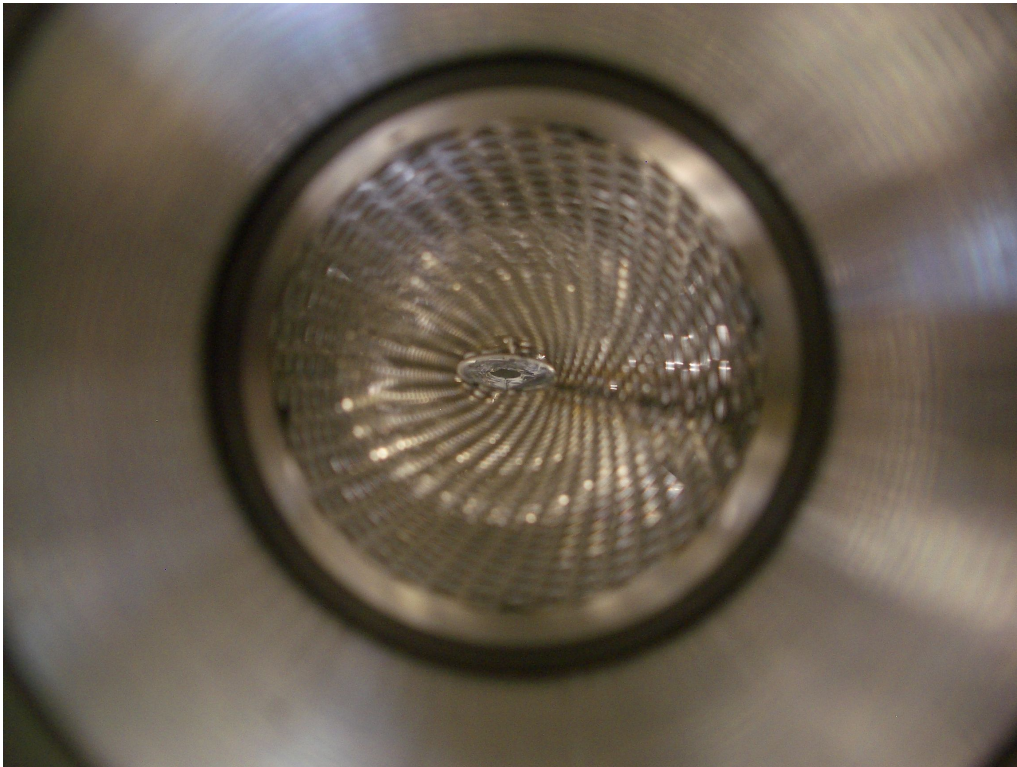
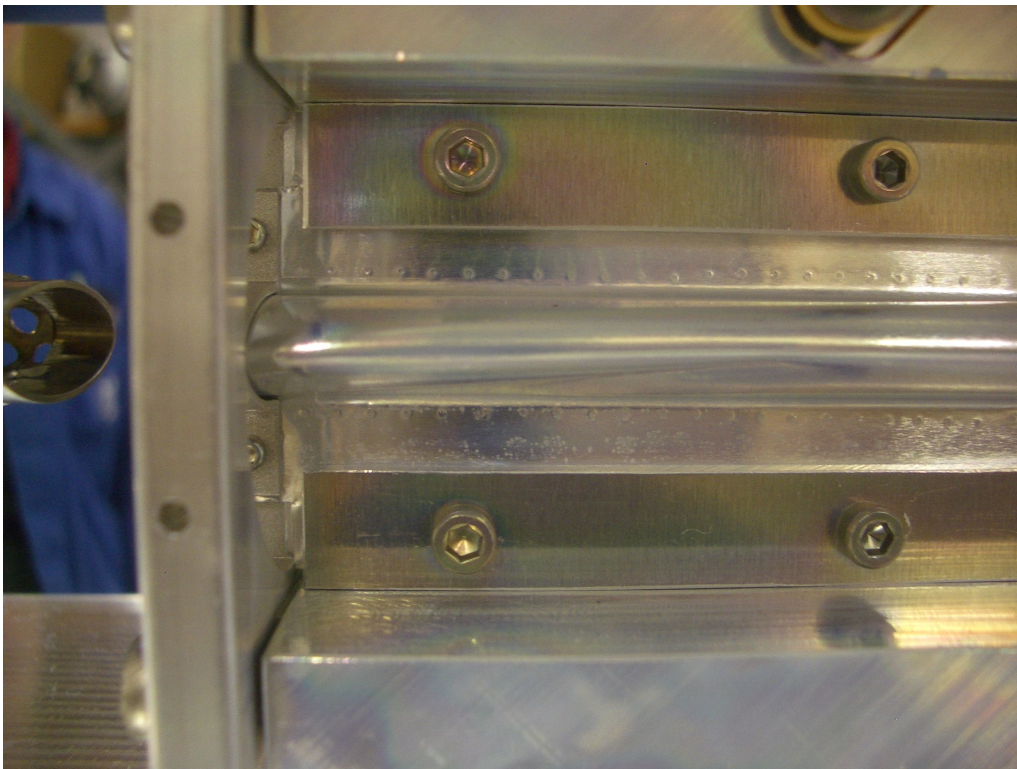
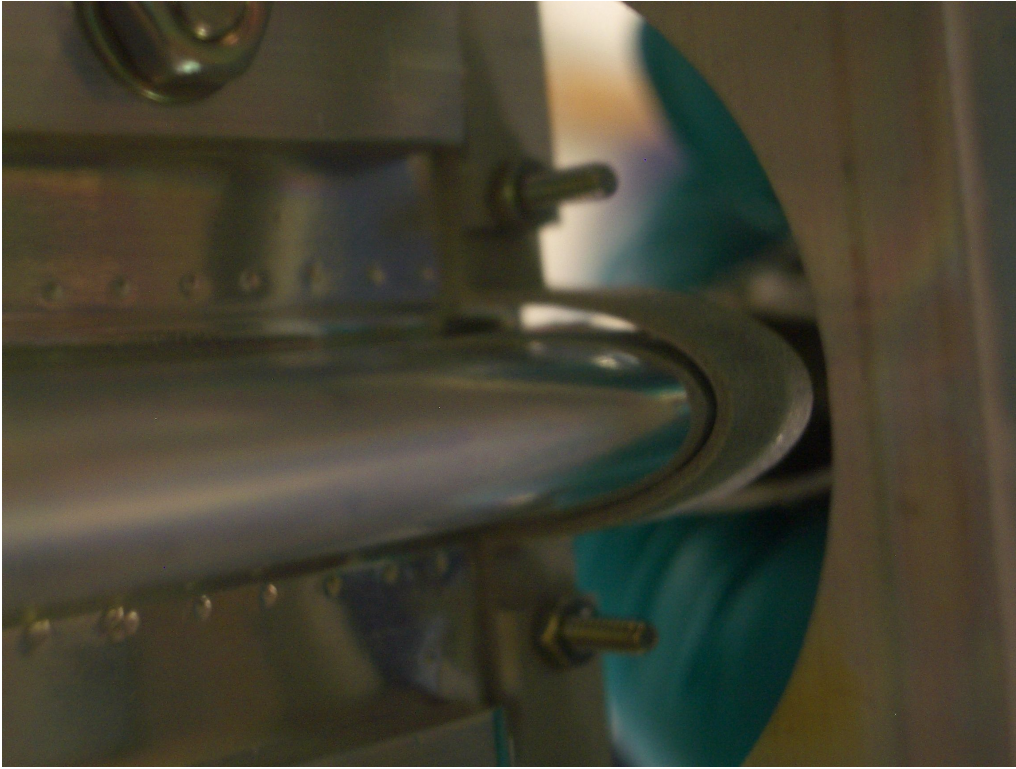
5.2 Downstream end. Images 20, 21, 89

Cell foil also does not have contact with the ring. Also, cell has a dent, maybe caused by heat induced warping of the cell holding structure.
