# Status of the Drift Chambers

Becky Russell  
MIT Group

January 16, 2012

OLYMPUS January Collaboration Meeting

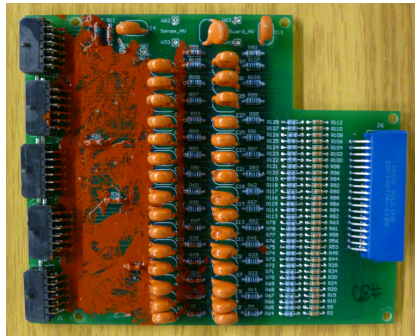
# Old HV cards

- Sparking mostly between traces
- Cards tested and slathered in Super Corona Dope at Bates
- Spark even more depending on humidity conditions
- Have to “fix” by watching/listening for corona discharge on bad cards and insulating problem areas

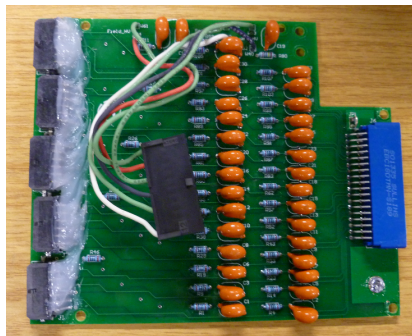
# Improved HV cards

- New board design
- Four-layer circuit board that avoids having traces with large voltage differential
- High-voltage connectors instead of soldering HV lines directly into boards (easier to replace)
- Populated at MIT in December
