CARE International Indonesia

Rapid Shelter assessment (Remote and Rural areas)

West Sumatra Earthquake of 30 Sept 2009

DRAFT Zero 15th Oct 2009

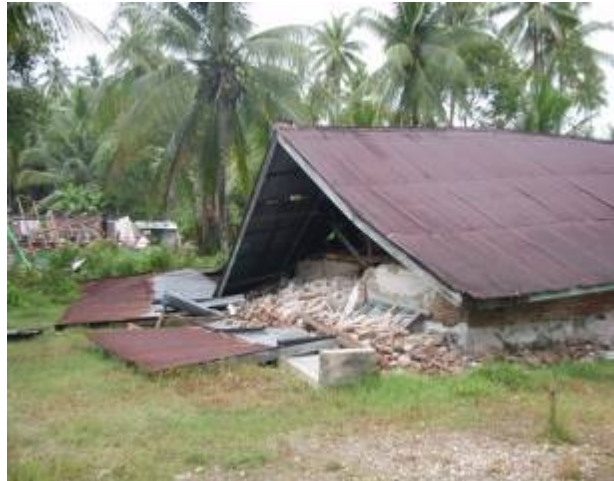
Severely damaged house

Four walls destroyed and roof collapsed to the ground. All household goods and assets are damaged or destroyed.

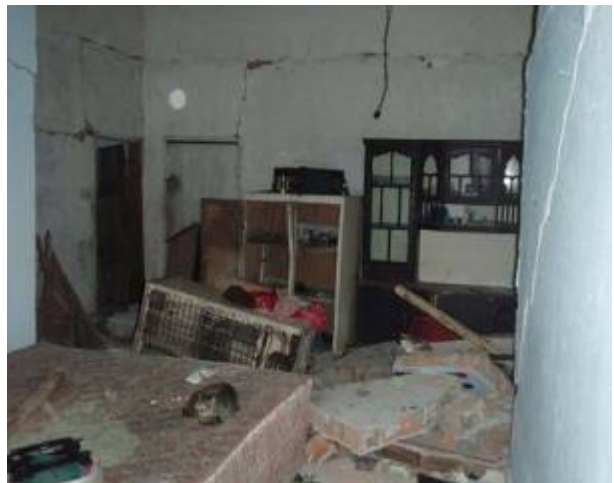
Internal of damaged house

Severely weakened structure, structural cracks in the walls. Brick walls failed damaging household furniture.

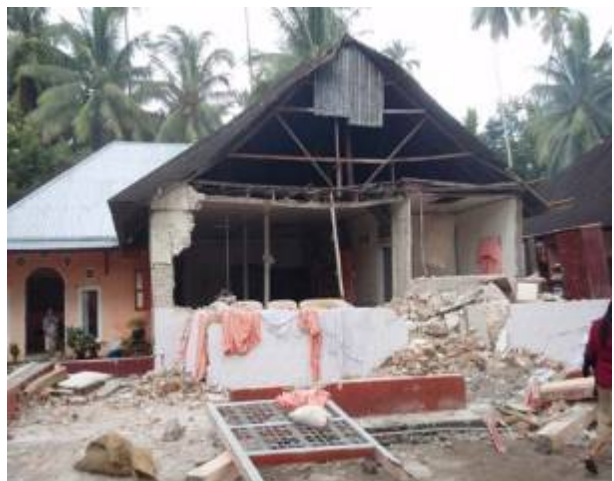
Partially damaged house

House still standing however major structural failure. The house rendered unsafe for habitation.

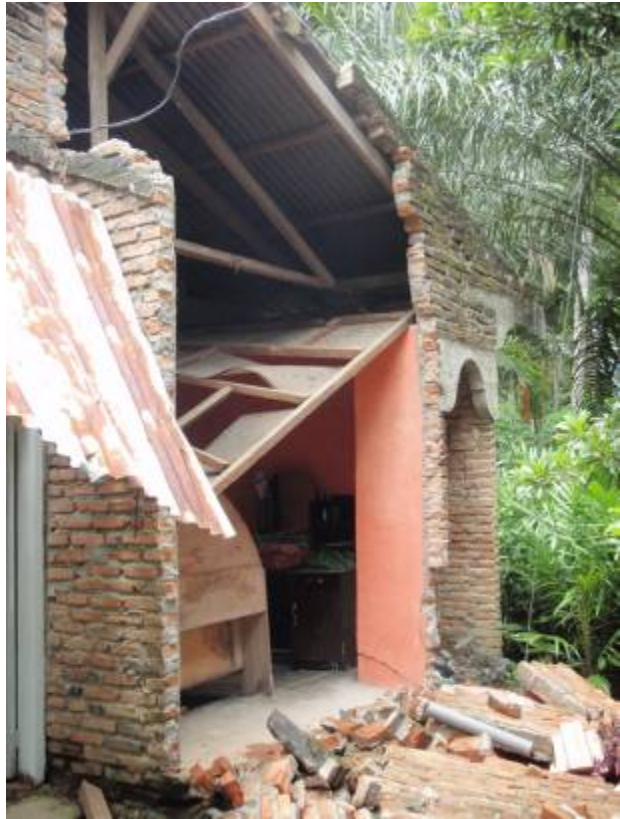
Brick walls

Brick wall construction is common in the region, however without reinforcement brick walls just crumbled and peeled away. This is a very hazardous construction technique as the wall collapse and roof cave in or the wall falls in on top of the people inside.

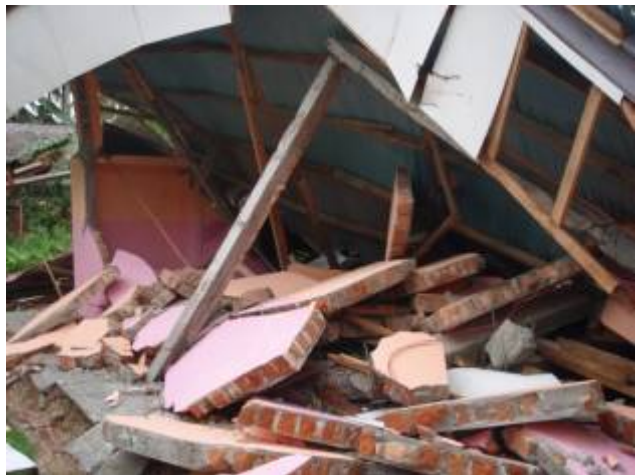
Concrete column with brick infill

Slender concrete columns failed. Brick infill walls peeled off the columns as there were no ties between column and wall.

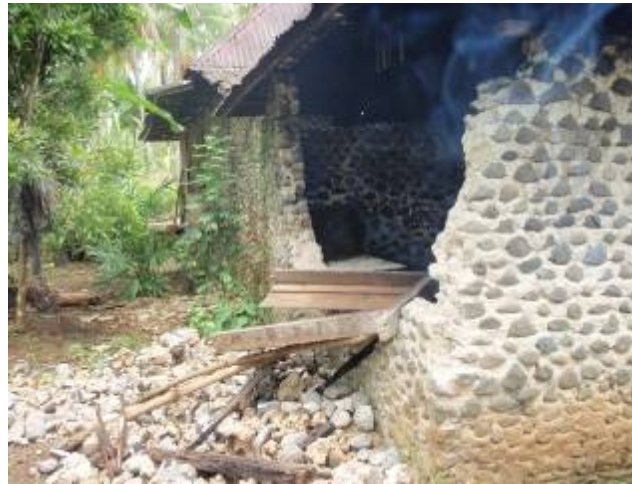
Stone with clay and lime mortar

In some areas the use of local stone with clay and lime mortar have been seen, however much of them have been damaged.

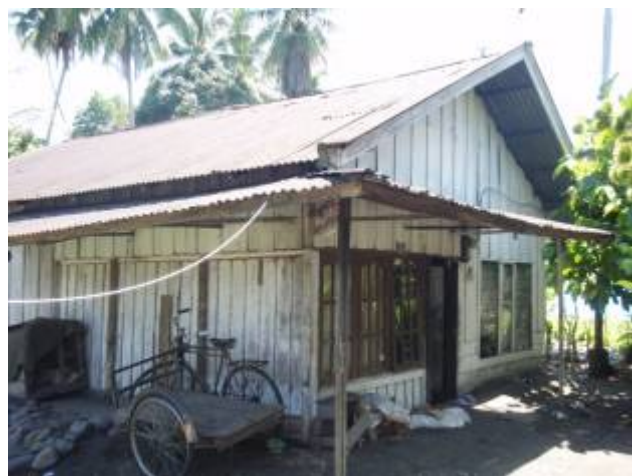
Timber frame houses are present in the area although brick building are more common as it is seen as “*permanent*”. In the same village, timber frame houses generally have seen less damage. This photo shows a undamaged timber house and next to this house a totally destroyed brick house.

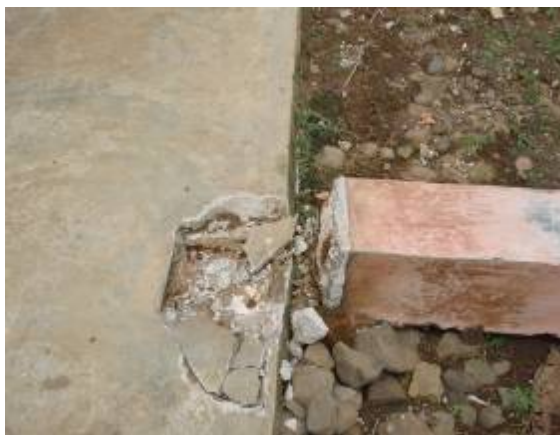
Lack of reinforcement connecting the column to the foundations.
No ring beam (sloth)

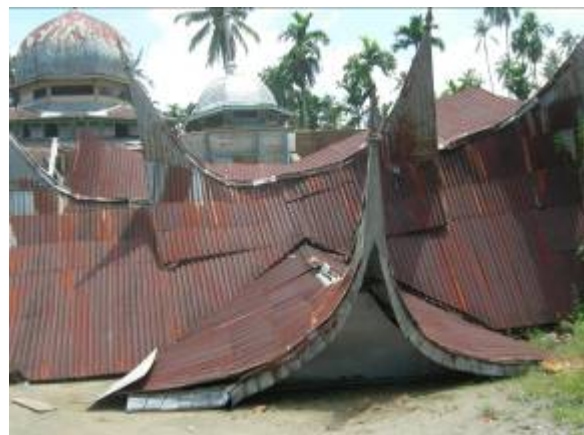
Traditional Padang roof structures are heavy and in this instance structural columns failed.

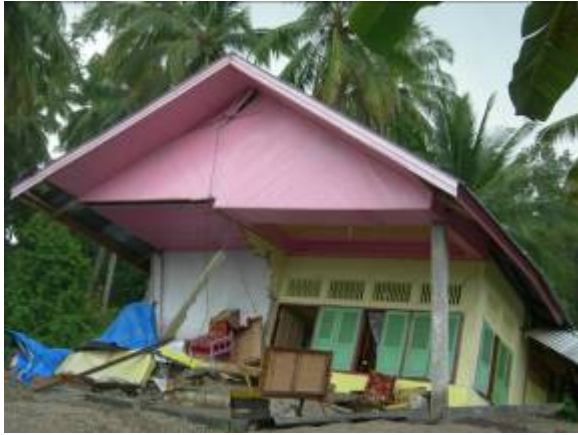
Land movement, causing sedimentation to the foundations, relocation and tenure issues may become important.

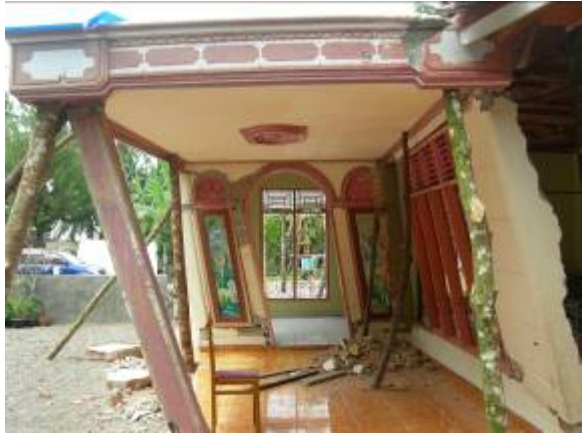
Lack of lateral bracing, dangerous structure.

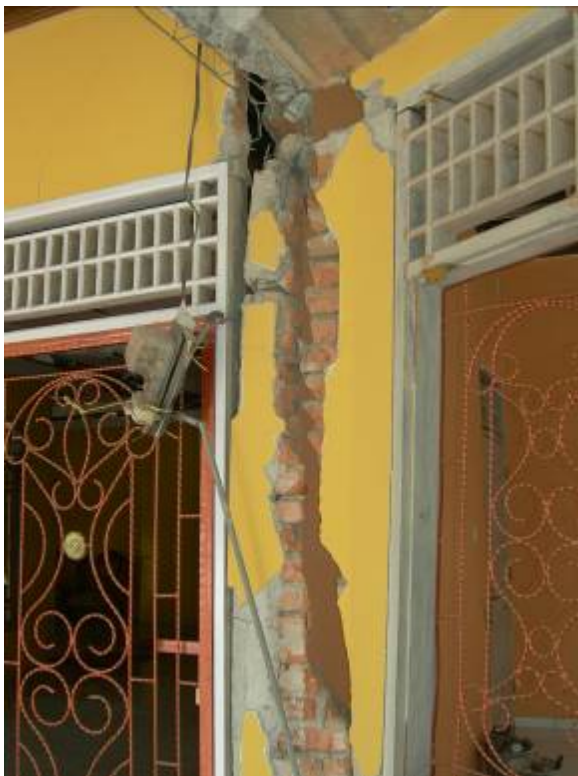
Size of structural columns too small and low quality of re-enforcement bars.

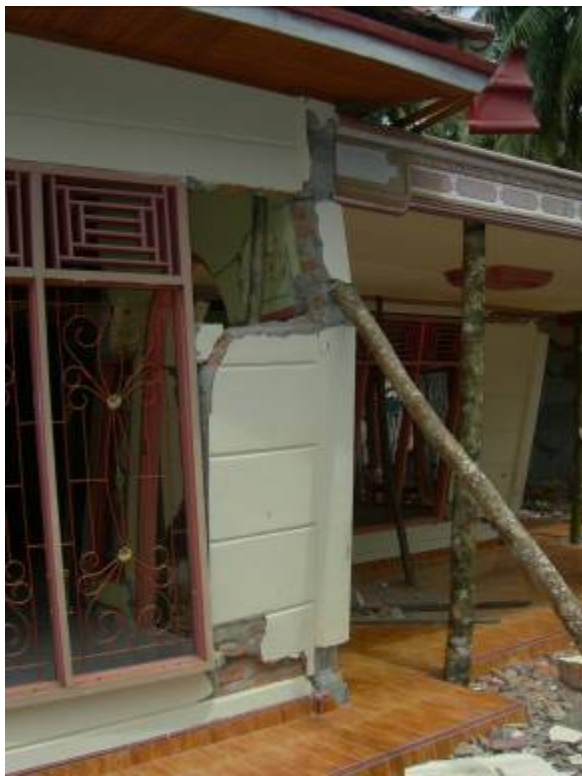
Dangerous structures left and owners put supports to avoid collapse.

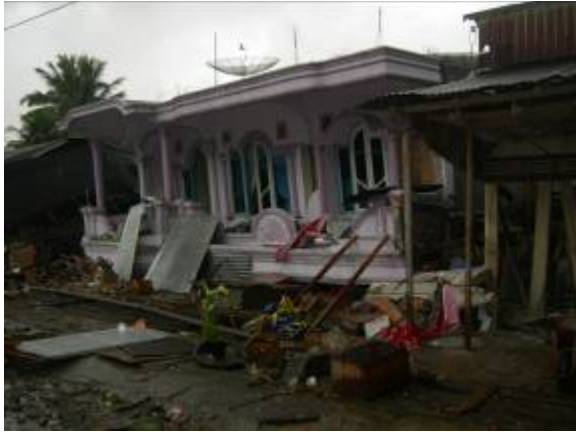
Entire ground floor collapsed.

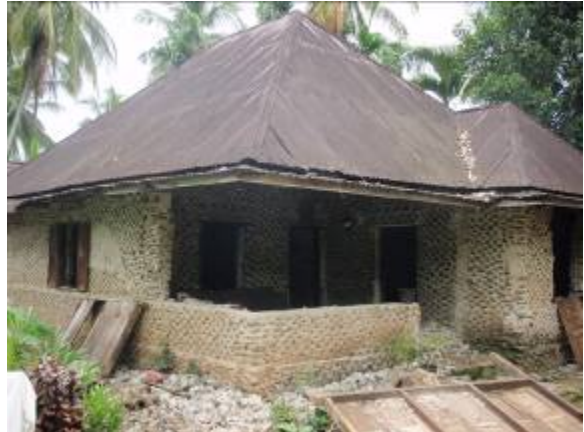
Weakness in corners without structural columns

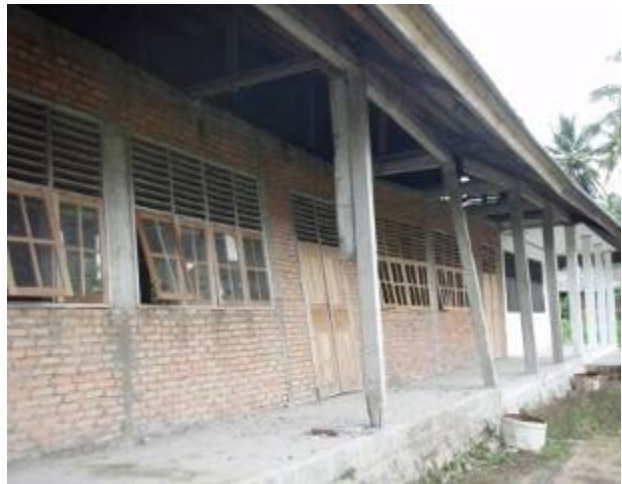
Weak structural columns

The low quality of the structural design can be clearly seen by the damage. Where there are no steel reinforcements at the beam to column connection the structure failed.

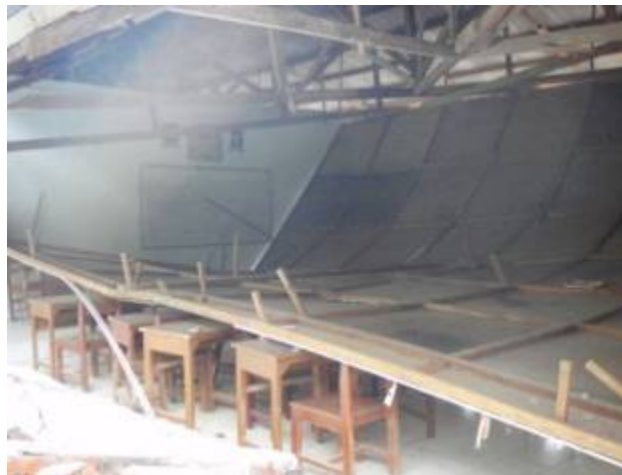
Ceiling caved into class room

This photo shows one of the external walls have collapsed and then the ceiling dropped.

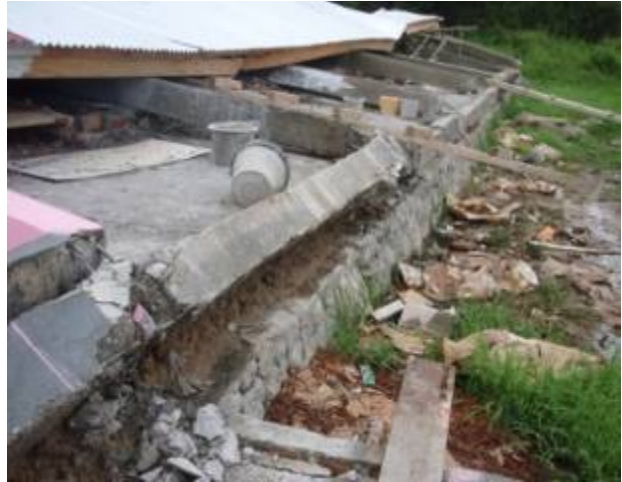
No connection from the Ring beam to the foundations

This detail shows the ring beam was not anchored to the foundations. Thus the building collapsed.

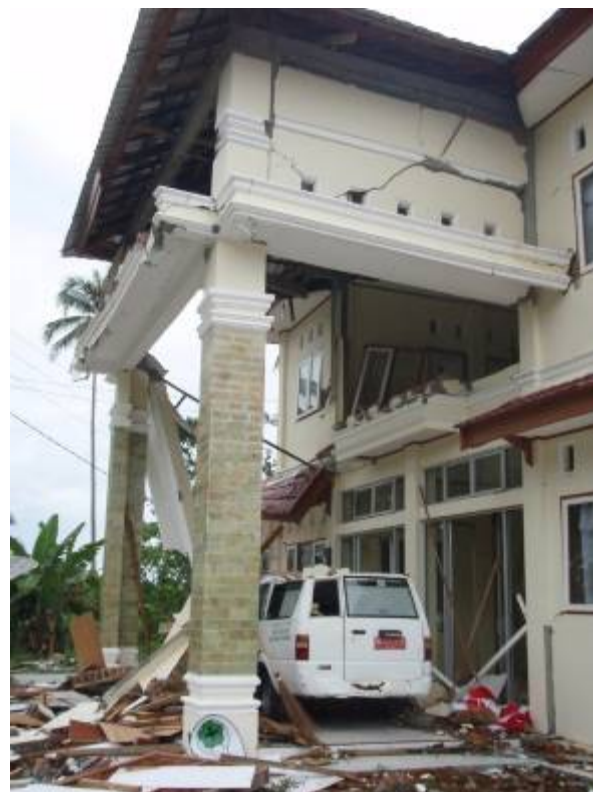
Central hospital in the sub-district have been heavily damaged and hospitals operate under tents.

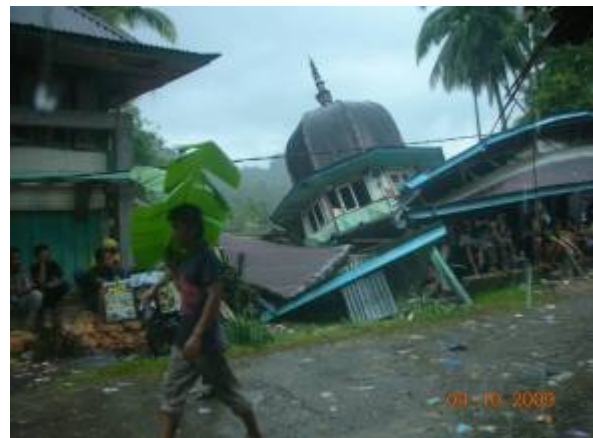
Some Religious buildings have collapsed also, destroying community space.

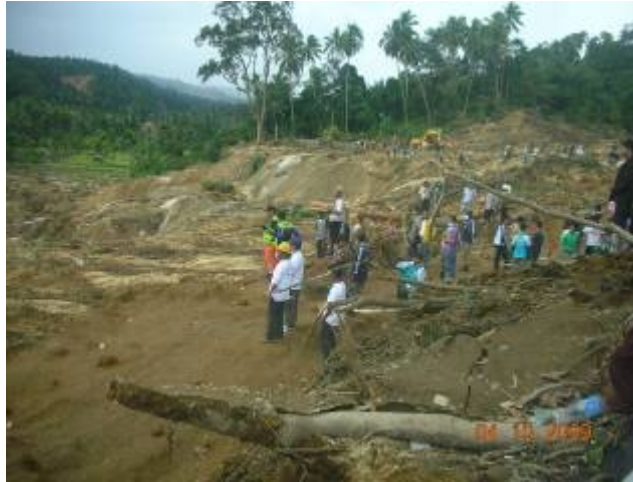
The area of Pariaman have experienced many landslides. This photo is from a village in Patamuar where three complete villages (300 households) were claimed by the landslide, only 4 survived.

- Weakened soil, higher risk of further landslides
- Risk of mud slides in heavy rain
- Loss of agricultural land
- Potential re-location and related tenure issues
