Monitoring the long-term performance of the Peace Tower in Ottawa

NRCC-47706

Monitoring the Long-term Performance of the Peace Tower in Ottawa

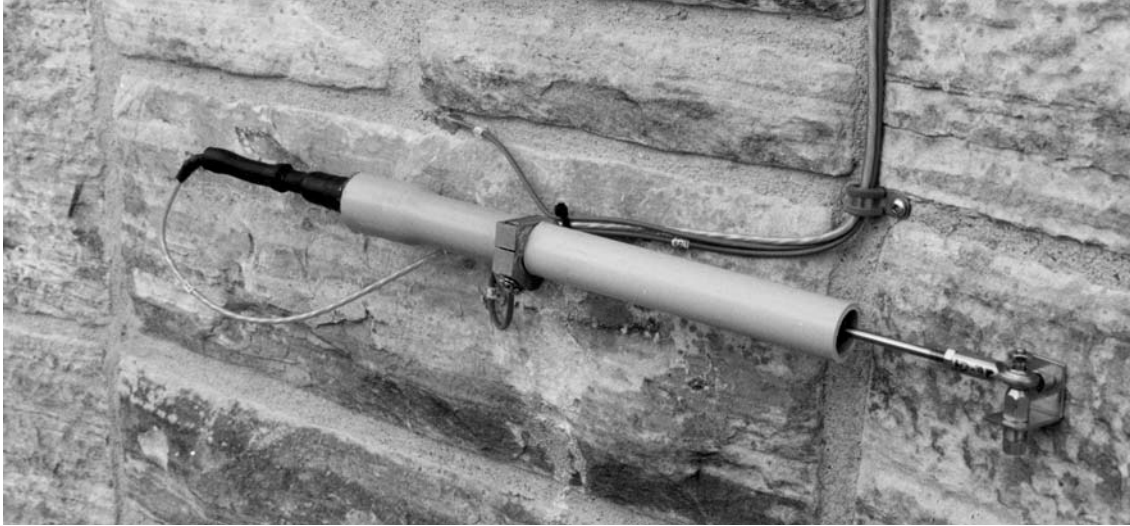
Figure 2. Linear variable differential transformer (LVDT) displacement sensor on the northwest face of the northwest buttress of the Peace Tower. A grey PVC tube covers the stainless steel LVDT to reduce its visibility to the public. A thermocouple temperature sensor glued to a mortar joint right above the LVDT measures surface temperature of the masonry.

Displacement sensors were installed across five repaired cracks to warn if the cracks re-open (Fig. 2). A displacement sensor was also installed to monitor movement at the vertical intersection of the north stone-veneer wall with the adjacent buttress. Tilt sensors were installed at three levels in both the north-south and east-west orientation to give an indication of the overall lateral displacement of the tower. The tower is built on rock so settlement is not occurring and measured movements are therefore very small. Vibration sensors (seismometers) were also installed at four levels to monitor dynamic movement and determine the natural frequency of the tower. Future changes in the natural frequency would indicate a change in the structural properties of the tower.

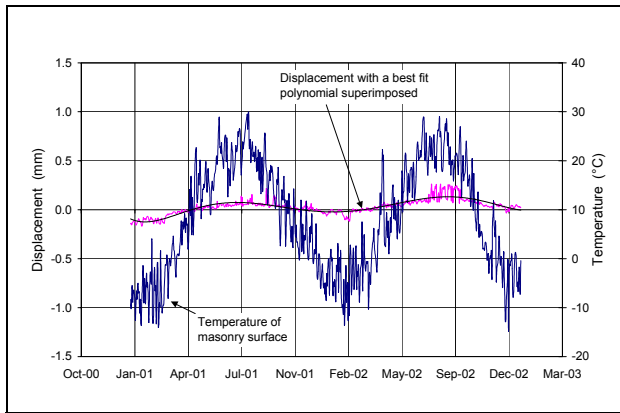
Movement across repaired cracks. Figure 4 shows the typical displacement across one of the repaired cracks in the north face of the north buttress. The temperature at the masonry surface is also shown. Measured displacement between the attachment points of the displacement transducer follows changes in the masonry temperature. The displacement increases as temperature increases. This indicates that the displacement is due to the thermal movement of the masonry, which expands and contracts as its temperature changes. It also indicates that the crack that was previously located at this location has not reopened.

Fig. 4. Movement across an earlier crack in the masonry (crack has not reoccurred). All graphs by the authors unless otherwise specified.

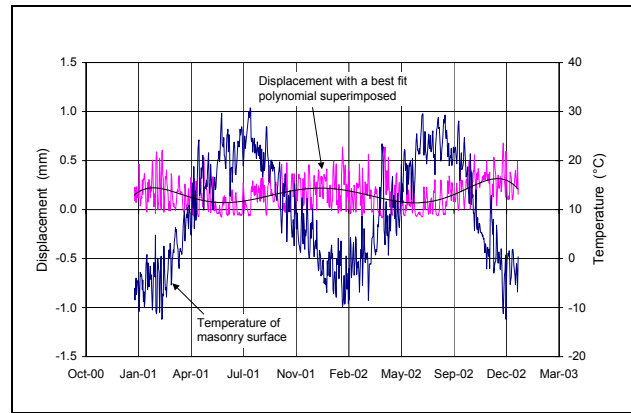
Fig. 5. Movement across an earlier crack in a window sill (crack re-occurred).

Figure 5 shows displacement across a repaired crack below a window sill on the south façade. The temperature of the masonry surface is also shown. In contrast to the previous displacement sensor, the distance between the attachment points of the sensor decreases as the masonry temperature increases, indicating a crack had formed. As the temperature increases, the crack tends to close, thereby shortening the distance between the attachment points. A finite-element analysis of the tower indicated that horizontal tension stresses are induced at this location under pure gravity load. In all likelihood this crack first occurred soon after the tower was constructed. The crack is small and stable, as indicated by the cyclic pattern of the measured displacement.

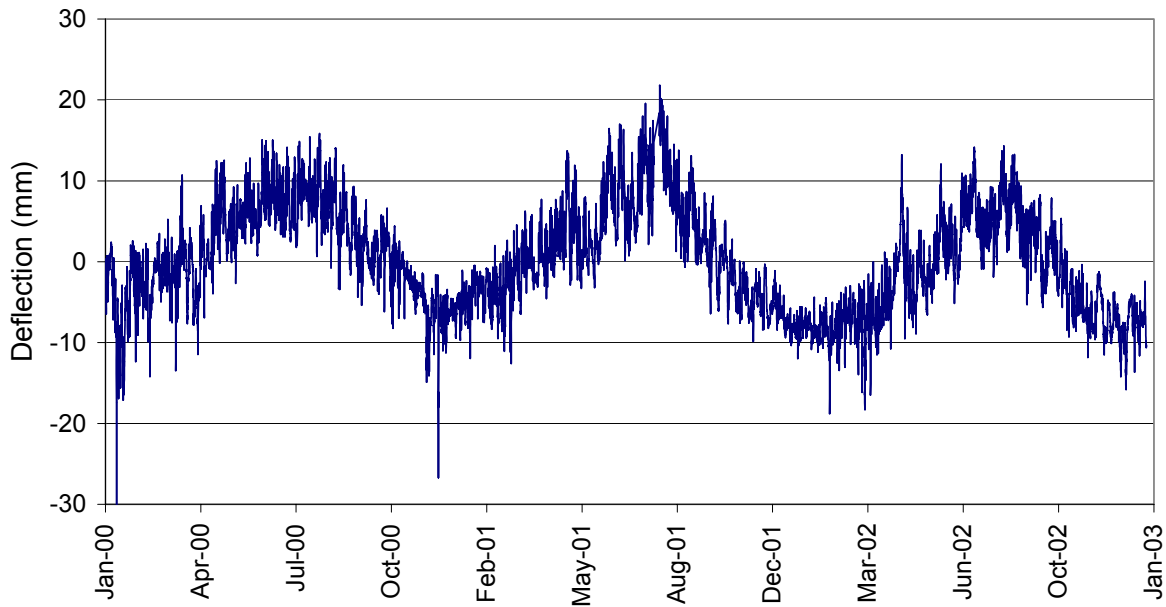
Figure 7 shows that the lateral movement at the top of the tower follows a seasonal pattern with a daily movement superimposed on it. There is a daily cyclical lateral movement of the tower of up to 0.4 in (10 mm) as the sun heats different faces. There is also a seasonal oscillation in the lateral movement of about 1.2 inches (30 mm) due to seasonal effects. Although temperature is supposed to have a negligible effect on the output of the tilt sensors, initial calibration tests show it may be significant for small changes in angle with the temperature swings experienced by the sensors over the year. This phenomenon will be taken into account when more accurate methods of assessing deflection are developed.

Fig. 7. Approximate lateral deflection at the top of the tower (east-west direction). Zero line is arbitrary (based on average over the period shown).

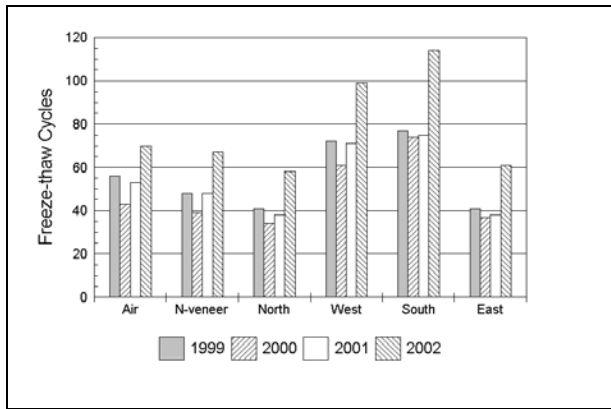
Freeze-thaw cycling combined with high moisture levels greatly increases the risk of frost damage to stone and mortar. The risk also depends on the rate of freezing and on material properties. A freeze-thaw cycle was defined as a temperature drop below 0°C and a return to above zero. Within the masonry wall freezing may occur at a lower temperature because of dissolved salts (for example de-icing salts used on the ground in the winter are absorbed by the masonry at the base of the tower). Figure 8 shows the number of freeze-thaw cycles experienced by the north, west, south, and east faces of the north-west and south-east buttresses. Also shown is the north veneer wall (a lighter construction) and outdoor air for comparison. As expected, the south and west faces experienced the highest freeze-

Fig. 8. Freeze-thaw cycles on the exterior surface of the masonry walls.

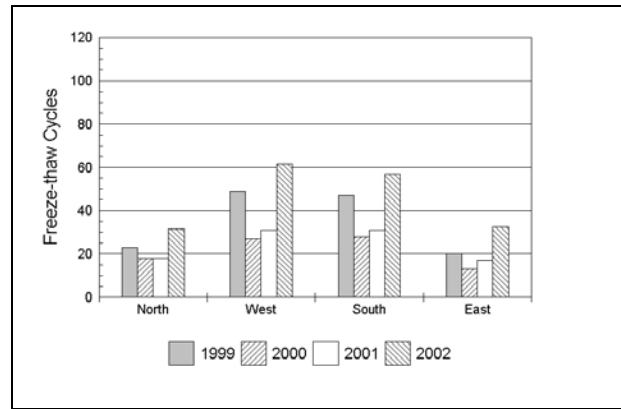
thaw cycles because these orientations have more exposure to sun than the north and east faces (in cold weather the sun warms the masonry above freezing point). The data also shows that freeze-thaw cycling can be significantly different from year to year. Figure 9 shows that the freeze-thaw cycles were also experienced at a depth of 8 inches (200 mm) into the wall. The south and west orientations again experienced the largest number of cycles, but the total number was much less than that on the exterior surface.

Fig. 9. Freeze-thaw cycles experienced within the walls at 8-inch (200 mm) depth.

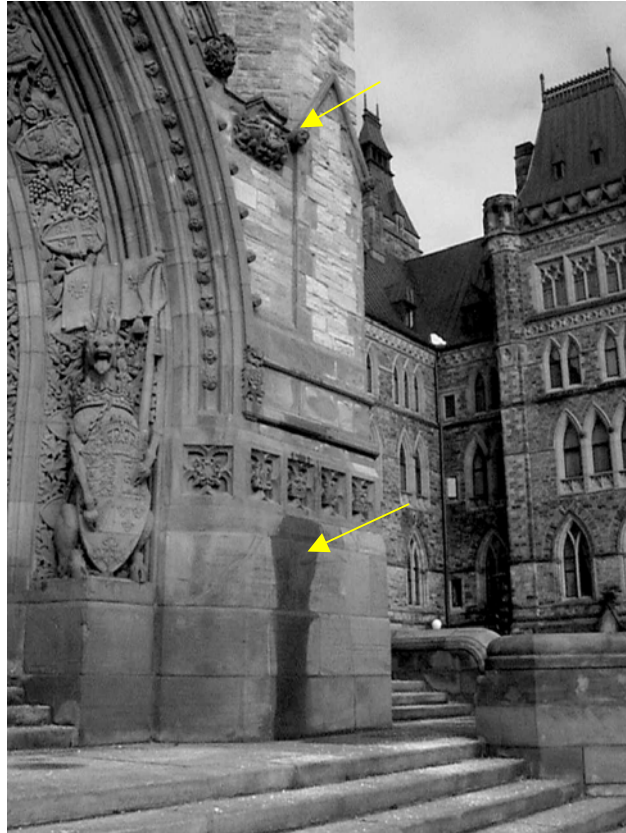
Freeze-thaw cycles do not cause damage unless the masonry has a high moisture content (>75 percent moisture by pore volume). So far frost damage has only been observed in a very few areas to mortar subject to high moisture levels, such as areas where snow melt drains straight onto the masonry or where a water shedding detail does not extend out far enough from the wall below it (Fig. 10).

Fig. 10. Snow-melt dripping onto the masonry from an inadequate water-shedding detail at the south entrance of the tower.

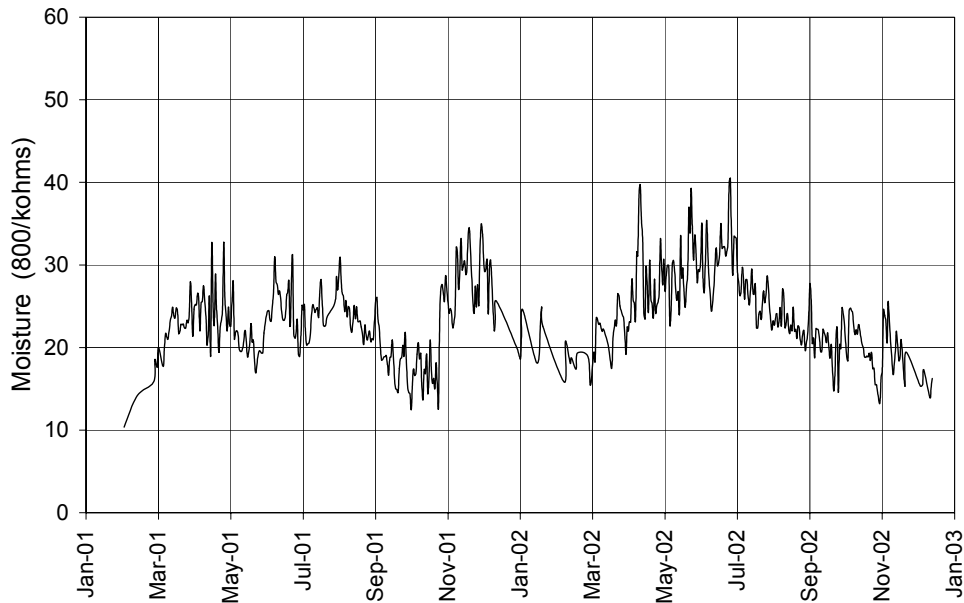
Five moisture sensors were also installed at a depth of 8 inches (200 mm) into the corner buttresses about 75 feet (23 m) above ground level with north, south, east, and west orientations. The 8-inch depth approximately corresponds to the masonry-concrete interface. The west and south sensors have shown significant moisture from the start of the monitoring. This moisture does not seem to be directly influenced by exterior wetting. The moisture may have remained there from the completion of the renovations in 1996, when sections of the wall were grouted. The level of moisture appears to vary over the year, tending to be higher during warmer periods (Fig. 11). The variation in level caused by the effect of temperature on the moisture sensor has been partly taken into account, but more work is needed to define better the temperature correction and determination of moisture content. Moisture variation may also be partly caused by temperature and vapor pressure gradients, which can drive moisture into the wall up to the masonry-concrete interface, where the concrete may be holding back

moisture. Computer modelling of the hygrothermal performance of the wall would provide more insight into the reasons for the damp condition. As noted earlier, the west and south walls are experiencing the highest number of freeze-thaw cycles. Thus, these walls are at a higher risk of frost damage, should the moisture level begin to exceed 75 percent of the pore volume. Methods for determining the actual moisture content at these locations are under investigation.

Fig. 11. Results of the moisture sensor installed 8 inches (200 mm) into the west face of the northwest buttress. The vertical scale is an arbitrary wetness scale. It is determined by the formula, $800/R$, where R (in k-ohm) is the measured resistance of the moisture sensor corrected for temperature: $R = \exp(\ln(R) + 0.02*(T - 20))$. Based on an equation and data from K. Altmann, "Measurement of Moisture in Concrete, in Particular in Construction Components Made of EPS-Concrete," Second International CIB/RILEM Symposium on Moisture Problems in Buildings, Rotterdam, Netherlands, 1974, Paper No. 5-1.1.
