## Monitoring as a tool for sustainable buildings

**NRCC-50436**

Said, M.N.A.; Paquette, J.; Lumsdon, C.

A version of this document is published in / Une version de ce document se trouve dans:  
2<sup>nd</sup> Canadian Conference on Effective Design of Structures, Hamilton, Ontario, May 20-23, 2008, pp. 115-131

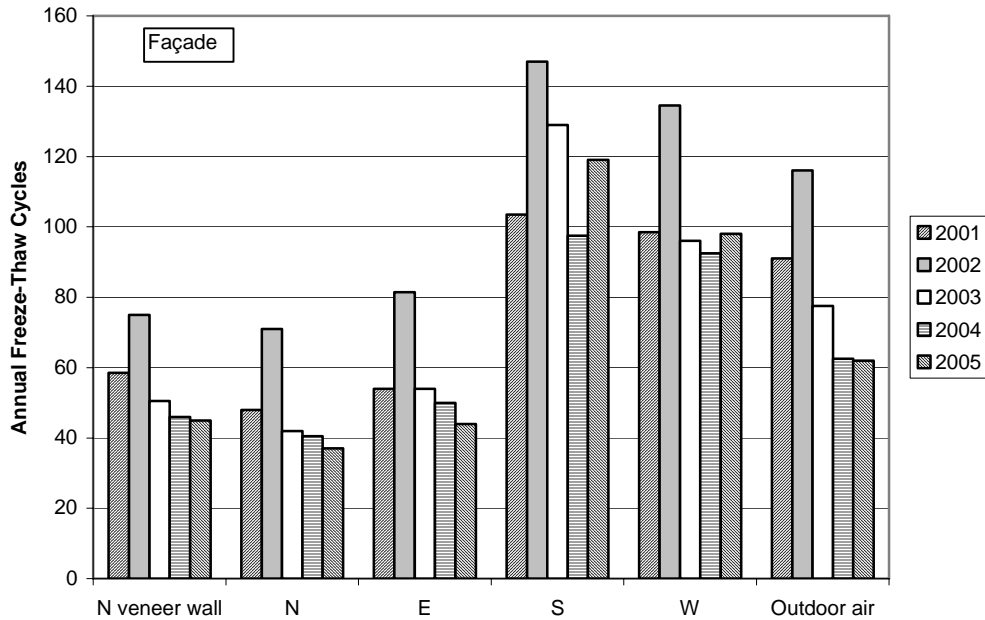
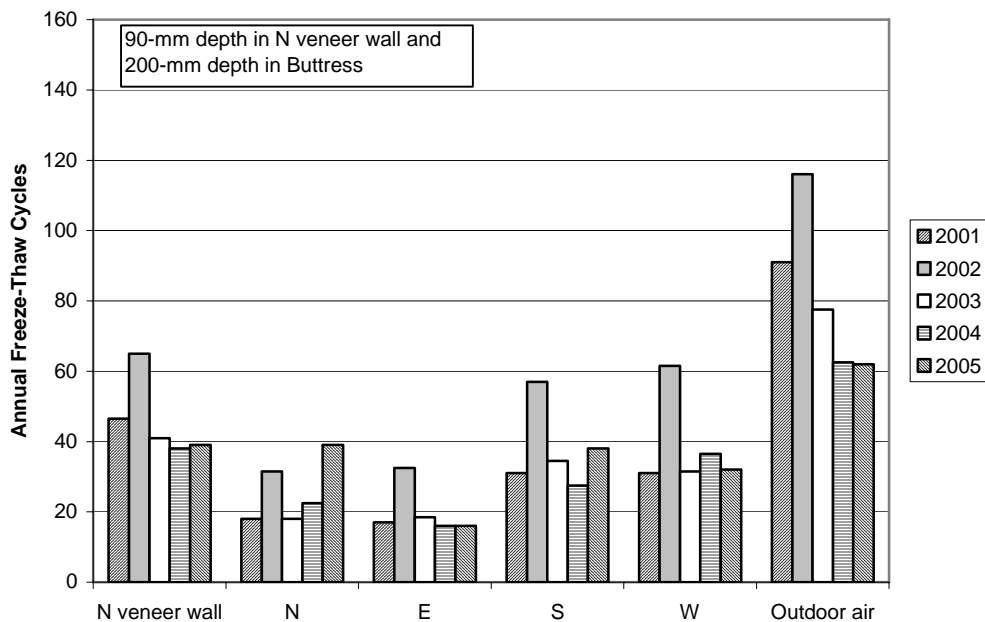
**Figure 7. Annual freeze-thaw cycles experienced by the exterior walls at level 2 for the monitoring period 2001 to 2005. Outdoor air is also shown for comparison.**

The number of F/T cycles experienced by the south façade (119 cycles) and the west façade (98 cycles) in 2005 is considered high. However, freeze-thaw cycles do not cause damage to the masonry or the mortar unless they have high moisture content (>75% moisture by pore volume). Frost damage potential also depends on the rate of freezing and the pore structure of the material.

Freeze-thaw cycles were also experienced within the exterior walls, but the number of cycles was much less than that experienced by the façade. Figure 7, Graph (B), shows F/T cycles experienced at level 2 at 200-mm depth in the buttresses and at 90-mm depth in the north veneer wall. Similar to the façade, the south and west façades experienced the highest F/T cycles (38 and 32 cycles respectively). At Level 9 (the Observation area level), the number of F/T cycles experienced by the west face at 50-mm depth was in the high side (70 cycles).

The F/T cycles results indicate that the south and west façades should be given priority in the spring inspection in order to insure that mortar joints are in good conditions ahead of the rainy spring and summer seasons. So far frost damage has only been observed in few areas in mortar joints in the west façade at decorative feature areas where snow usually accumulates and areas where snowmelt drains straight onto the masonry. Repair of damaged mortar joints should be given priority because they provide potential paths for water (wind-driven rain, melted snow, and run off water) ingress into the walls.

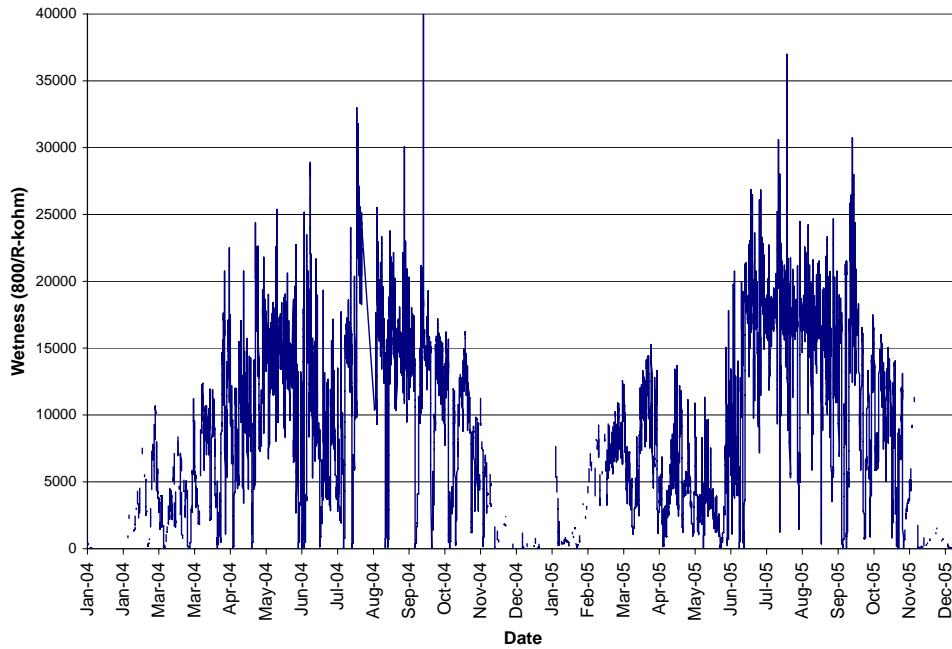
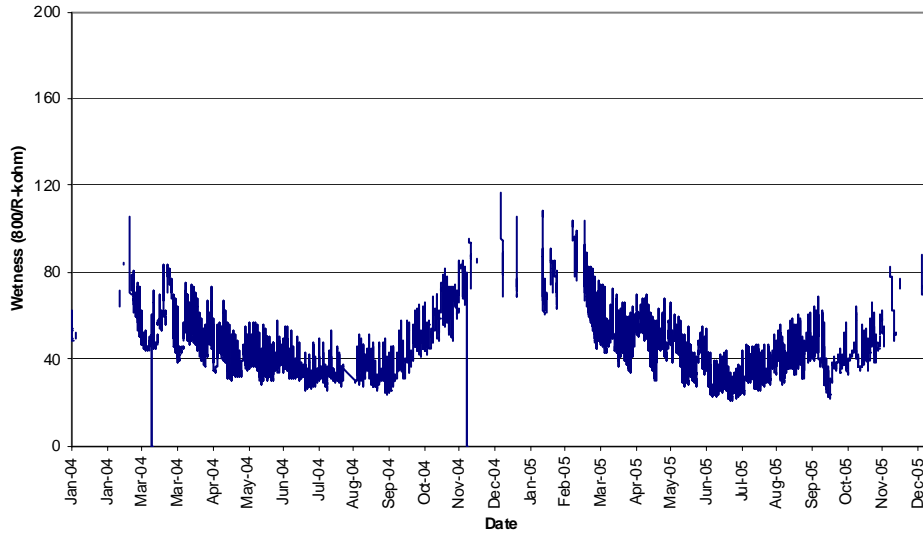
Figure 8, Graph (A) shows an example of wetness pattern of the west façade of the NW buttress. Moisture pins sensors (stainless-steel screws inserted to a 10-mm depth in a mortar joint) indicated that façade wetness occurred mostly in April to November months. Figure 8, Graph (B) shows the changes in moisture conditions at the 200-mm depth, the stone-concrete interface, in the west façade of the NW buttress. Moisture content started increasing in October and peaked in December-January. This indicates that during the fall-winter months, moisture movement was mostly inward where it accumulated at the less permeable concrete interface. With the start of favorable drying conditions outdoors in the spring, accumulated moisture started to dry to outdoors and the wall returned to its initial moisture conditions in June-July months; i.e. no net moisture accumulation over the 2005 period. Similar moisture variation pattern was observed in the north face of the NW buttress and the south face of the SE buttress.

**Figure 8. Example of wetness variation pattern of the façade and at 200-mm depth of the W-face of the NW buttress, level 2. The vertical scale is an arbitrary wetness scale. It shows changes in moisture conditions. The scale is determined by the formula,  $800/R$ , where  $R$  (in k-ohm) is the measured resistance of the moisture sensor.**

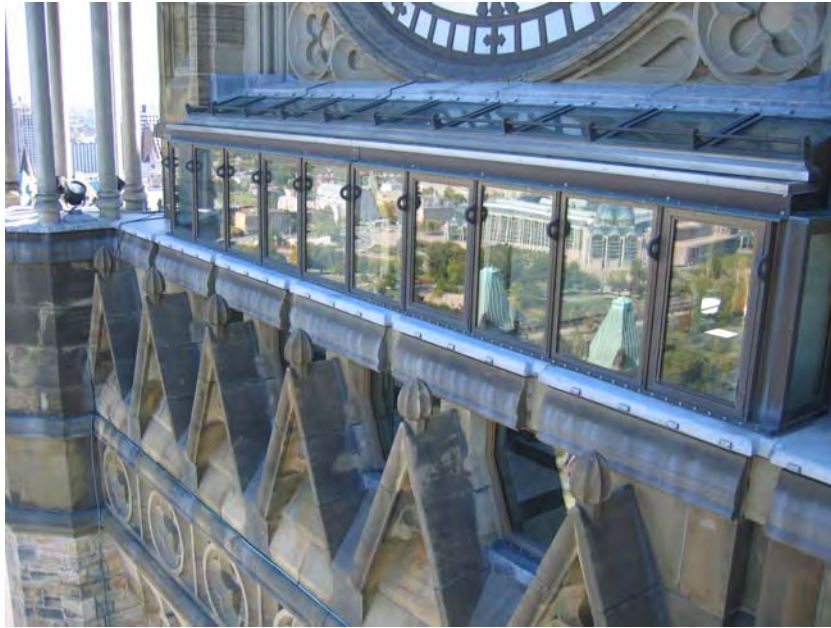
**Figure 9. Photo showing dampness of the north façade at the Observation level. Notice the good condition of the Wallace stone and the mortar joints. The gray stain is a result of run-off water from the lead flashing above.**

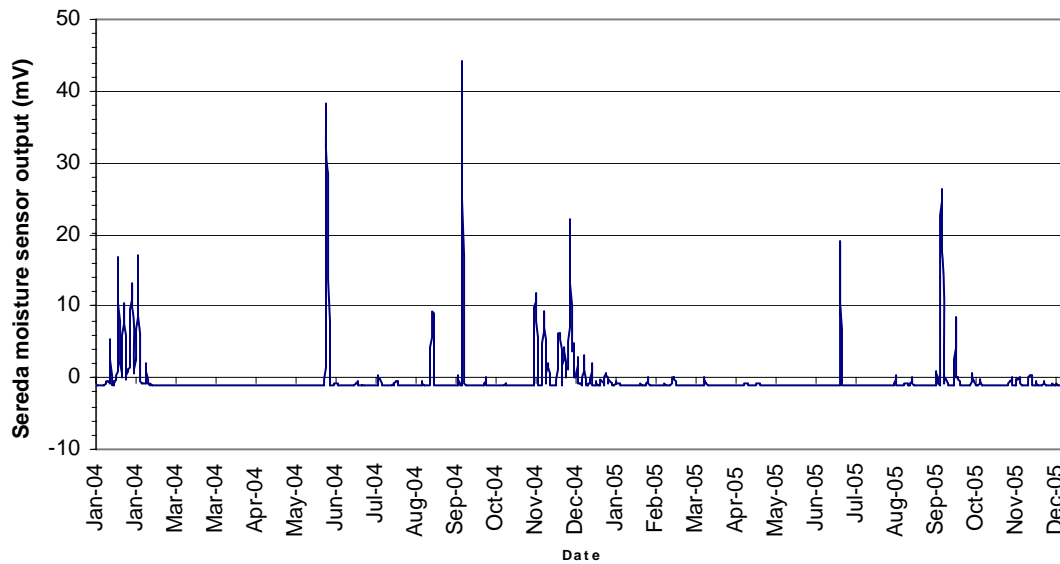
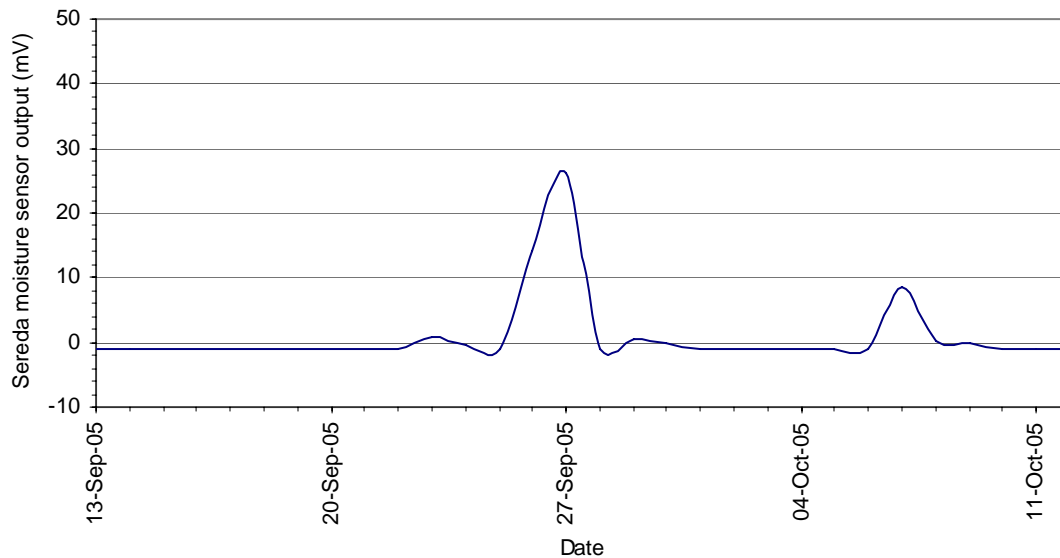
*Moisture on interior surfaces:* There was no indication of surface condensation on the north-glazing units in the Observation area. The surface temperatures of the glazing and the frame were above the dew-point temperature of indoor air during the 2005 period. At the clock level (level A), periods of condensation were recorded in January, July, and October 2005 by the Sereda moisture sensor located by the 6-O'clock numeral on the inside surface of the clock's north glazing, see Figure 10, Graph A. The condensate dried out within 2 to 3 days (an example is shown in Figure 10, Graph B).

**Figure 10. Periods of condensation recorded by the Sereda moisture sensor located by the 6-O'clock numeral on the inside surface of the clock's north glazing during 2004 - 2005.**

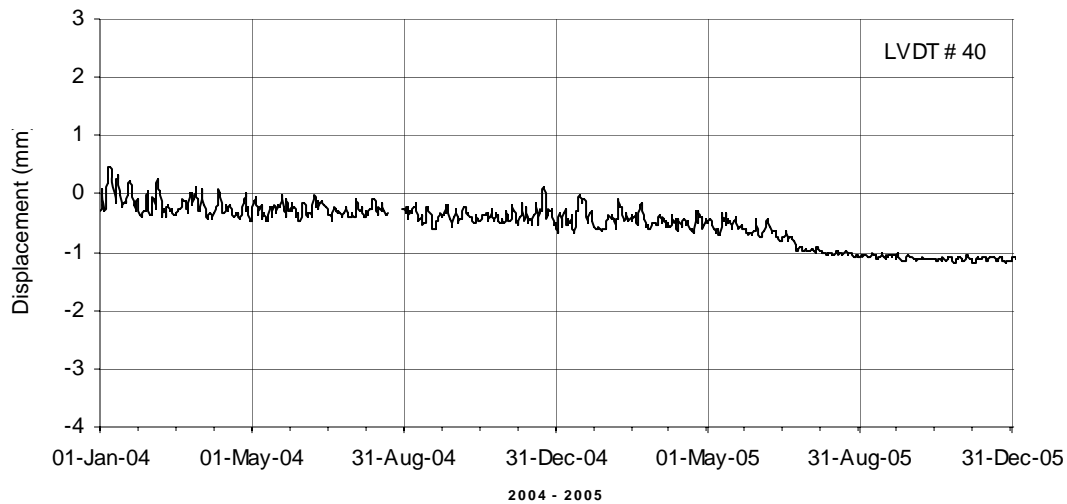
*Crack displacement:* The displacement sensor (# 40 in Figure 11) located in the south façade under a windowsill at level 1D changed its normal behaviour in July 2005 (see Figure 12). The displacement showed a gradual contraction leveling off to approximately -1.2 mm. The permanent contraction means that there was no restraint to shrinkage movement probably due to loss of pointing mortar. Figure 3 shows the condition of the mortar joint in November 1999 and Figure 13 shows its condition in September 2007. The displacement at this location is expected and probably was there since the tower's construction. A finite element analysis [7] indicated that horizontal tension stresses are induced at this location under pure gravity load. Frost damage was probably an aiding factor in the loss of the pointing mortar once it lost adhesion to the stones. The south façade has been experiencing high number of freeze-thaw cycles (see Figure 7). The crack at this location provides a high potential path for water entry into the wall because snow usually accumulates right above it.

**Figure 12. Displacement under a windowsill in the south façade at level 1D over 2004 – 2005 monitoring period. Daily values are based on hourly average before midnight; datum value is January 1<sup>st</sup>, 2000 and displacement is corrected for temperature.**

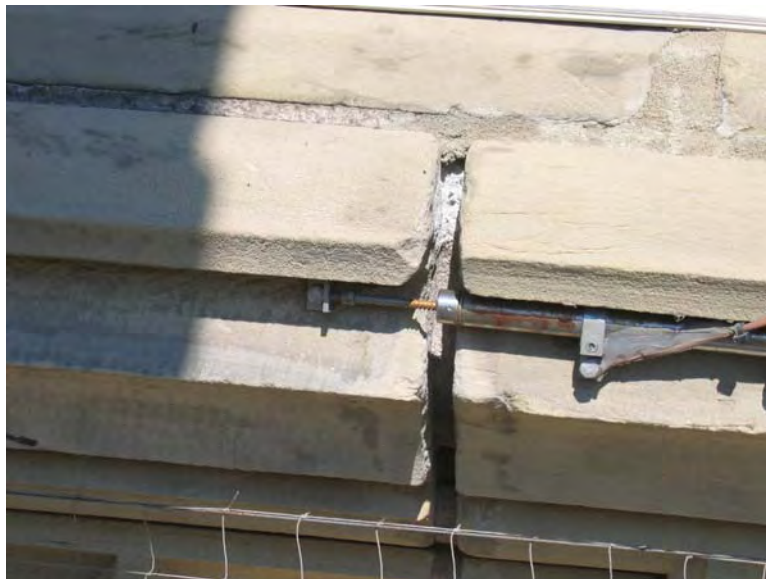
**Figure 13. Photo (Pt070920-24) showing the condition of the mortar joint in September 2007.**

Displacement sensors showed long-term movement trend of former cracks. Some sensors indicated possible hairline cracks that have remained stable. The sensor monitoring a repaired crack under a windowsill in the south façade showed a gradual contraction leveling off to approximately -1.2 mm a result of pointing mortar loss. Frost damage was probably an aiding factor in the loss of the pointing mortar once it lost adhesion to the stones. The crack at this location provides a high potential path for water entry into the wall because snow usually accumulates right above it.

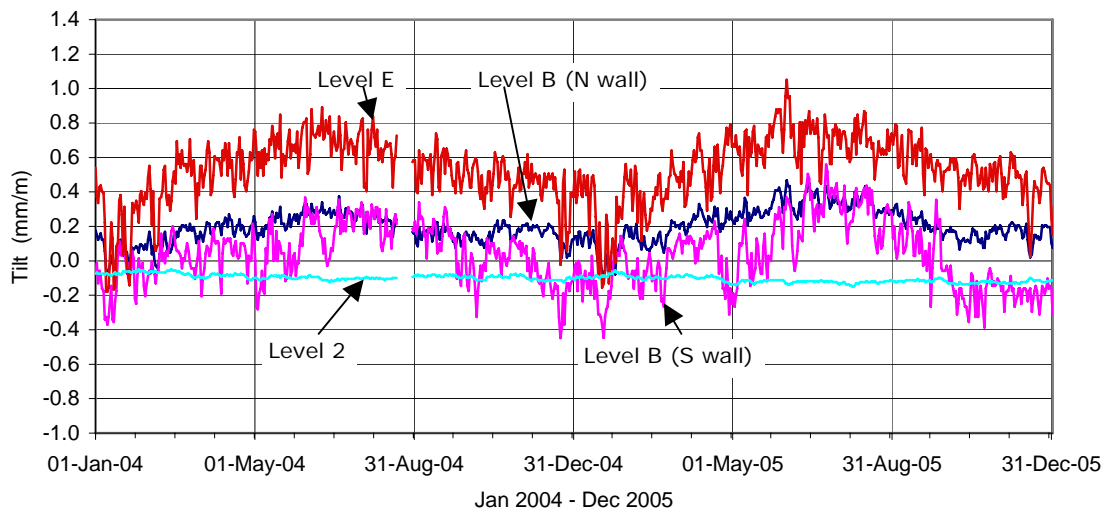
The tower's tilt in both the E-W and N-S directions, with one exception, showed the normal yearly cyclical movements and appear to gradually increase in value with time (Figure 14). The exception occurred at Level 2, where the tilt meter in the E-W direction hardly showed any annual cyclical movement and seems to gradually decrease in value with time. This suggests that there is a very small gradual change in the tower's structure. Also the very small tilt in the E-W direction at level 2 is due to restrain by the connection to the Center Block building close to this level.

Over 2004 – 2005 period, the largest tilt movement was about 1 mm/m in the E-W direction at the top of the tower. The resulted tilt behaviour of the structure is a result of its 30° offset, which expose the E, W, and S façades to the sunrise and sunset heat.

**Figure 14. Tower's tilt in the E-W direction at levels over the period 2004-2005.**
