THE MECHANICS OF LANDSLIDES IN LEDA CLAY

W. J. EDEN AND R. J. MITCHELL

RESEARCH PAPER NO. 441
OF THE
DIVISION OF BUILDING RESEARCH

The mechanics of landslides in Leda clay¹

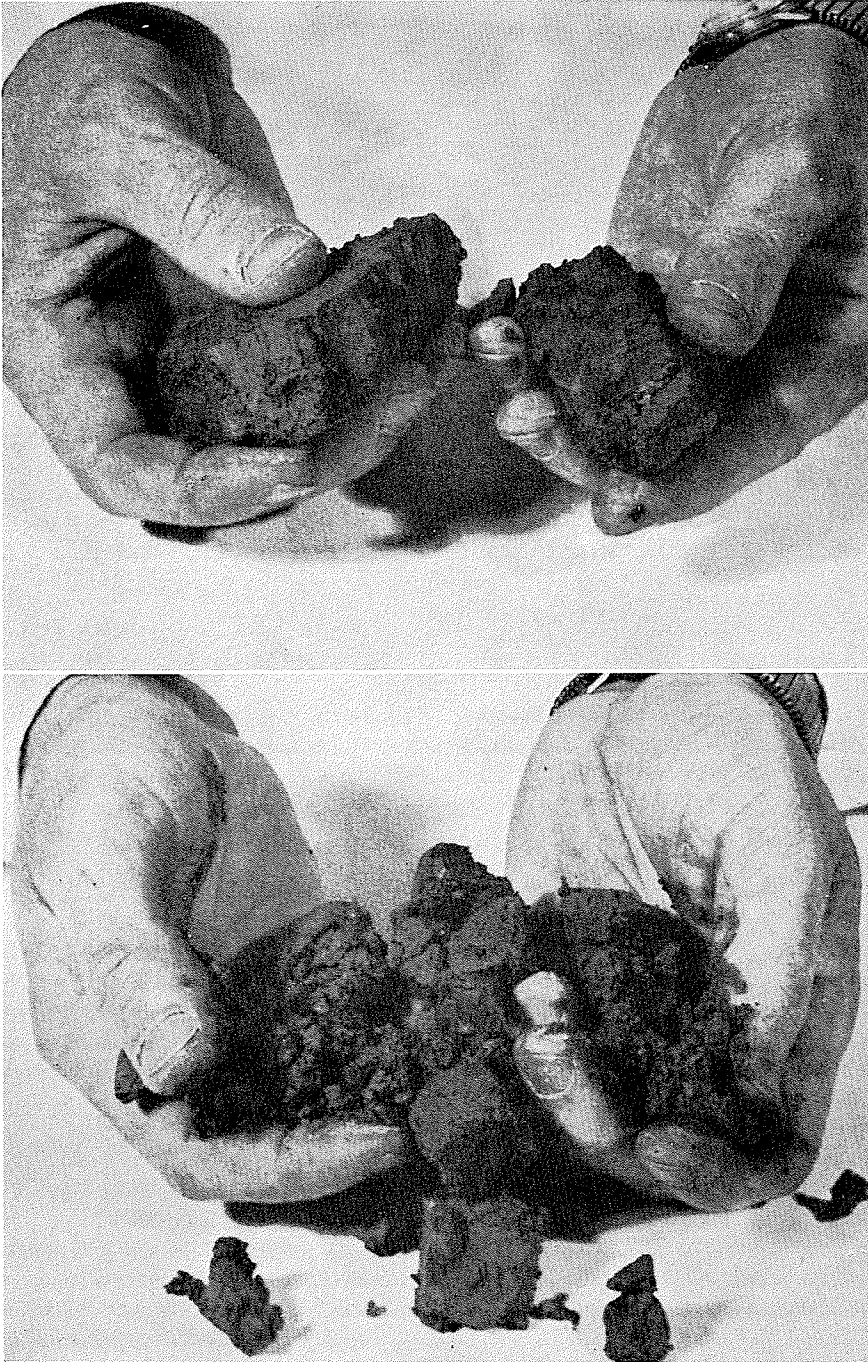
FIG. 1. Nodular composition of Leda clay.

The strength of Leda clay in the low stress region appears to be predominantly frictional, i.e. dependent on normal stress. Dilatant behavior is attributed to the existence of structural defects (closely spaced hairline fractures or 'closed fissures') which allow strain discontinuities to occur within the material. Features illustrated in Fig. 1 were observed in the test specimens after failure.

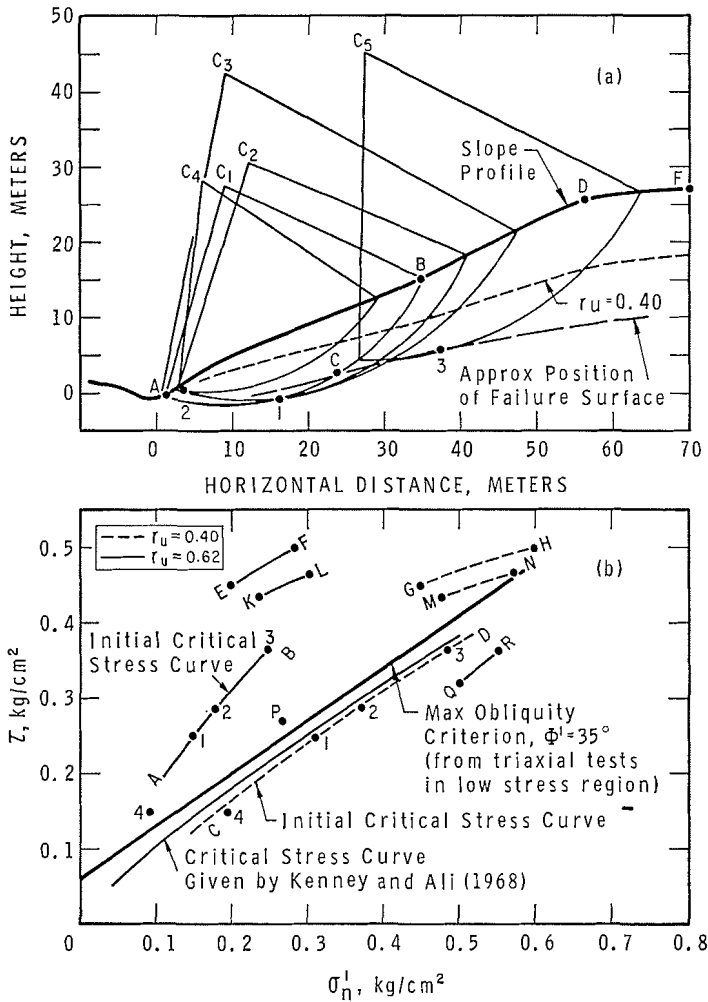
FIG. 6. Analysis of the Breckenridge landslide. (a) trial circles; (b) critical stress curves.

Because of the geometry of the Breckenridge slope it is believed that the initial slide did not involve the total slope height (Kenney and Ali 1968). In Fig. 6a various possible circular slip surfaces for the Breckenridge slope are drawn with centers C_1 to C_4 and passing through points 1 and 2 in the vicinity of the failure surface. Stability analyses based on these failure surfaces and two values of r_u yield the critical stress curves AB and CD in Fig. 6b. The critical stress curves can be compared directly with the maximum obliquity criterion (c', Φ') obtained

A variable r_u factor (varying from 0.50 at the top of the slope to 0.62 at the toe to approximate the conditions considered applicable at the time of the slide) was used in a modified computer program to obtain a critical toe circle for $\Phi' = 35^\circ$. This circle lies between circles c_1 and c_2 in Fig. 6a and gives a factor of safety, F.S. = 0.95 (point P in Fig. 6b, where

Assuming that the initial slide occurred along the arc given by circle c_1 in Fig. 6a the first retrogressive slide was analyzed using the geometry ACBDF. The computer was restricted to searching for critical circles through point 3 (Fig. 6a) on the failure surface and yielded the critical stress curves EF and GH in Fig. 6b. A second retrogressive slide was analyzed in a similar manner by approximating the geometry of the slope after the most critical circle (center c_5 in Fig. 6a) was assumed to slide during the first retrogressive failure. This analysis yielded the critical stress curves KL and MN in Fig. 6b. These critical stress curves all lie above the failure criterion in Fig. 6b indicating that retrogressive sliding would occur at average r_u values of 0.4. These calculations make no allowance, however, for the stabilizing effect of that spoil material which comes to rest in the landslide crater.

Finally, the existing stable back scarp was analyzed with respect to circles tangential to the projected failure surface. These computations yielded the critical stress curve QR in Fig. 6b and predicted the stability of the scarp under the extreme conditions of full hydrostatic saturation.

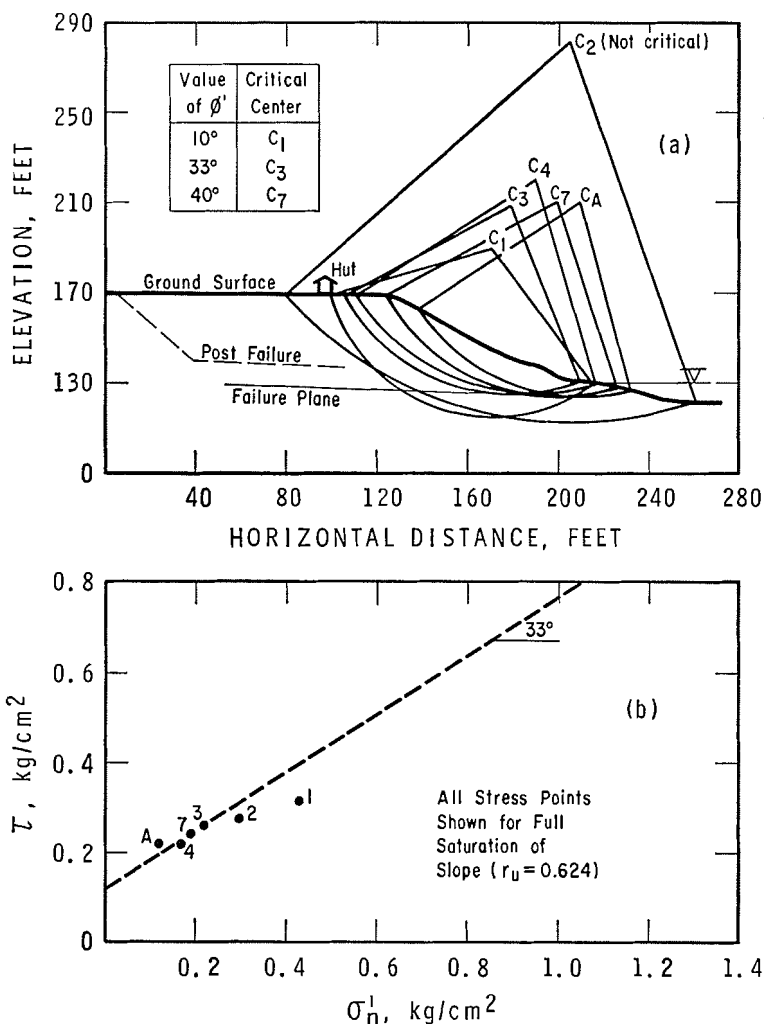
Average stress points are plotted in Fig. 7b for several trial circles shown in Fig. 7a (the stress points are numbered to correspond to

the trial circle numbers). A failure envelope ($c' = 0.12 \text{ kg/cm}^2$, $\Phi' = 33^\circ$) was chosen to approximate the triaxial test data in Fig. 4. The circles with centers at c_3 , c_4 , and c_7 in Fig. 7a yield stress points 3, 4, and 7 which lie on this failure line. As the circle with center c_3 was calculated to be critical for $\Phi' = 33^\circ$ the analysis indicates that the slope would be at a condition of limiting equilibrium when fully saturated under a hydrostatic groundwater condition.

Personnel working in the vicinity of the slide claimed that a hut located on the upper terrace (Fig. 7a) was missing immediately after they heard the noise caused by the initial slide. Stability analysis suggests that the initial failure surface would intersect the upper terrace quite close to the hut. Some approximate calculations regarding the retrogressive slips indicate the gross instability of the slope remaining after the initial slide. The stability of the post failure ground surface (Fig. 7a) was considered with respect to trial circles tangential to the projection of the failure plane and with respect to trial circles emerging at the toe of the back scarp. In both cases a safety factor in excess of unity was obtained.

FIG. 7. Analysis of the Rockcliffe landslide. (a) critical circles; (b) critical stress points.

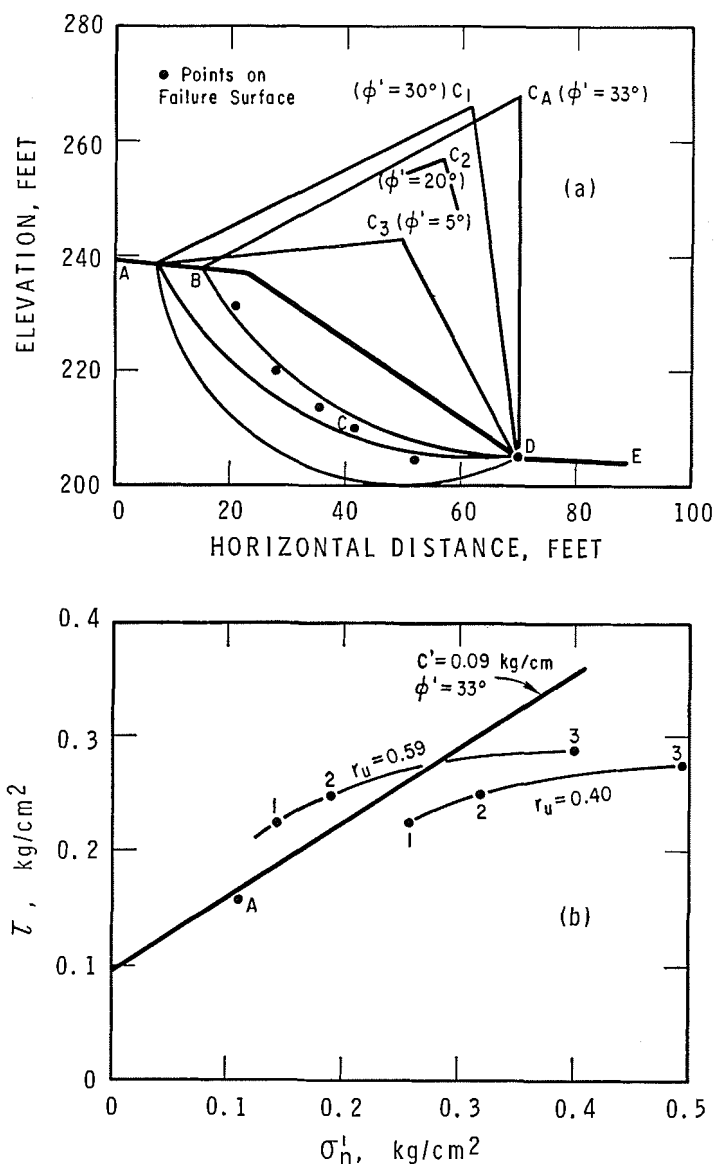
Three critical circles, as shown in Fig. 8a, were analyzed and gave the average stress

points 1, 2, and 3 plotted in Fig. 8b for the two limits of r_u . A comparison of these stress points with the failure criterion indicates that failure would not occur on the deeper circles (calculated critical for $\Phi' < 20^\circ$). For the condition of full saturation instability is predicted for circles with centers c_1 and c_2 . The factor of safety calculated for circle c_1 is 0.84. For an average r_u value of 0.40 the slope would be considered stable with respect to these circles.

$\Phi' = 33^\circ$, in Fig. 8a and appears to approximate the observed failure surface reasonably well. The closed solution gives the average stress point A in Fig. 8b for the condition of full saturation. The factor of safety predicted by the latter calculation is 1.05. A similar analysis of the profile ABCDE in Fig. 8a gave a factor of safety of 1.10 for the slope remaining after the slide.

FIG. 8. Analysis of the Orleans landslide. (a) critical toe circles; (b) critical stress curves.
