Status Report on the Drift Chambers

Brian S. Henderson
Massachusetts Institute of Technology
OLYMPUS Collaboration Meeting
June 27, 2011

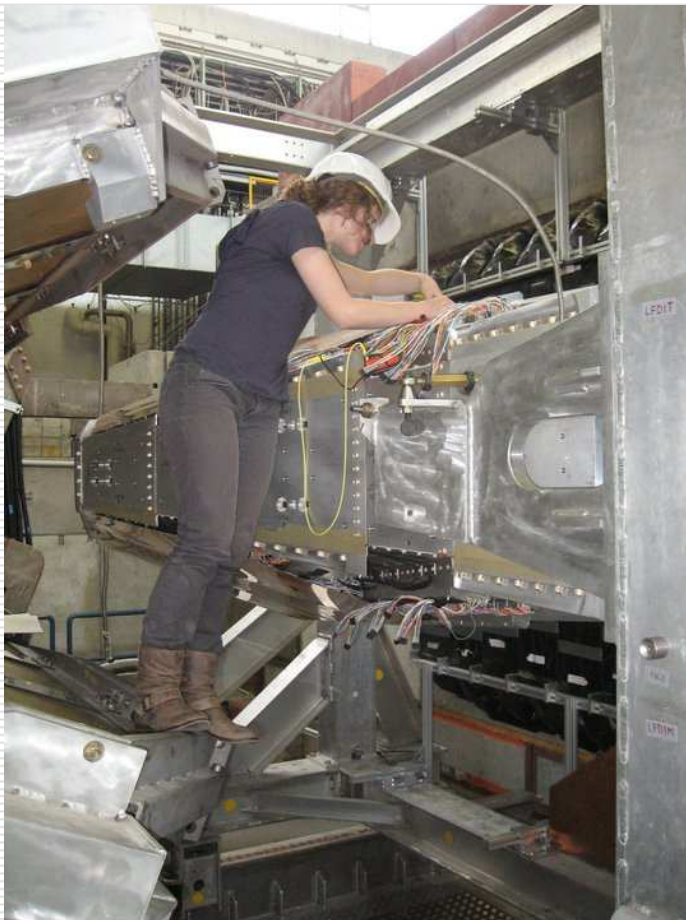
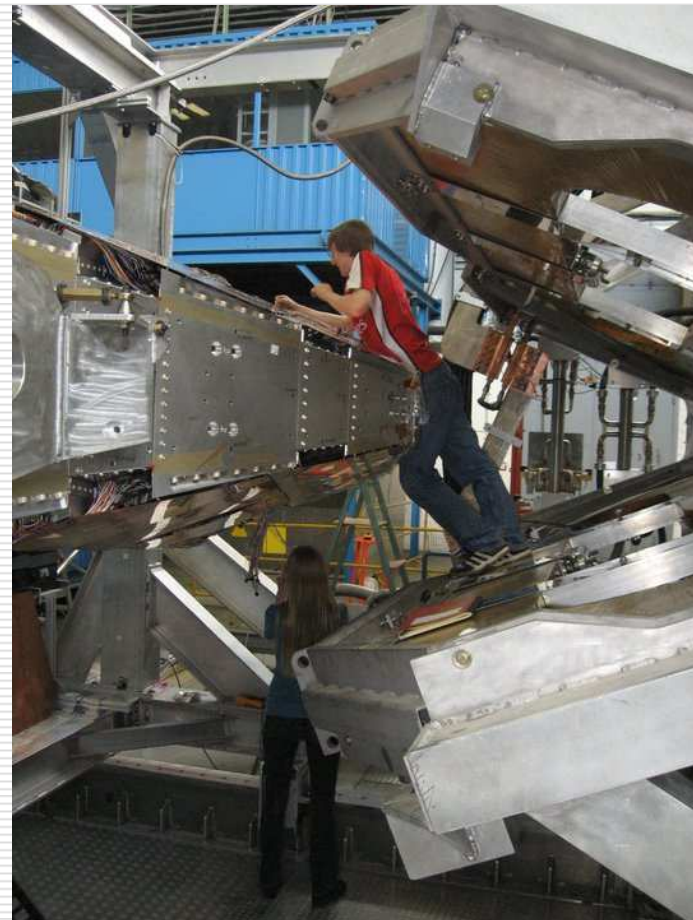
Wire Testing and Repair

- Graduate students arrived in mid/late May
 - Brian Henderson (MIT), Lauren Ice (ASU), Colton O'Connor (MIT), Becky Russell (MIT), Axel Schmidt (MIT)
- All ~10000 wires checked for continuity and crossings
 - Visual inspections for slack wires
- Necessary repairs made in situ
- Repairs are ongoing as new problems are identified
