# Heating of Olympus Target Cell

## Frank Brinker

I tried to collect and document here some of the phenomena connected with the intense heating of the Olympus target cell. I use archived data from the runs and pictures taken by Jan Bernauer as well as my own observations. This collection is surely not complete and should be complemented by other observation, calculations etc.

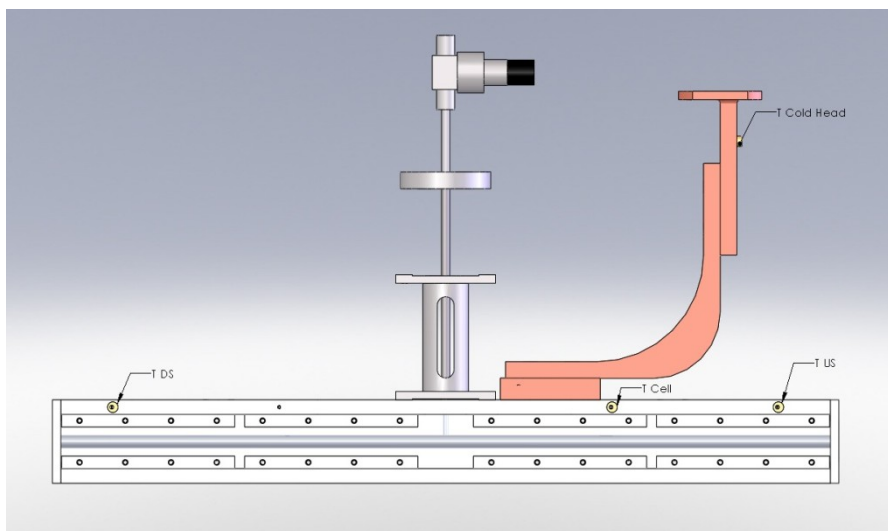
Figure 1: Positions of temperature sensors

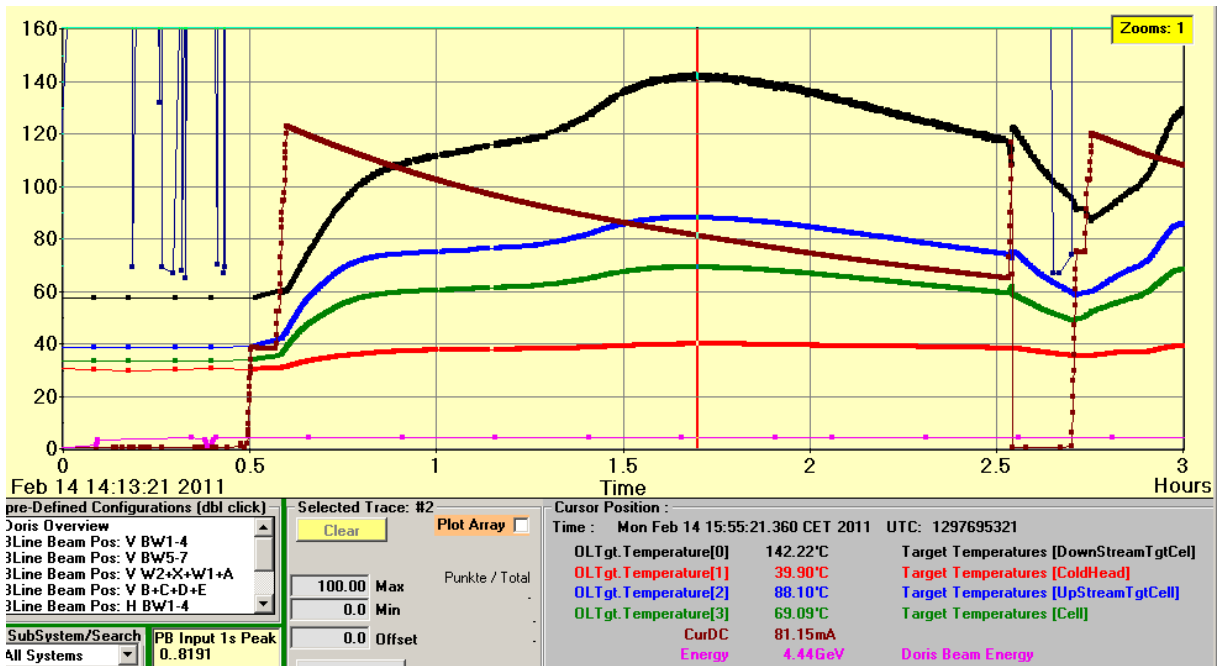
Figure 2: Temperatures at sensors, 10 Bunches 120 mA max., beam oscillations until 1.3 hours

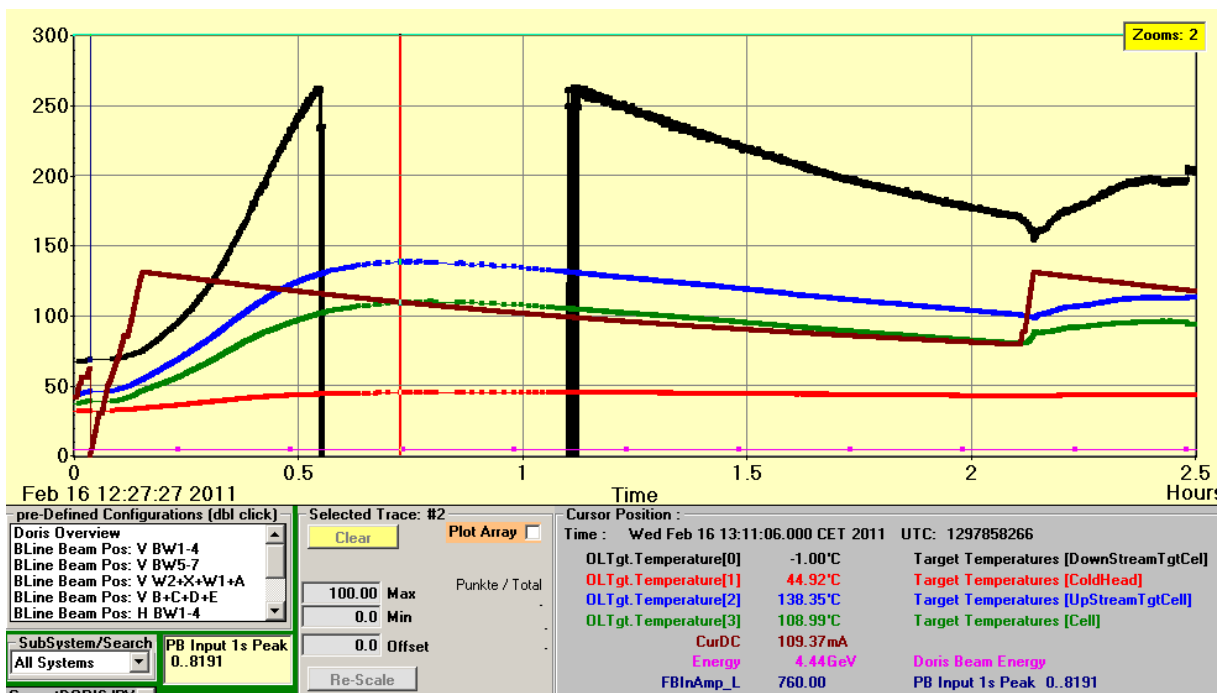
Figure 3: Temperatures for 130 mA, 10 Bunches, 4.4 GeV, w/o oscillations

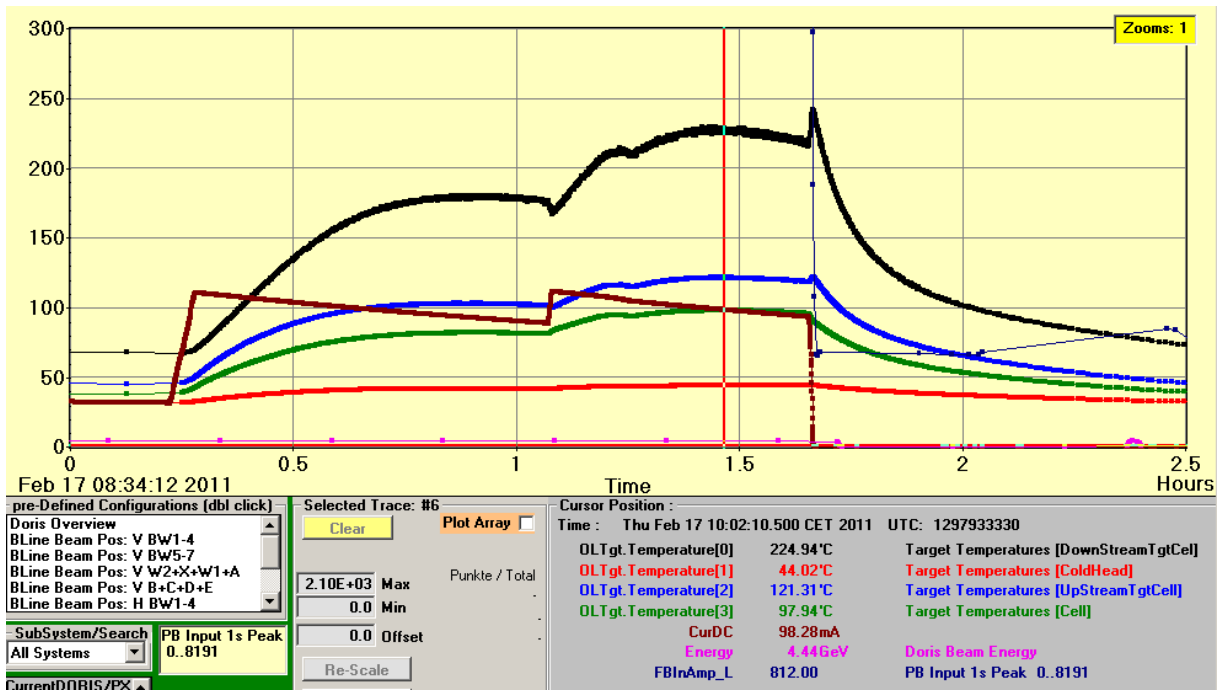
Figure 4: Temperatures, 2 consecutive runs with  $I_{max}=110$  mA, 10 Bunches, 4.4 GeV, no oscillations

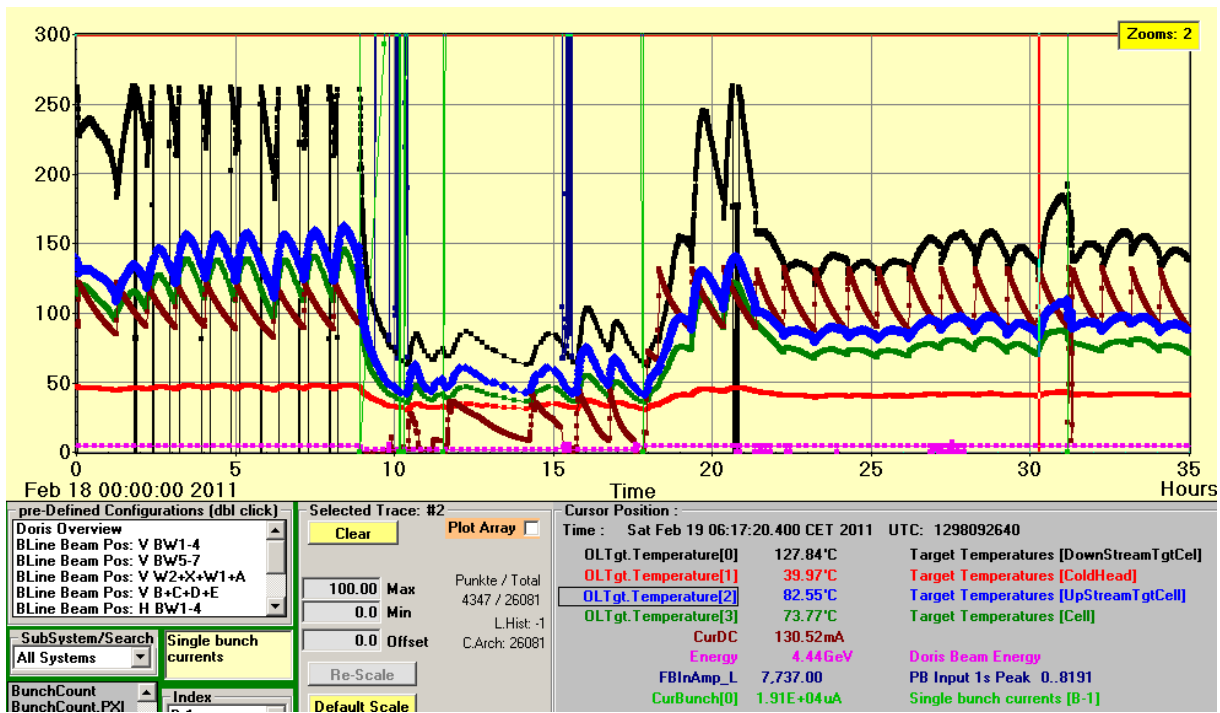
Figure 5: Temp., 10 Bunches, 130 mA, 4.4 GeV, w/o oscillations up to 22 hours and with oscillations afterwards. Low current runs were with 2 GeV. The one run at 31 h had 19mA filled in the first bunch instead of 13mA.

1. In Figure 5 one sees the influence of longitudinal beam oscillations on the temperatures. The difference U-C is nearly constant (~20K) whereas the difference D-C more than doubles from 60-70K to ~140K when the oscillations vanish. D-C is about 7 times U-C!

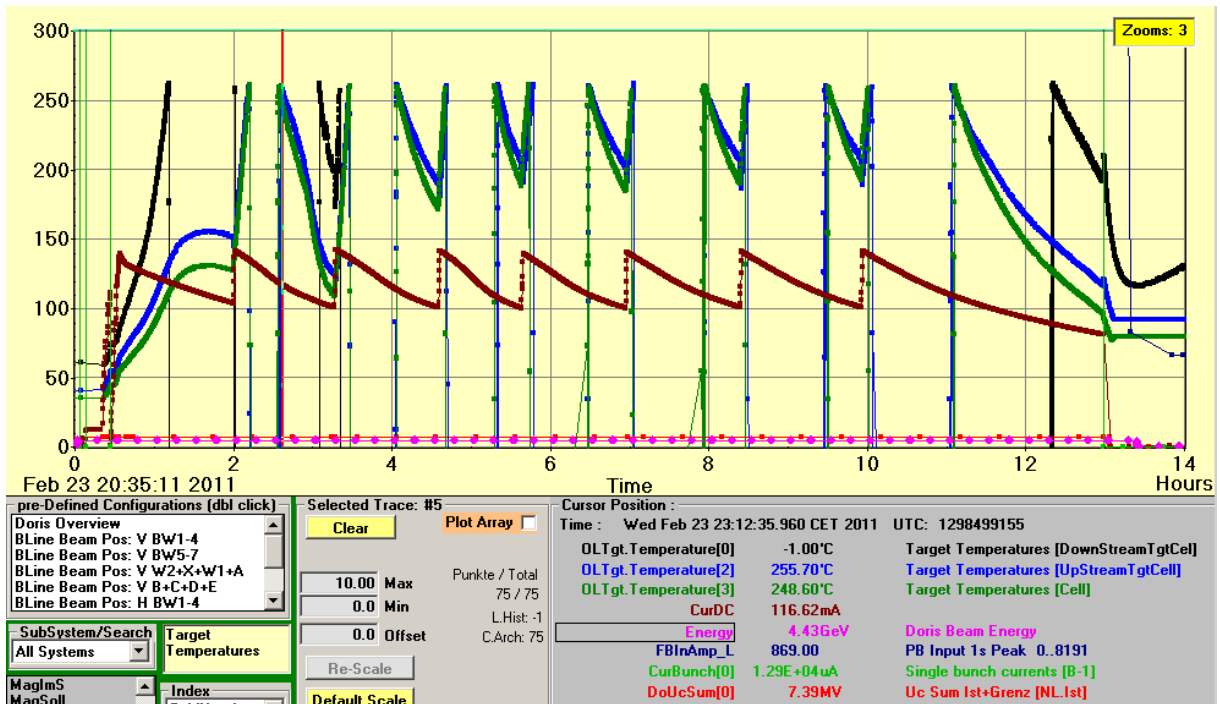
Figure 8: Temp. during the last night. 140mA in 10 Bunches at 4.4 GeV w/o oscillations.

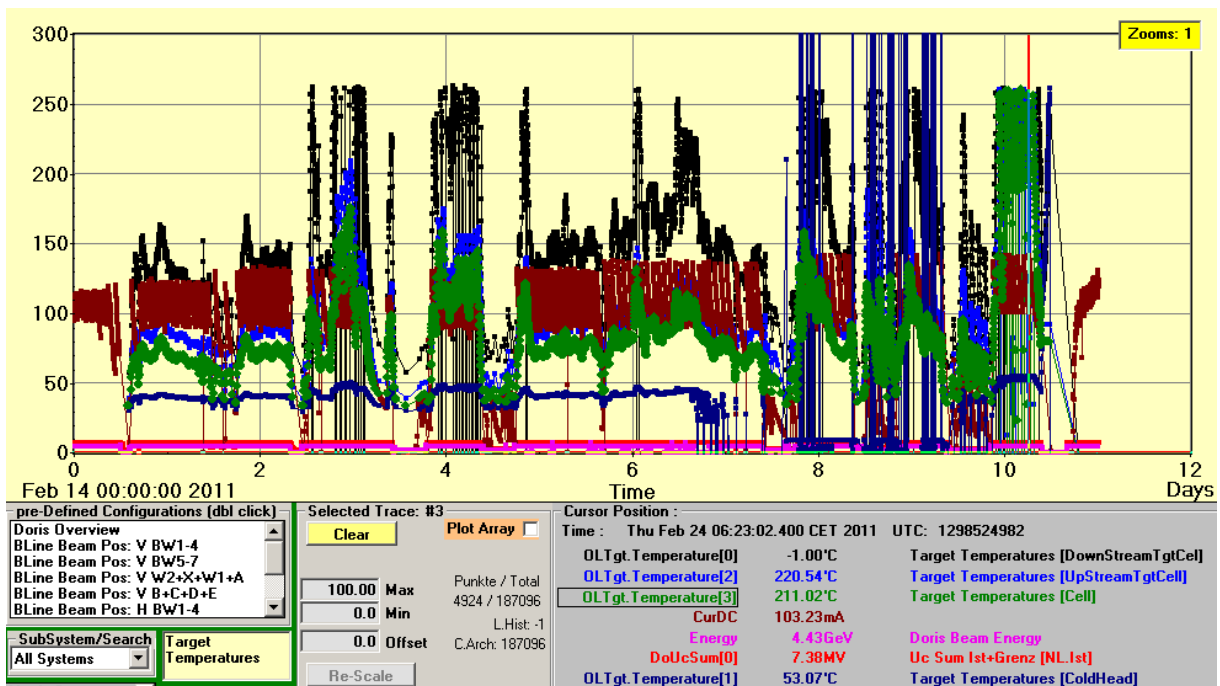
Figure 9: Temp. from Feb 14th until 24th with a sudden increase during the night Feb 23rd.

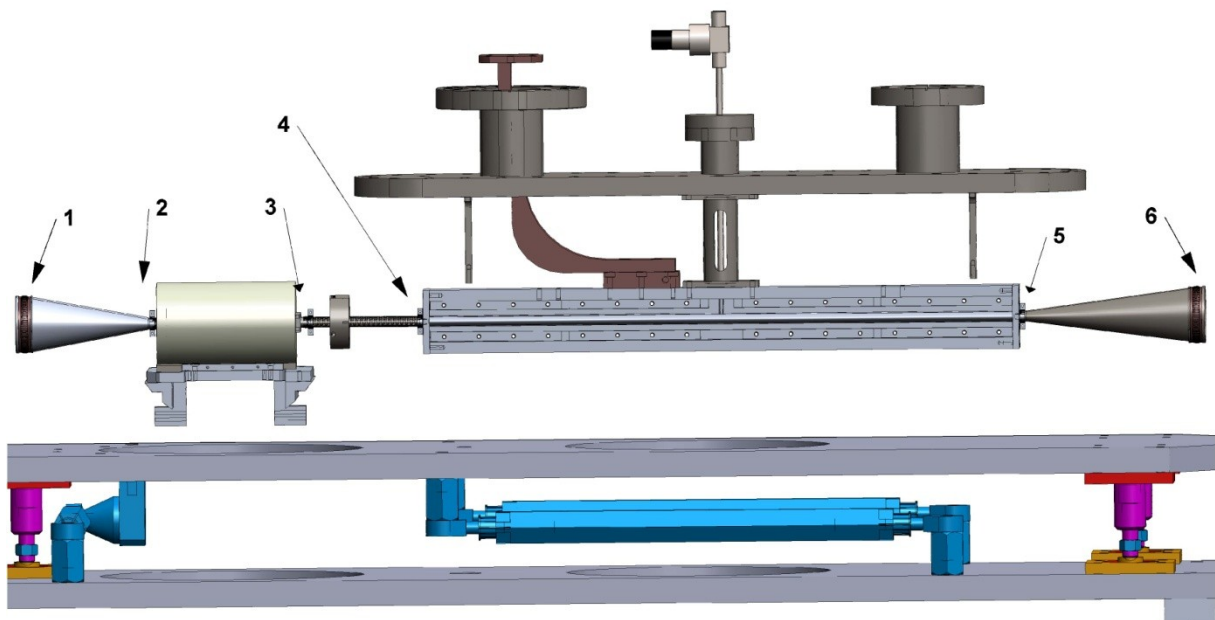
Figure 10: The six transitions between different parts of the target chamber

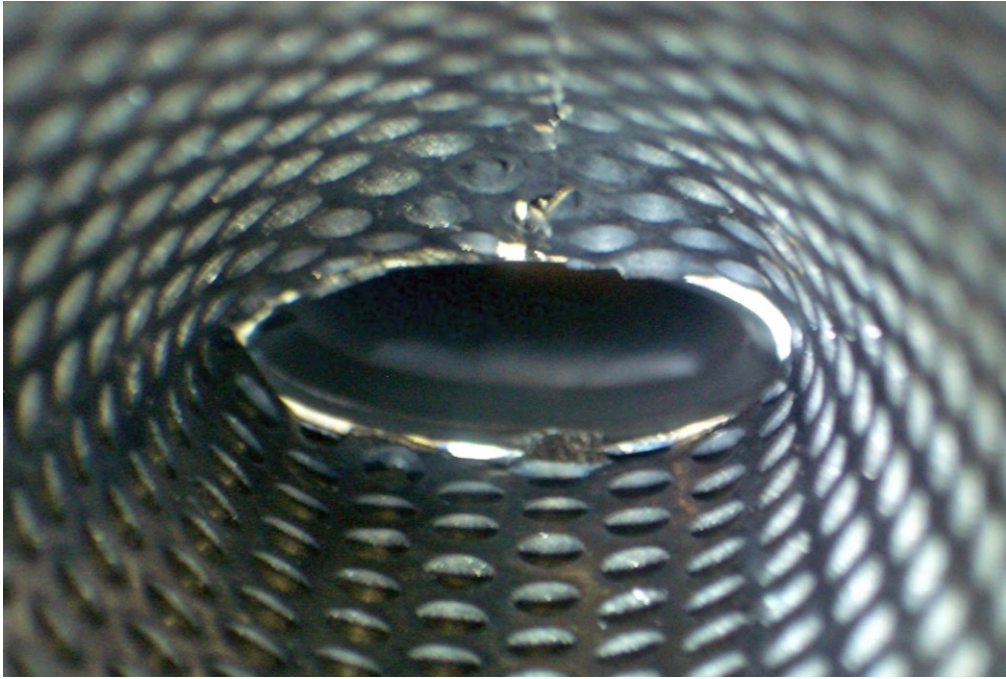
From Figure 11 and Figure 12 one can see that the connection is intact but one recognizes also some small steps and bumps at the end of the cone and at the transition to the end ring. Figure 14 shows this connection from the outside. One can recognize that the aluminum cone is welded(?) at some (4-5) points to the ring which supports the RF-fingers. The image current of the beam has to find its way over these connections. These details surely increase the distortions of the wake fields.

Figure 11: View from the upstream side before opening the chamber

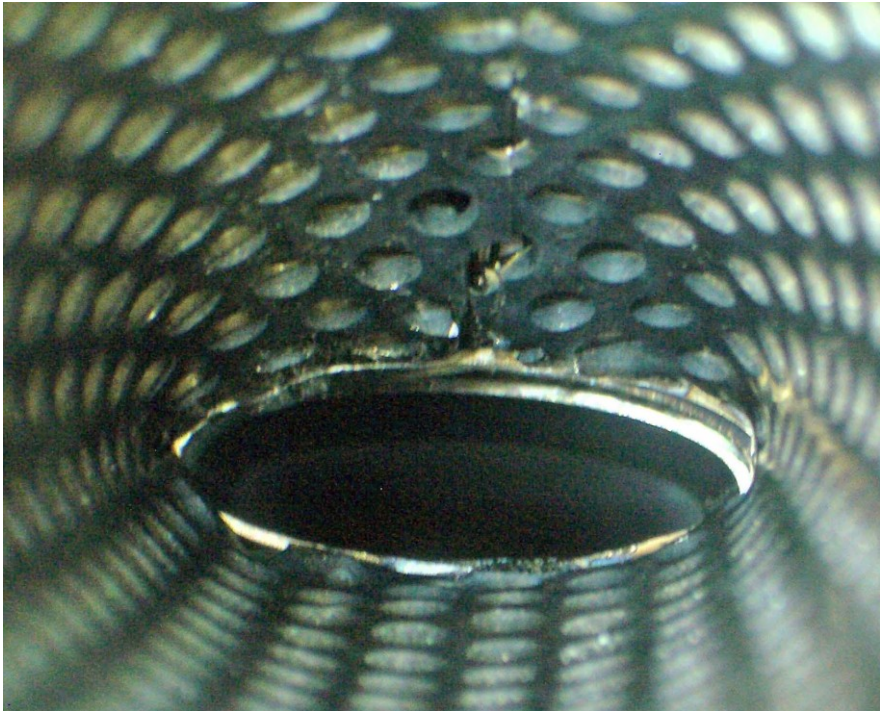
Figure 12: same as before, but under a different angle

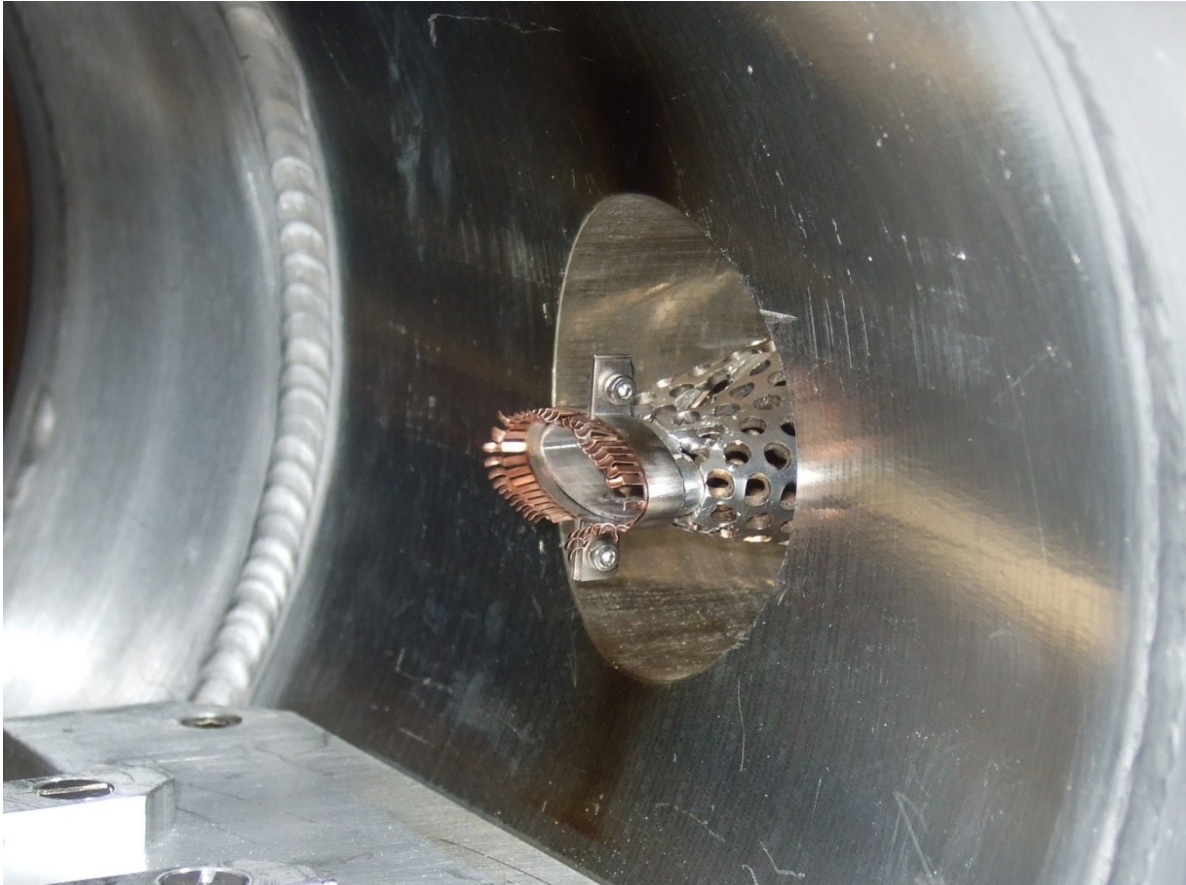
Figure 13: End of wake field suppressor which was connected to the collimator. On top and bottom side colors can be seen which stem probably from a thin layer of metal. The damage of the springs on the side are probably caused by the removal of the collimator.

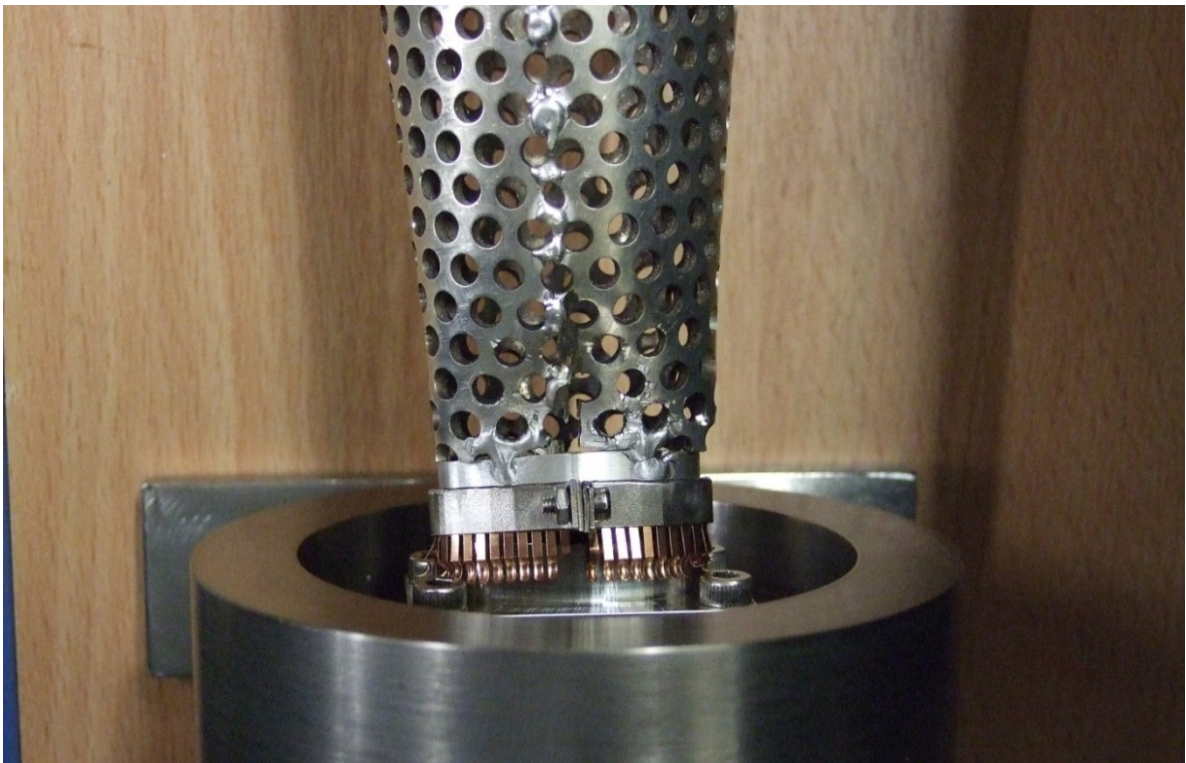
Figure 14: View on the upstream end of the collimator. The damage on the fingers happened during the disassembly. One can see the two welding spots and the larger hole on the top.

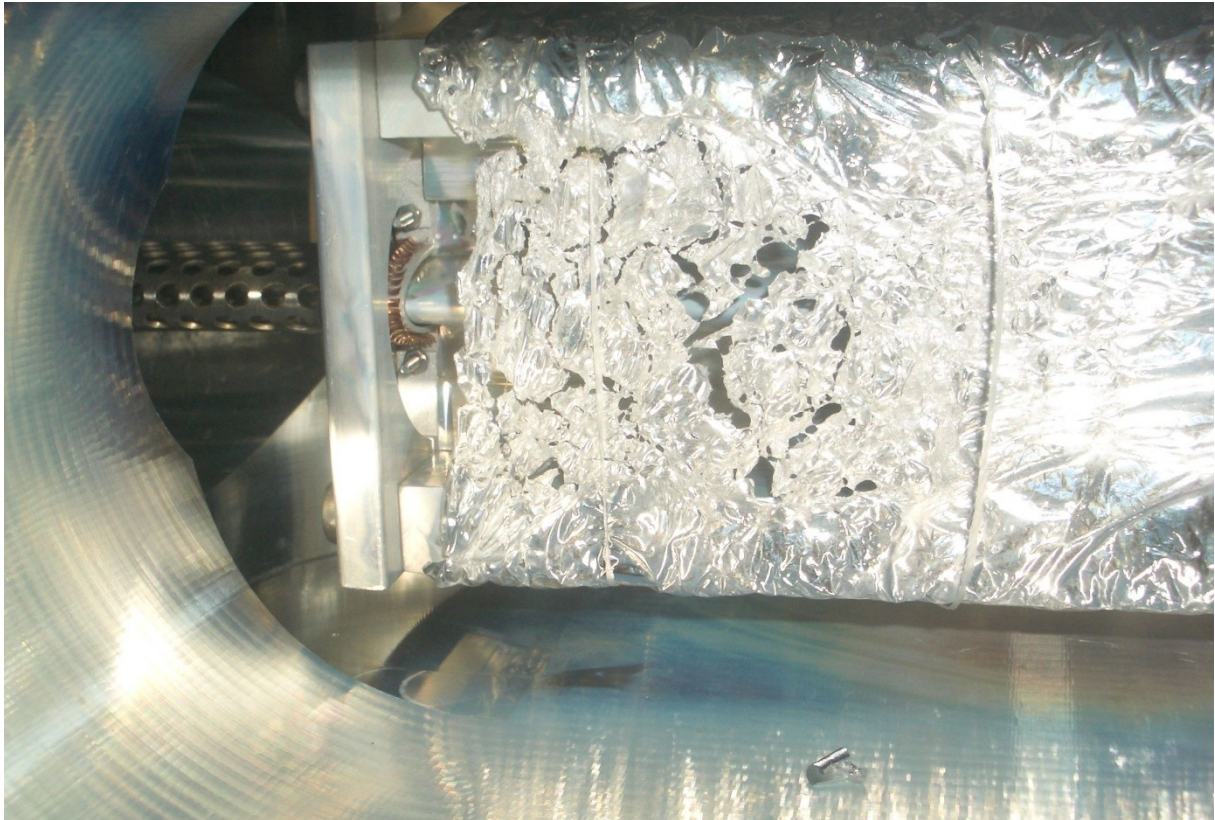
High temperatures appeared in this region as can be seen by the melted insulation in Figure 15. The wake field suppressor looks fine as well as the RF-Fingers. But the support ring lost its contact to the cell foil at least on the upper half. The welding spots are broken and left small holes in the aluminum foil of the cell.

**Figure 15: Insulation at upstream end of cell after runs.**

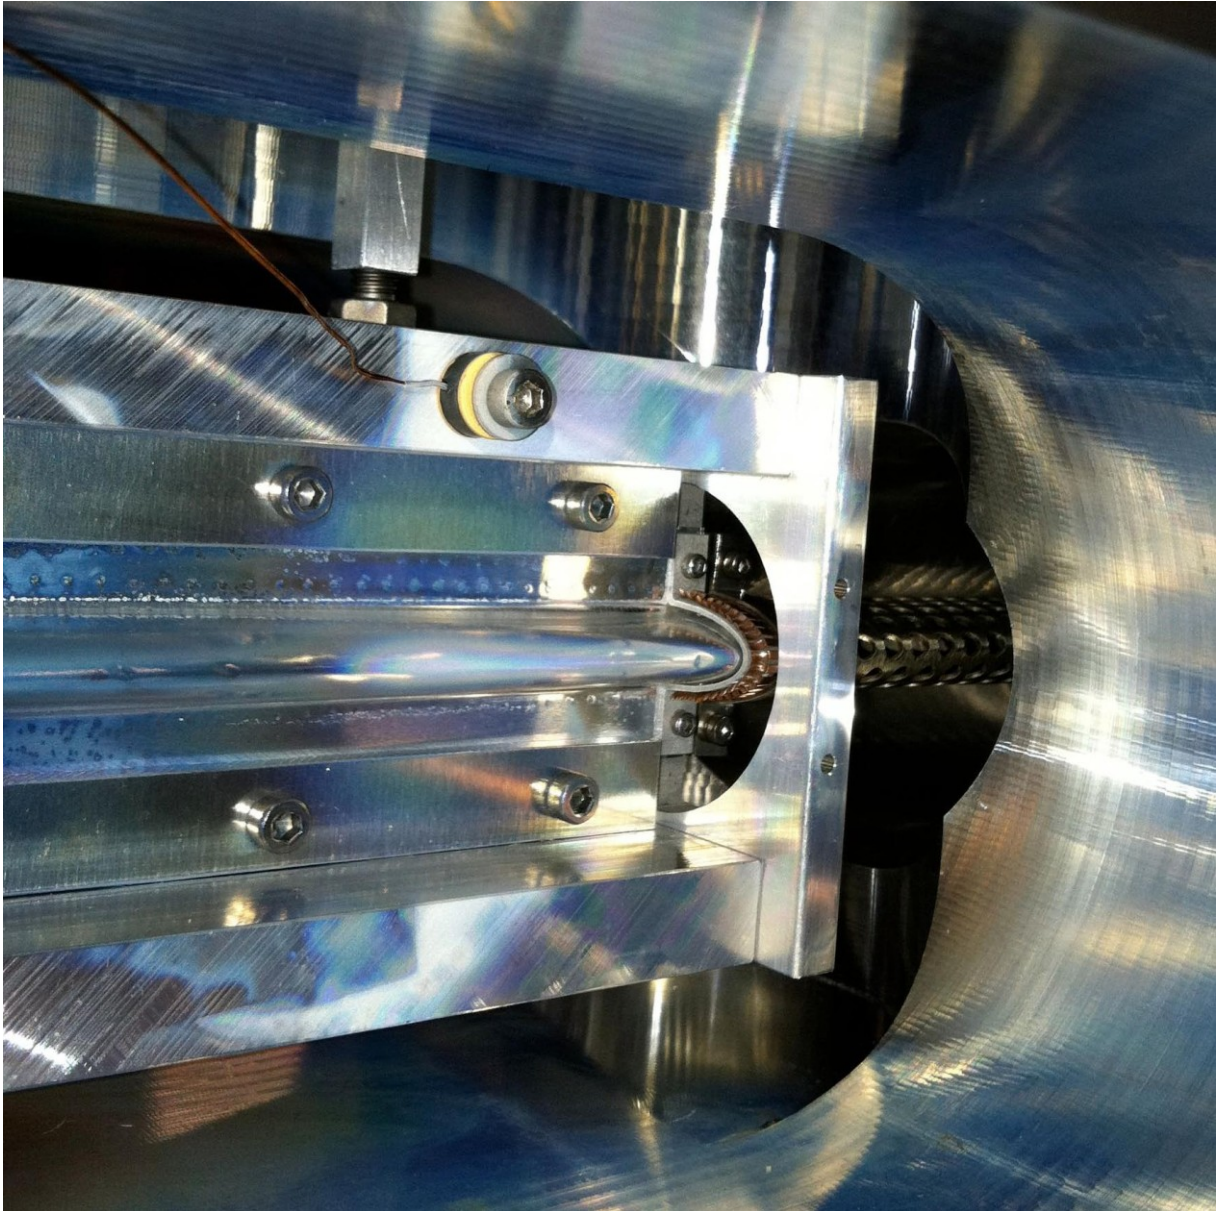
Figure 16: Upstream end of cell. The transition from collimator to cell looks fine as well as the RF-fingers. But it seems that the cell does not have a direct contact to the support ring.

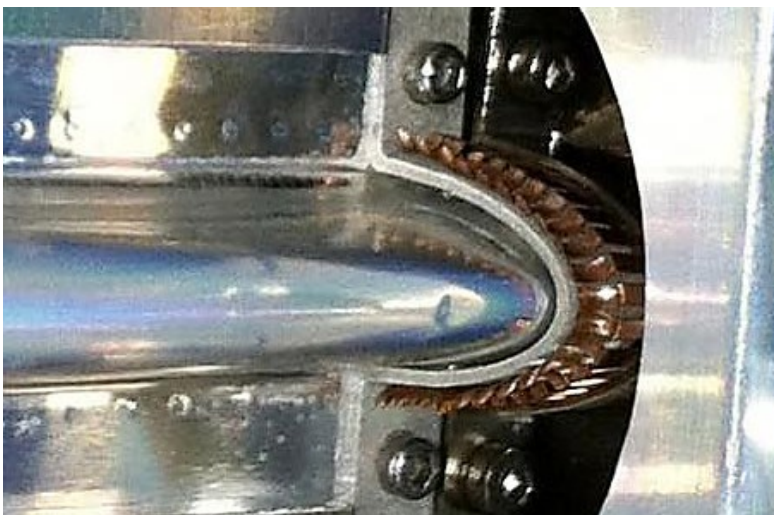
Figure 17: Detail of the previous picture.

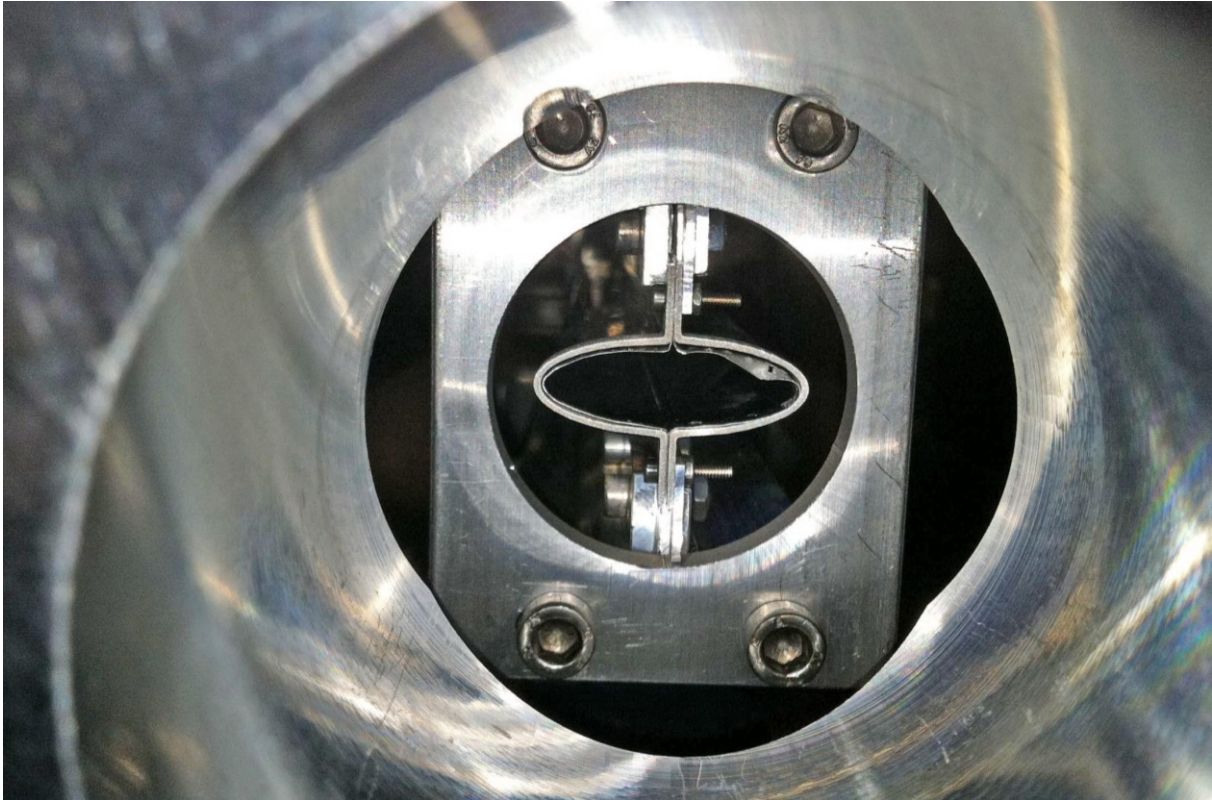
Figure 18: View to upstream end of the cell. One can recognise that the cell is damaged and the welding spots are broken.

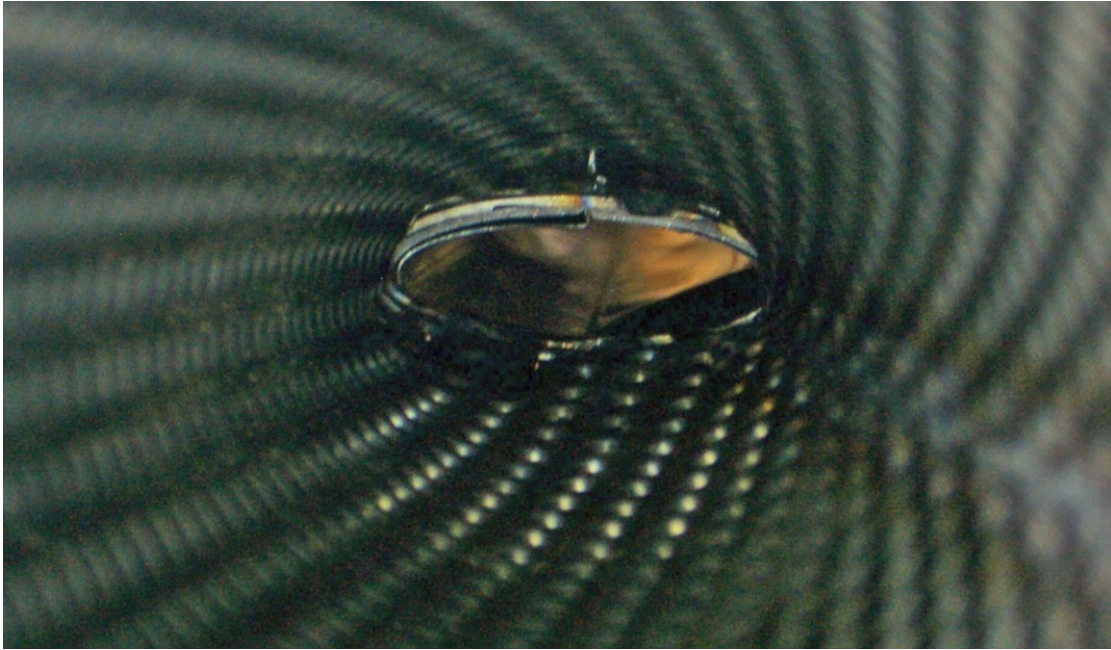
At this transition one could already see from the downstream end of the chamber that the cell had an offset relative to the wake field cone. Also at this end high temperatures caused the insulation to melt. From the outside one sees clearly the offset between cell and cone and that the RF-fingers lost contact to the support ring. Figure 19 shows that also on this end the cell foil separated from the support ring.

Figure 19: View to the downstream side wakefield suppressor and and of cell.

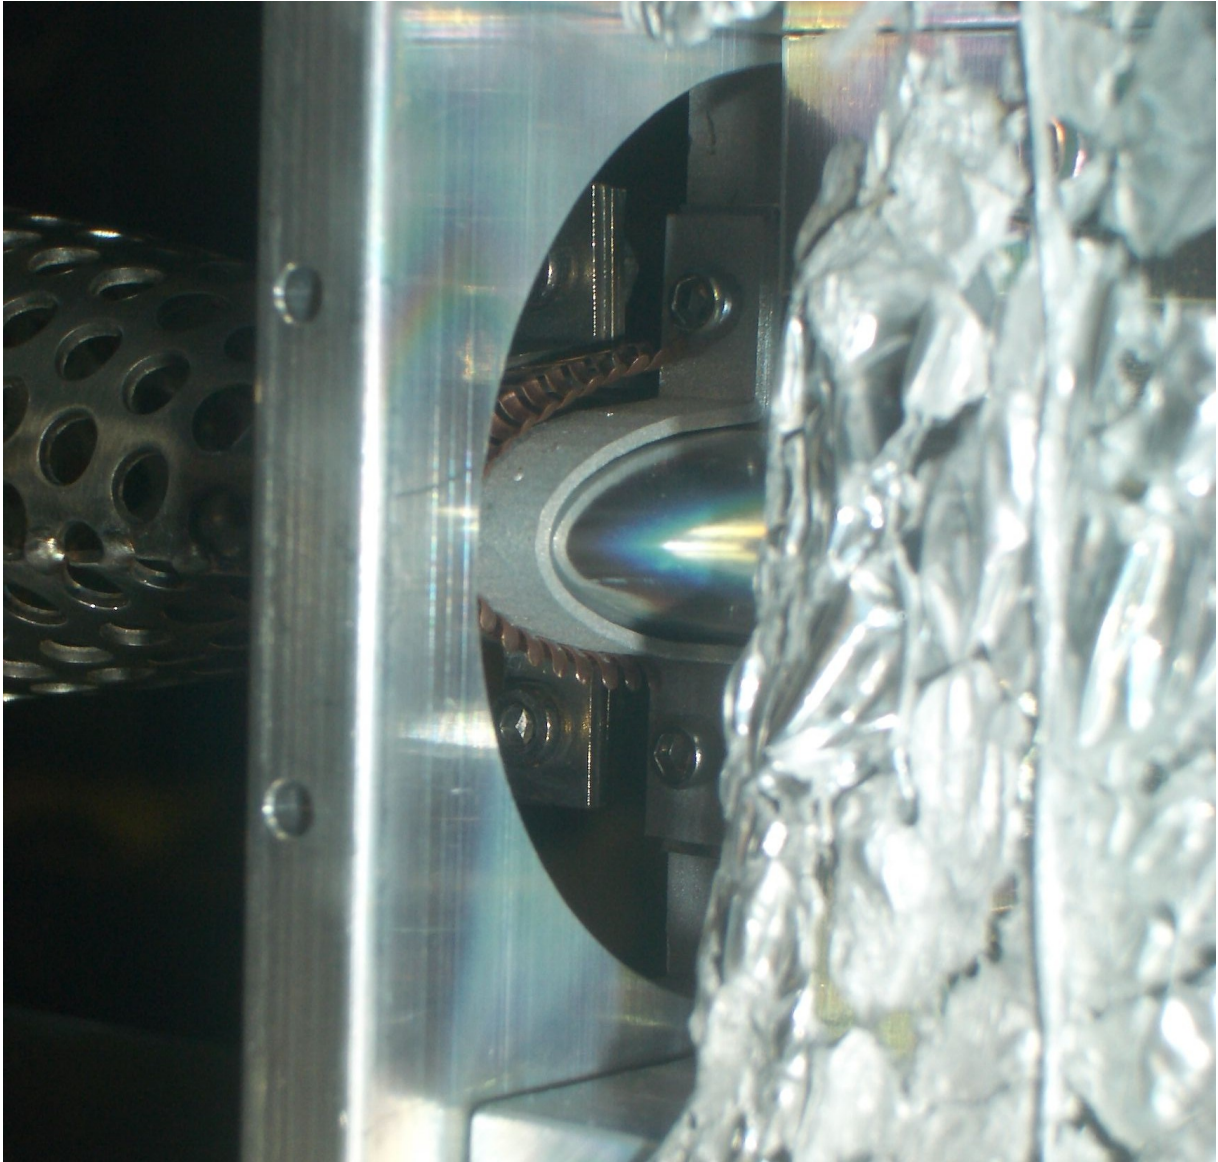
Figure 20: Downstream end. Fingers on top side without contact

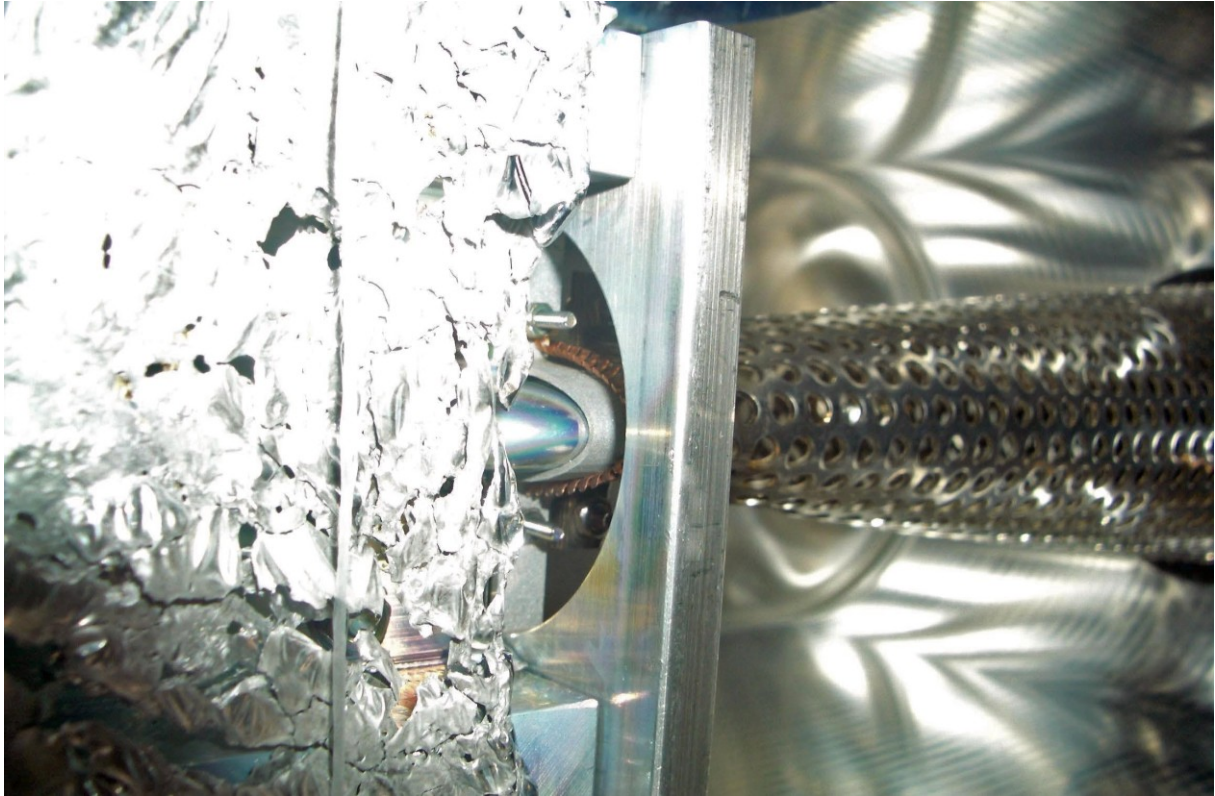
Figure 21: Downstream end of cell. Insulation is partly melted. A gap between the cell and the support ring can be seen as well as a gap between the fingers and the support ring on the upper side.

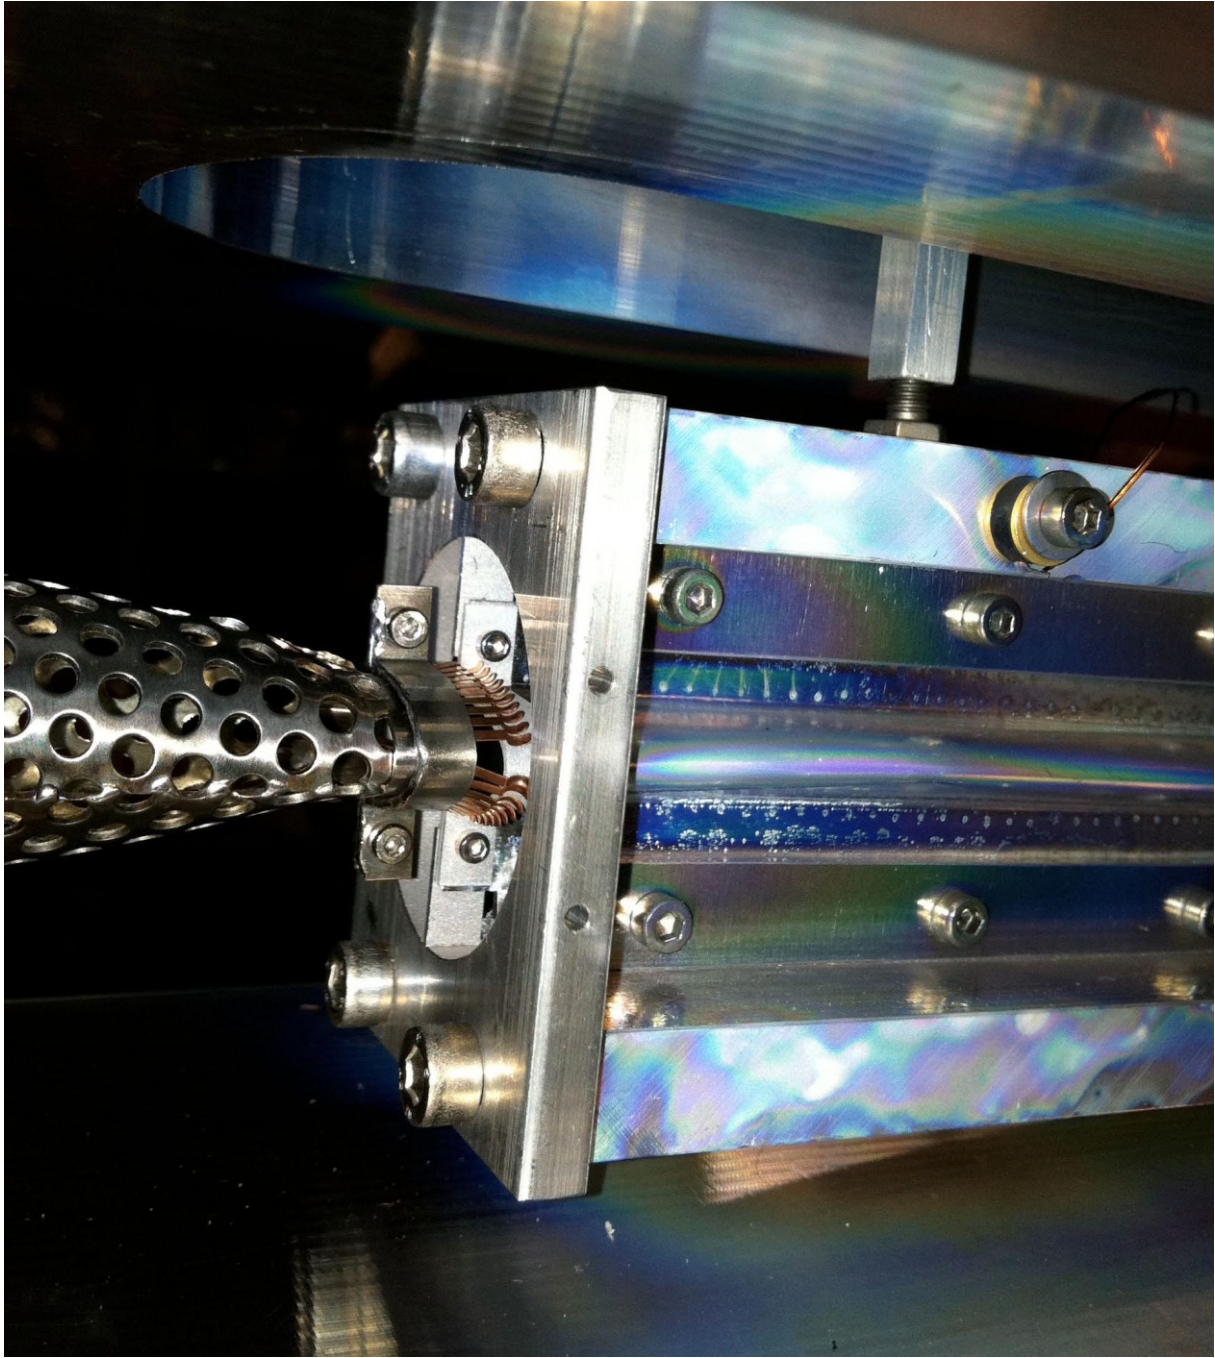
Figure 22: Downstream end of cell. the RF-fingers are bend on the lower side and have no contact on the upper side. On the top the temperature sensor can be seen.
