The Towers Lost and Beyond

A collection of essays on the WTC by researchers at the
Massachusetts Institute of Technology

Table of Contents

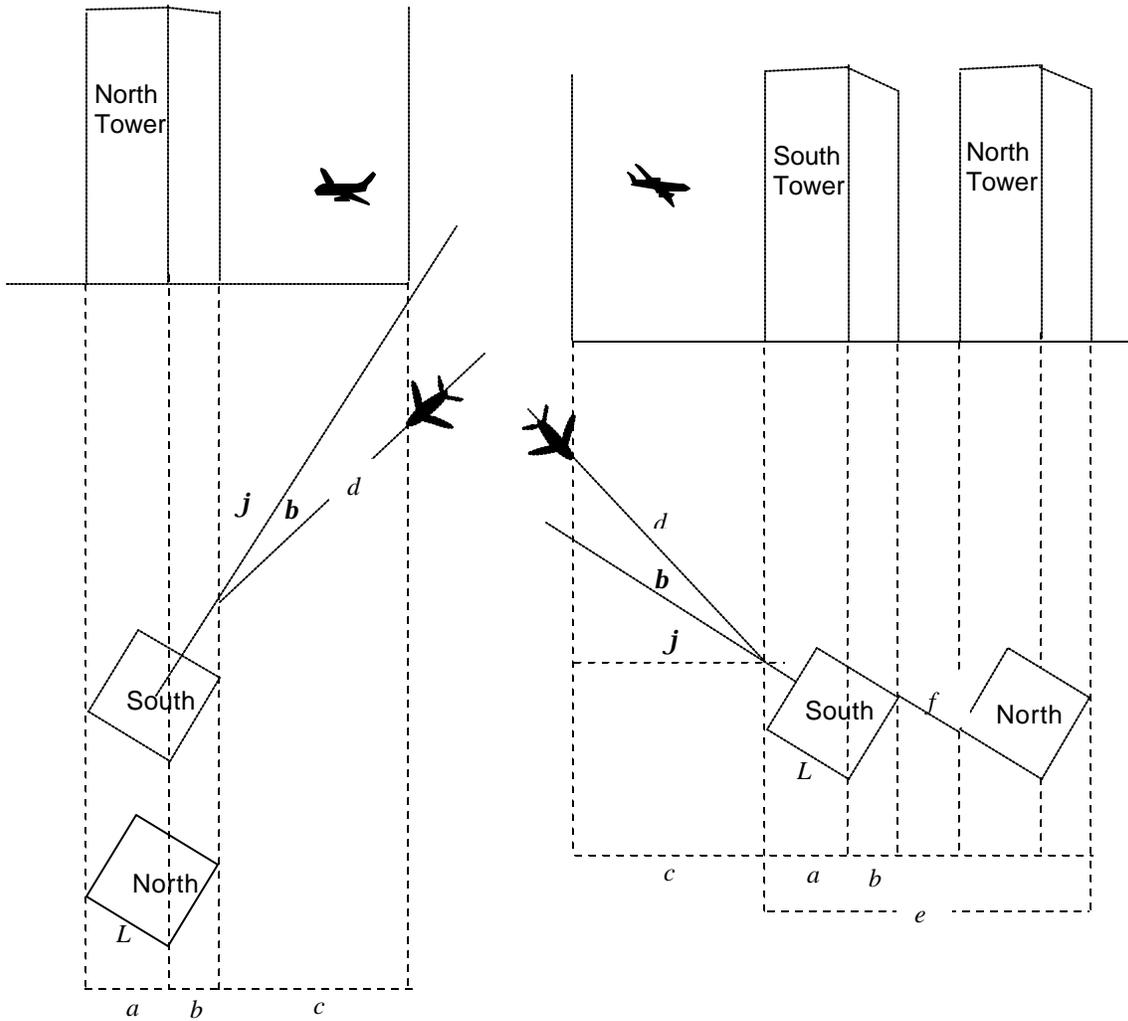
Fig. 3: Diagrams for northerly view (left) and easterly view (right) videos. (Unknown broadcaster).

Considering that the orientation of the WTC is some 27 degrees east of north, the above angle is thus only some four degrees west of north, so the camera's filming direction was nearly directly from north to south. The angle b can be found by combining the previous information with data from other images taken from an East-West direction. As will be seen, this angle is on the order of 15 degrees. The above values imply

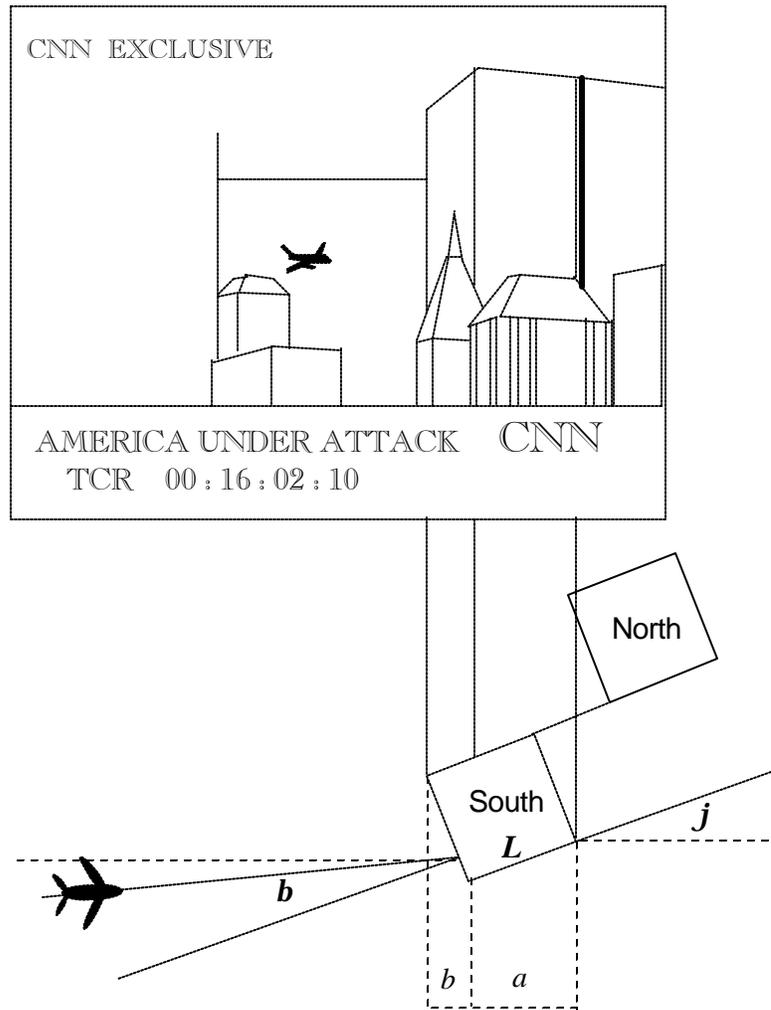
Fig. 4: Still image and diagram for easterly view CNN

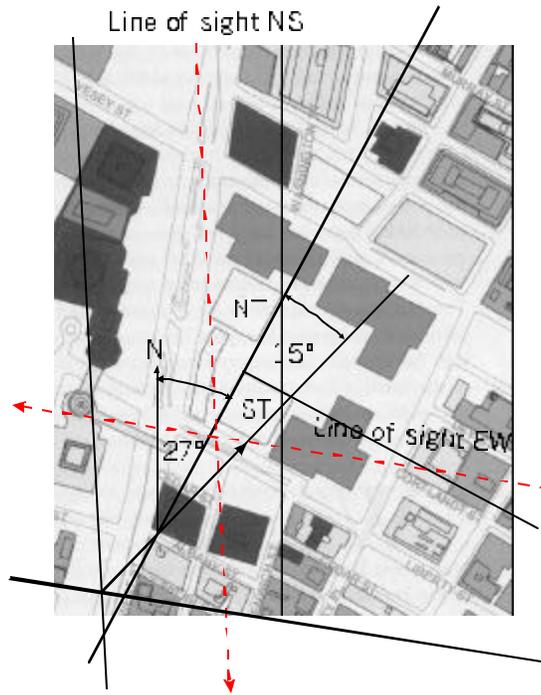
Fig. 5: Map of WTC neighborhood showing lines of sight. for northerly and easterly views

From the previous sections, the NS line of sight was 4 degrees west of north and the EW line of sight was 9 degrees south of east. These directions are indicated by the dashed arrows in the WTC neighborhood map shown in Fig. 5. Drawing parallels to the NS and EW lines of sight at the locations that match the right and left edges of the still images, respectively, which were both crossed by the aircraft at about 1 second prior to collision, we can estimate from their intersection the true location of the plane relative to the towers at this point in time. Drawing from this point the flight path to the South Tower, we obtain an angle of flight of about 15 degrees with respect to the alignment line of the two towers, which is 27 degrees east of north. Thus, this justifies the angle $b=15$ degrees we applied in the previous sections to estimate the flight velocity.

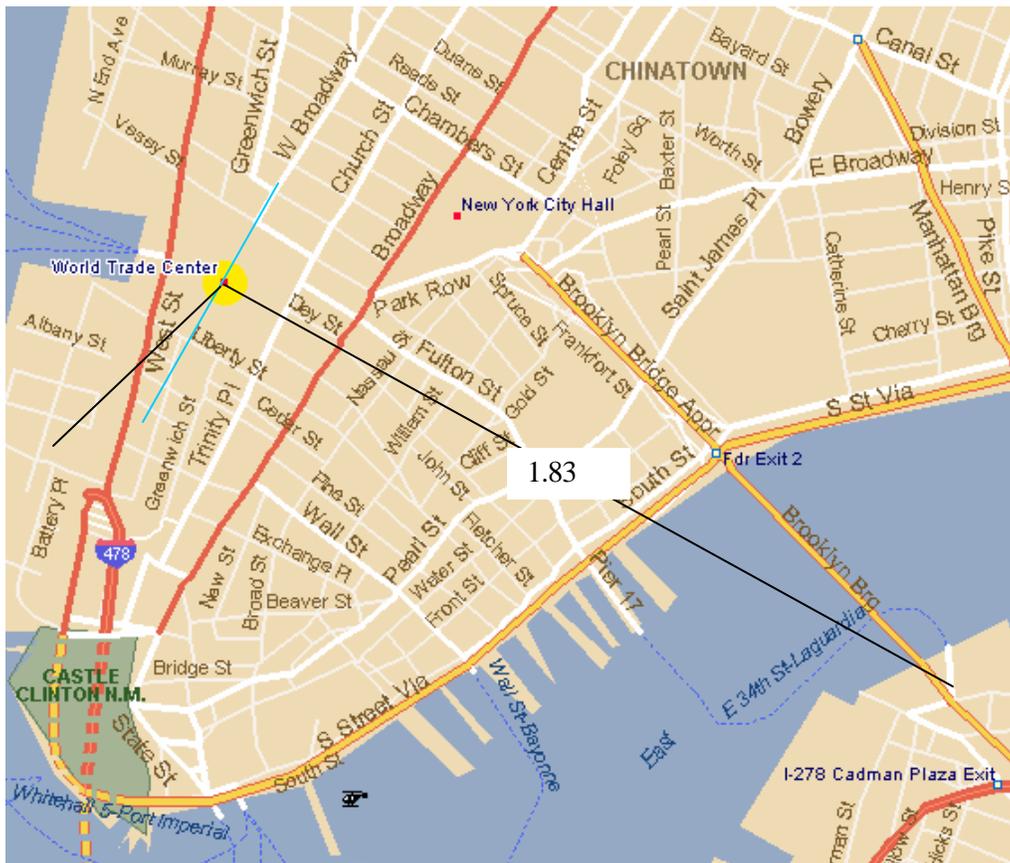
Fig. 6: Map of WTC neighborhood showing lines of sight for Brooklyn Bridge video

A very informative video showing the approach of the second plane to the South Tower was filmed from a position slightly to the North of the easternmost pier of the Brooklyn Bridge, almost immediately underneath the bridge. This places the filming position at about 1830 m from the World Trade Center, as determined by means of the *MS Streets-98* program. Fortunately, the line of sight from this position to the World Trade Center is virtually perpendicular to the alignment line connecting the twin towers in the NE-SW direction (black and cyan lines shown in map below). This video, which was taken at a rate of 25 frames per second without zooming or panning, provides probably the best evidence available for determining the trajectory and speed of the plane.

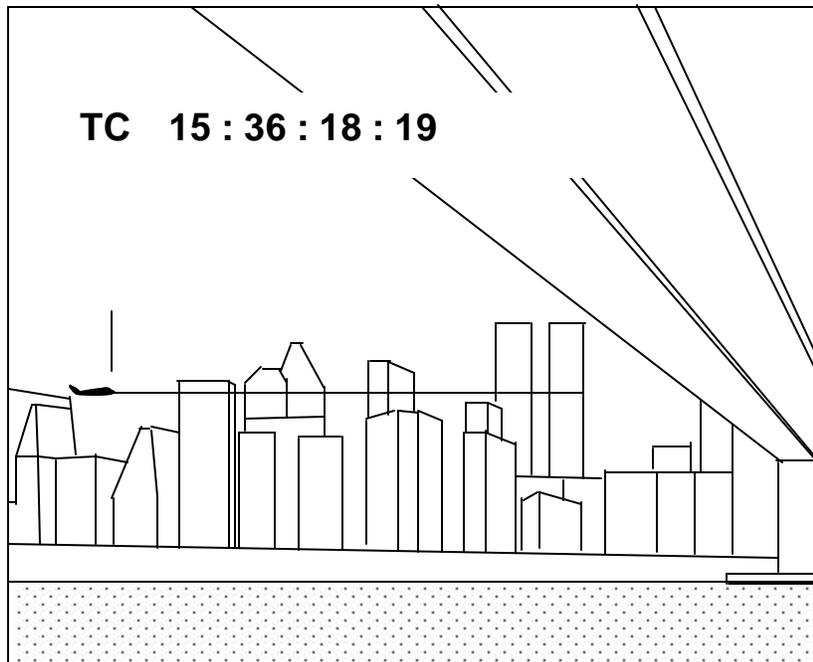
Fig. 7 a-g: Final approach, as seen from Brooklyn Bridge

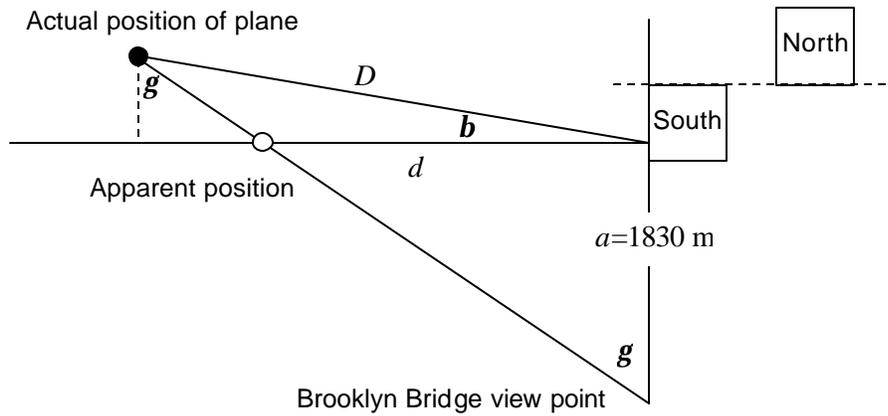
Fig. 8: Plan view of approach to South Tower, as seen from Brooklyn Bridge

After measuring in the image the position d of the plane with respect to the South Tower, and considering the angle of flight \mathbf{b} with respect to the apparent flight direction—which in the image is perpendicular to the Brooklyn Bridge line of sight—we can determine the actual position of the plane in terms of \mathbf{b} , and thus the actual speed of flight. From the other videos of the WTC taken from a northern and eastern filming position, we know that the angle \mathbf{b} is about 15 degrees. Thus, we can use this fact to determine the speed of flight.

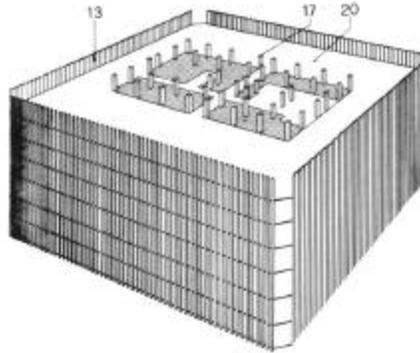
Figure 1. Double hollow tubes structures of the World Trade Center showing exterior columns (13), floors (20) and core columns (17)

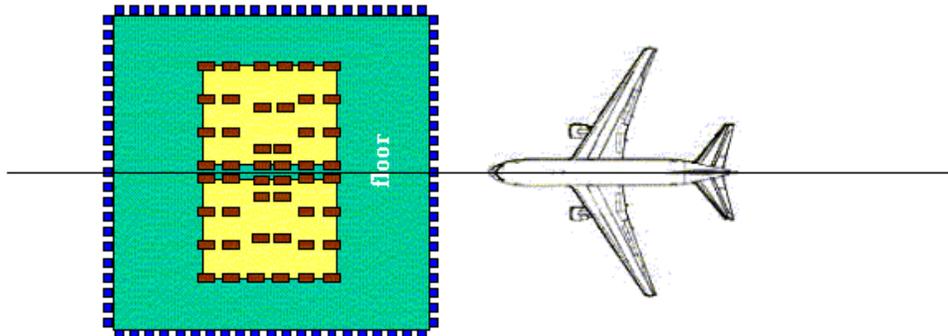
Figure 3. Orientation of North Tower head-on impact

The relative position of the aircraft with respect to the North and South Towers is shown (to scale) in Figure 3 and Figure 4 respectively.

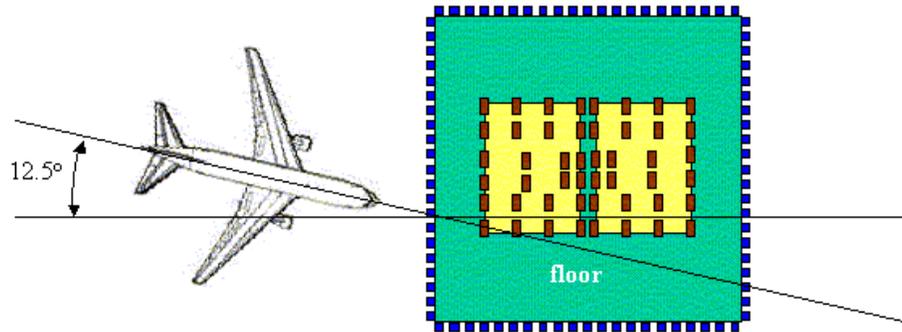
Figure 4. Orientation of South Tower oblique impact

Before colliding with the North and South Tower, the planes banked to the left and hit the Tower with a roll angle of approximately 26° and 35° . This roll angle will have significant influence on the number of destroyed floors.

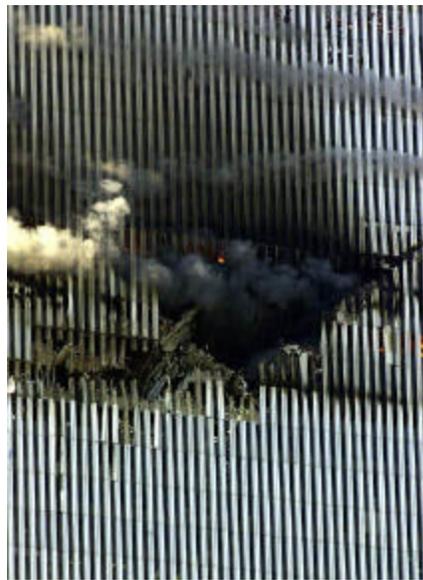
Figure 5. Damage to the exterior columns of the North Tower immediately after the impact.

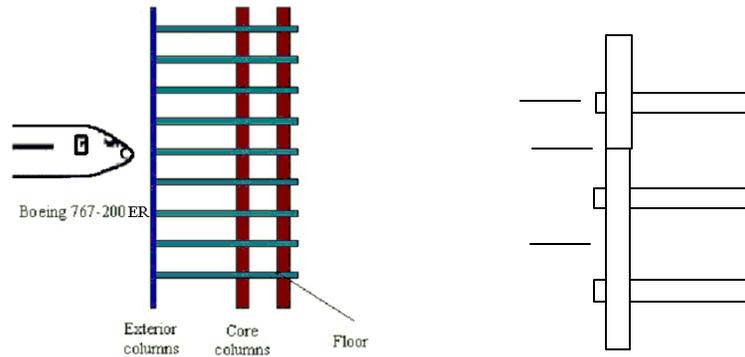
Figure 6. Relative orientation of the aircraft and the floors

At the same time, the 3m diameter engines and the wings could easily fit between office floors. This will be most probably the case with the North Tower impact, which occurred with less roll angle.

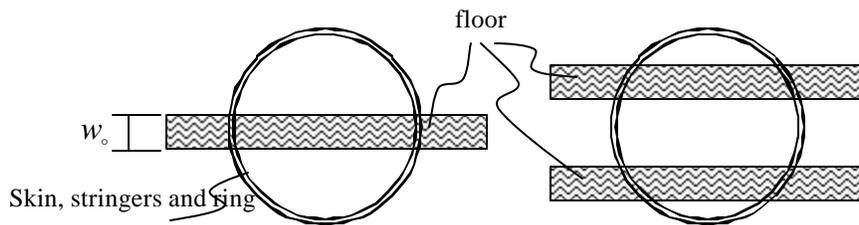
Figure 7. The 5-meter diameter of the fuselage can get engaged with one or two floors depending on the relative orientation

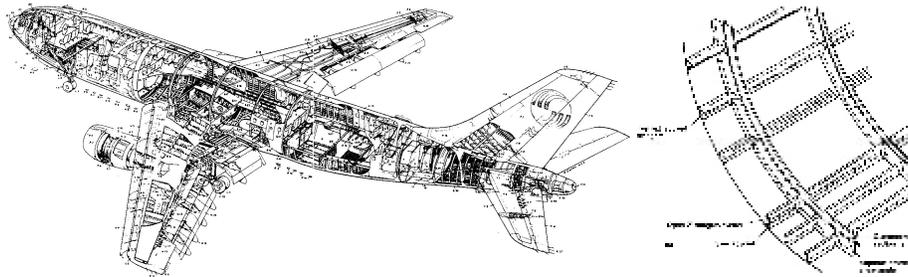
Figure 8. Internal structure of Airbus 320 (Reprinted from Ref. [25])

The fuselage consists of a system of rings and stringers attached to sheet metal. The floor separating the passenger and cargo area runs slightly below the diameter of the round fuselage. At this level of the first order engineering analysis, it is not possible to account for the individual contribution of rings, stringers, and the skin.

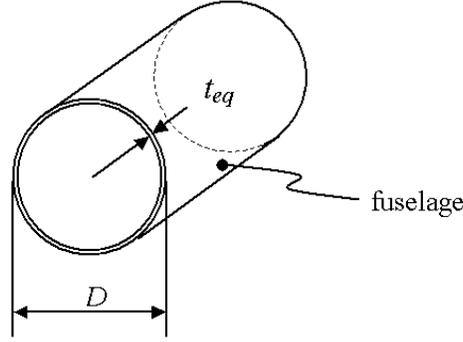
Figure 9. Simplified model of the fuselage

From the above equation, it is found that for $D = 5.03\text{m}$, the equivalent thickness is $t_{eq} = 18.4\text{mm}$.

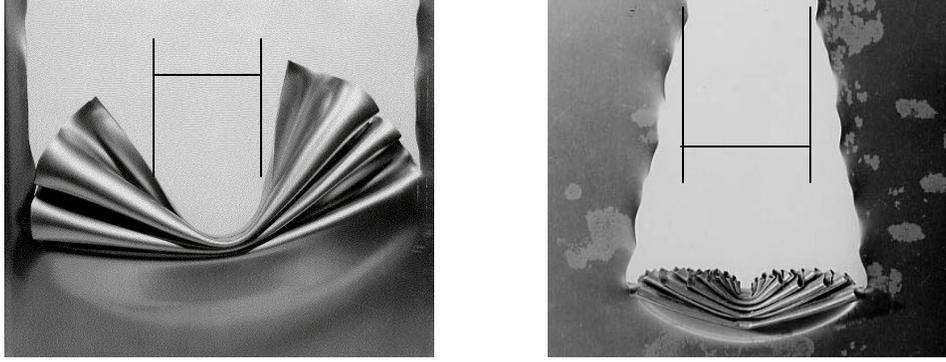
Figure 10. Concertina tearing of a sheet by a blunt object with parallel cracks (left) and diverging cracks (right)

Now the fuselage is getting engaged with one or two floors of the height $w_o = 0.9\text{m}$ each. The floor is relatively narrow compared to the diameter of the fuselage and may in fact slice through the fuselage and cut it into two or three pieces. Wierzbicki [27] derived an approximate solution for plastic resistance of a blunt object cutting into thin sheet, such as tubular wall of the fuselage model. He identified the so-called “concertina” tearing mode, which consists of two diverging cracks enclosing a strip which progressively folds back and forth. A photograph of the damaged pattern induced by a rigid punch of width w_o is shown in Figure 10.

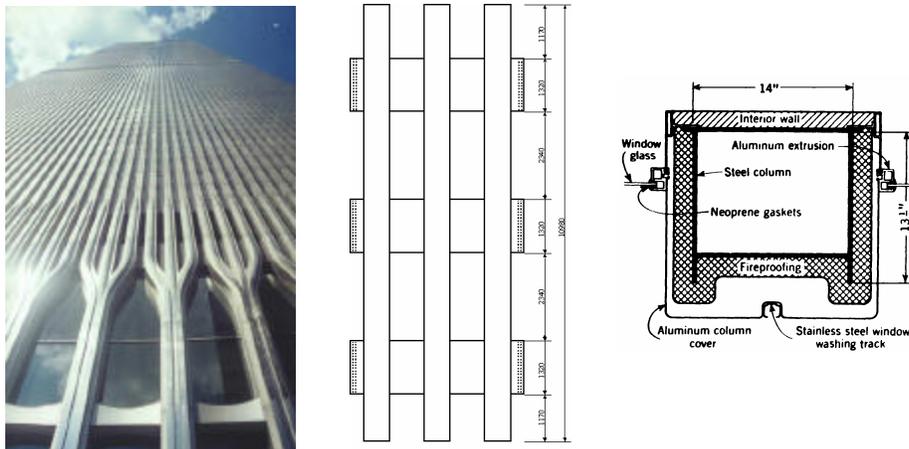
Figure 11. Prefabricated panel consisting of three columns of three-floor-high

The 64m (208 ft) wide façade is, in effect, a prefabricated steel lattice. The exterior columns are narrowly spaced and finished with a silver-colored aluminum cladding. The main building block of the outer structure was a prefabricated element, which was comprised of 3 floors, was 11 m high and 3.07m wide, Figure 11.

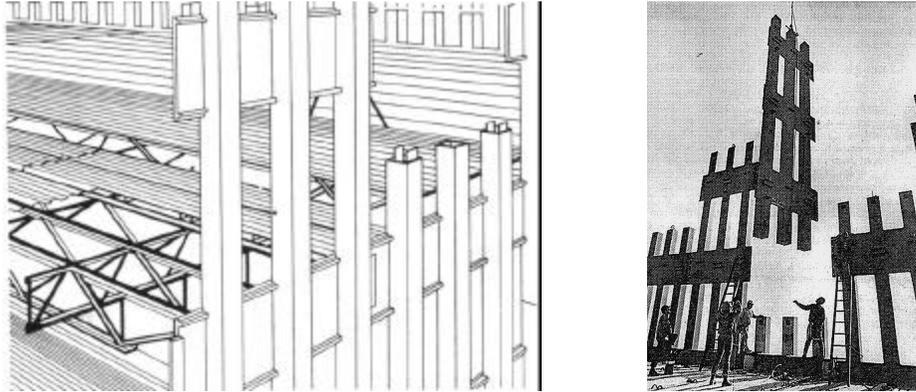
Figure 12. Assembly of the external wall units (alternately staggered in one-story heights) and floor units.

The prefabricated panel consisted of three columns connected by 3 transverse plates, called spandrels. The steel columns are of square cross-section ($b \times b \times t = 356\text{mm} \times 356\text{mm} \times 9.5\text{mm}$), and they were spaced 570 mm apart from each other. The segments were staggered and bolted to their neighboring elements in every direction, Figure 12.

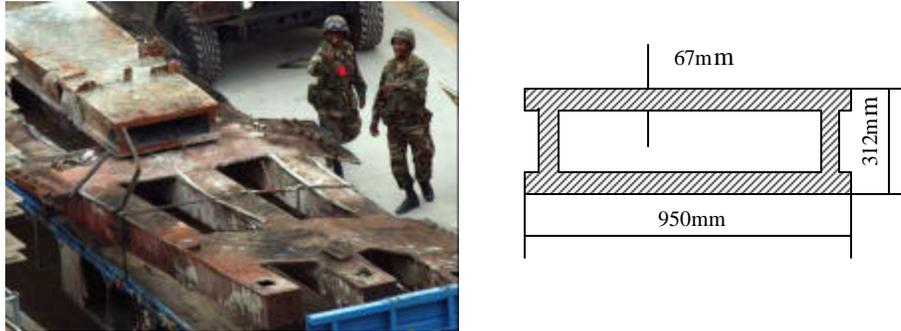
Figure 13. Relative size of core column compared to the exterior column. We have estimated the geometry of the core column from this photograph.

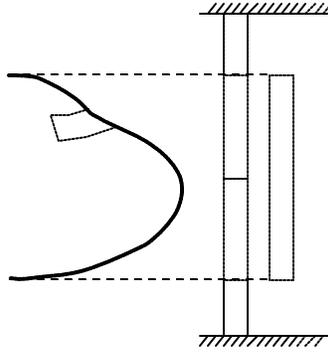
Figure 14. The shearing failure of exterior columns by the aircraft fuselage (and wings). Details given in Figure 25.

Let us look at the exterior columns individually. The plane could have struck the building with its nose localized at the point of a floor junction; this would have been the strongest resisting point. It could have struck where two of the steel lattices had been joined together via steel bolts; this being the weakest of the defenses. Or, it could have struck simply in the middle of the beam sections between floor junctions.

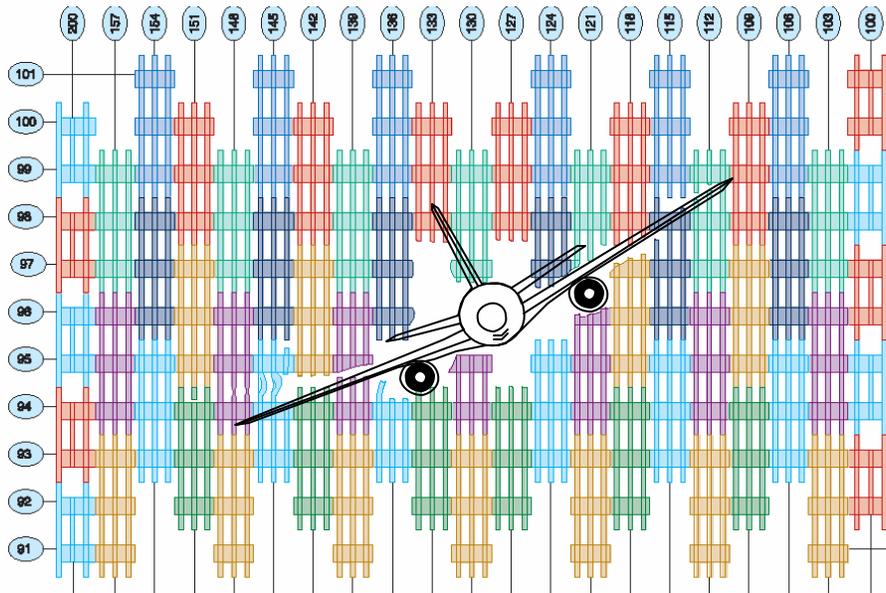
Figure 15(a). The outline of the airplane superposed on the hole driven in the exterior wall of the North Tower

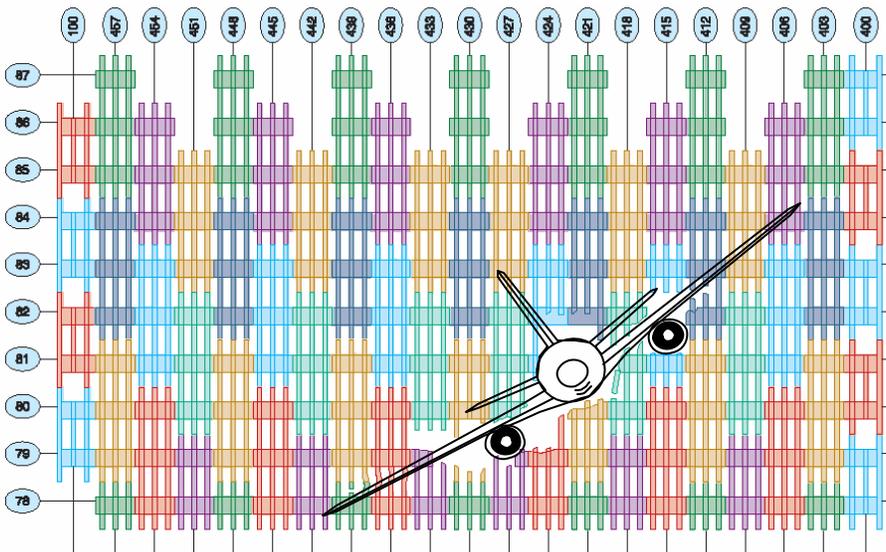
Figure 15(b). The outline of the airplane superposed on the hole driven in the exterior wall of the South Tower

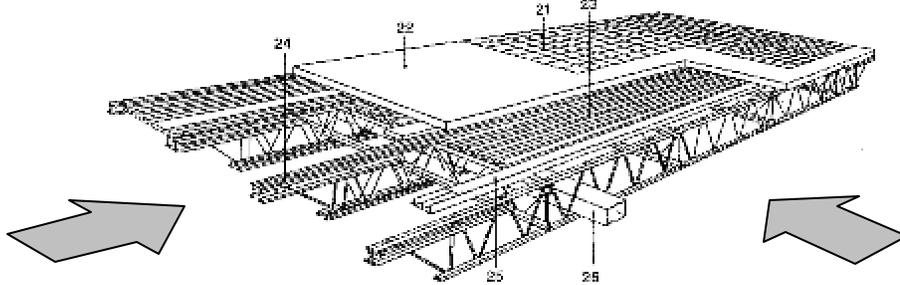
Figure 16. Aircraft impact direction with respect to the layout of floor structure

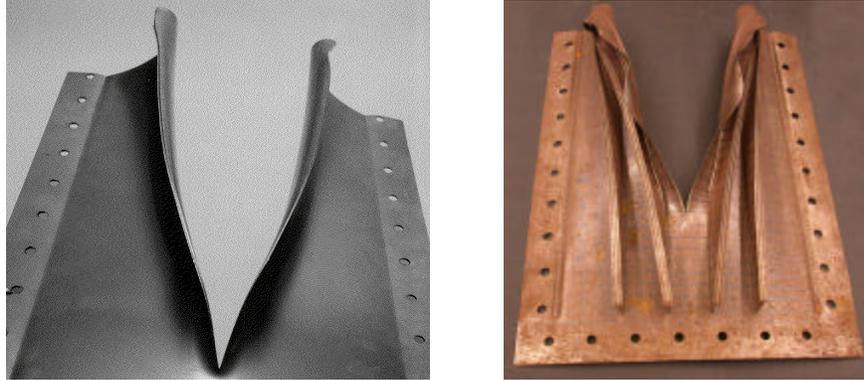
Figure 17. Unstiffened and stiffened cut by a shape wedge

damaged of oil takers and ships. Photographs of two typical failure modes are shown in Figure 17.

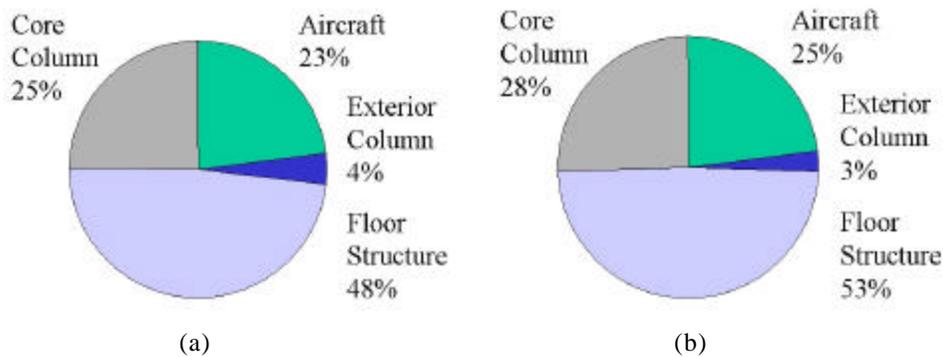
Figure 18. The contribution of various members to the energy dissipated during the initial impact. North Tower (a), South Tower (b).

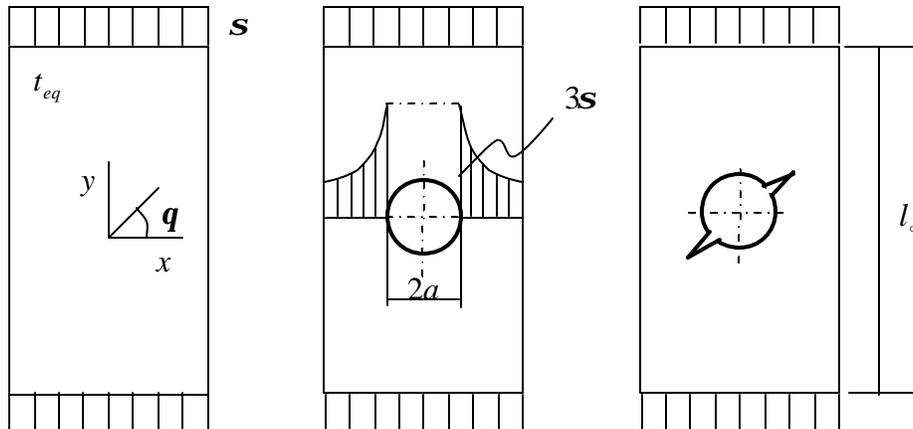
Figure 19. Stress concentration around a circular hole in a plate. Note that there is a stress singularity at the tip of any crack emanating from the hole.

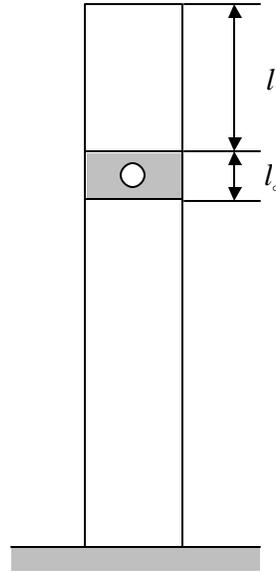
Figure 20. Stresses due to the dead weight will be concentrated around the hole

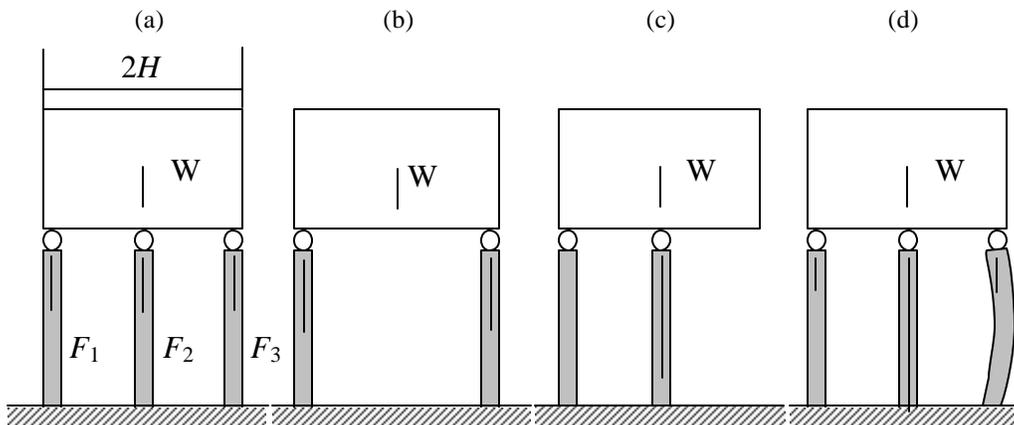
Figure 21. Simplified model of damaged eccentrically loaded system of column. Intact condition (a), center column removed (b), edge column removed (c) and edge column bent (d).

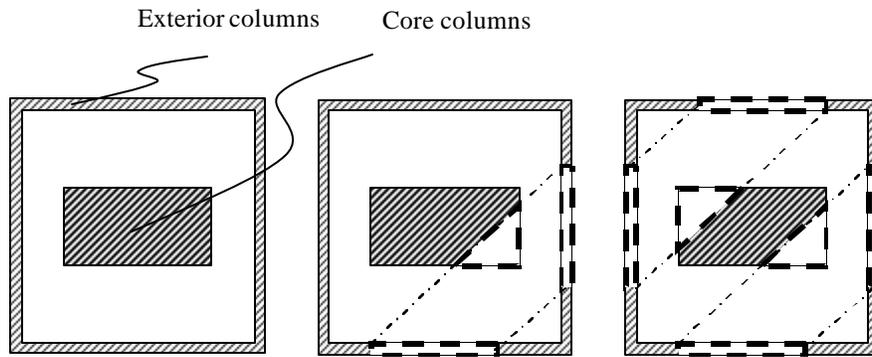
Figure 22. Conceptual sketch of the cross-section of the tower showing vertical members (left). Asymmetric damage (South Tower) removes a portion of exterior and core columns (center). Columns at mirror reflection becomes immediately inactive (right).

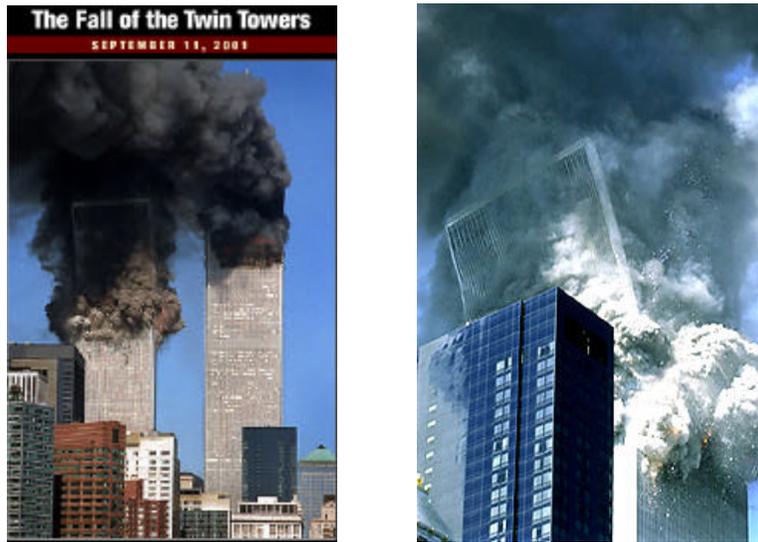
Figure 23. Few first seconds into the global destruction of the South Tower

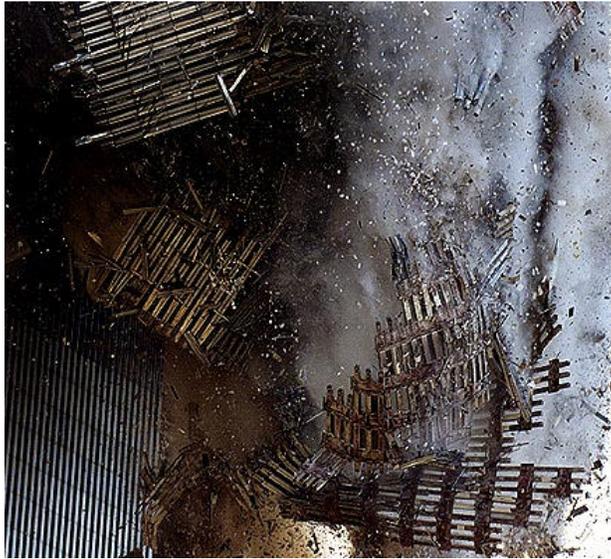
Figure 24. Prefabricated columns of the exterior wall falling to the ground completely detached from the floor structure.

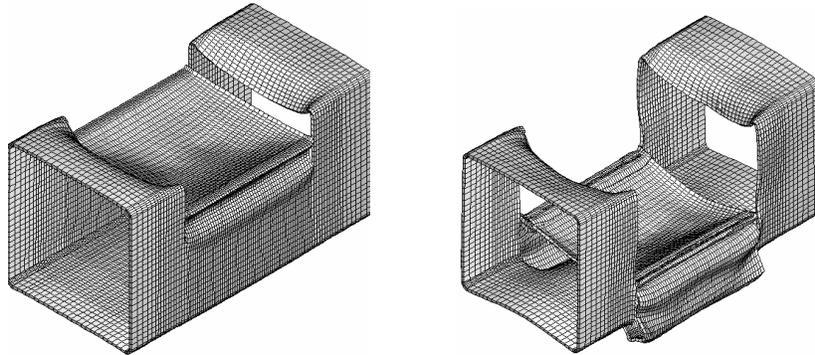
Figure 25. The problem of rigid mass (representing airplane wing) cutting through the exterior column has been solved numerically by Zheng and Wierzbicki [13].

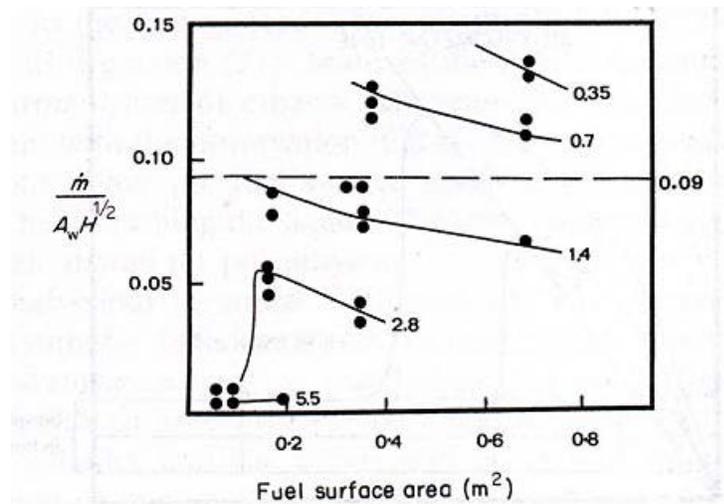
Fig. 1: Dependence of burn rate of ethanol pool fire in a small compartment on the opening parameter $A_w \sqrt{H} / A_f$ (values shown on individual curves) and the fuel surface area. Reproduced with permission from [2]

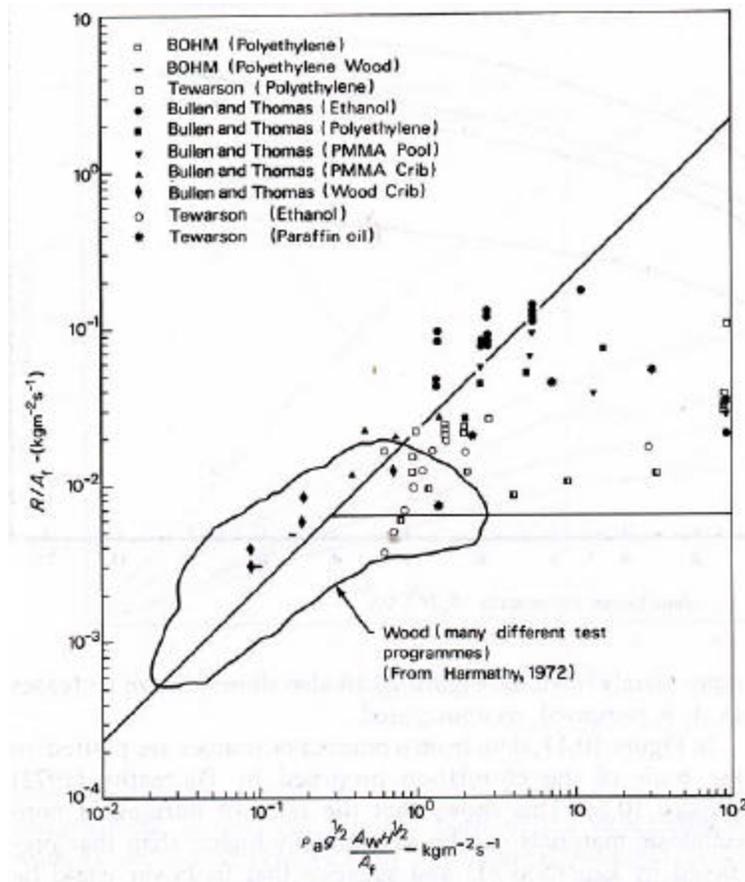
Fig. 2: Compartment fire burn rate for different fuels. While a wide scatter is exhibited, reasonable correlations are observed above the horizontal line close to the classical scaling). Reproduced with permission from [2].

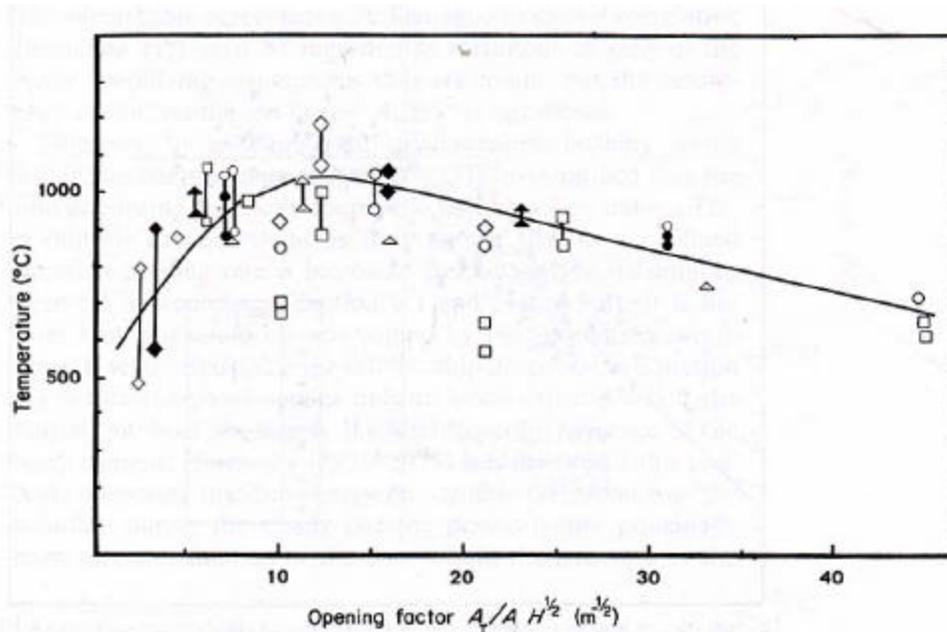
Fig. 3: Average gas temperature in a compartment fire (burning wood) and its variation with ventilation. Note that A_T is the total wall area and A is the window opening. Reproduced with permission from [2].

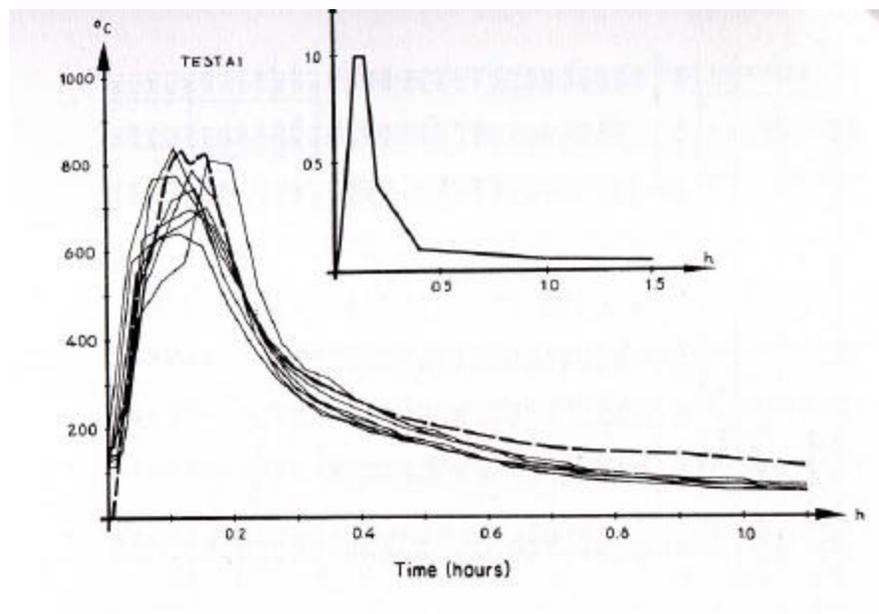
Fig. 4: Measured and modeled temperature history for a compartment fire burning wood, 96 MJ/m² load and opening factor of 0.068 m^{1/2}. The insert shows the burning rate for the same fire. Reproduced with permission from [2].

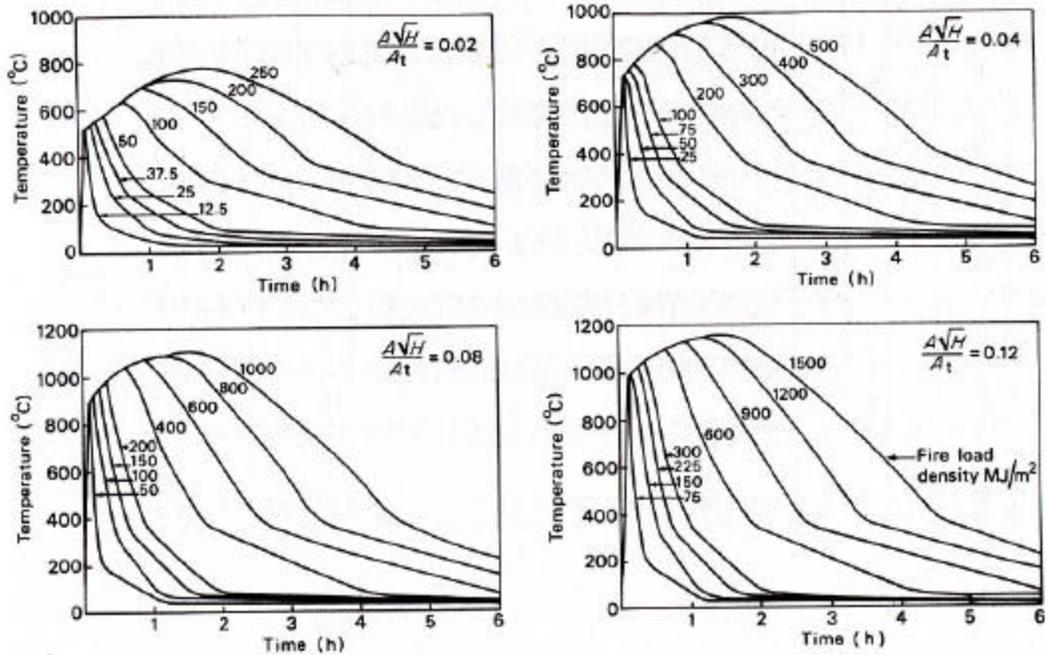
Fig. 5: Impact of fuel loading in MJ/m² and opening factor on gas temperature history in compartment fire. Reproduced with permission from [2]

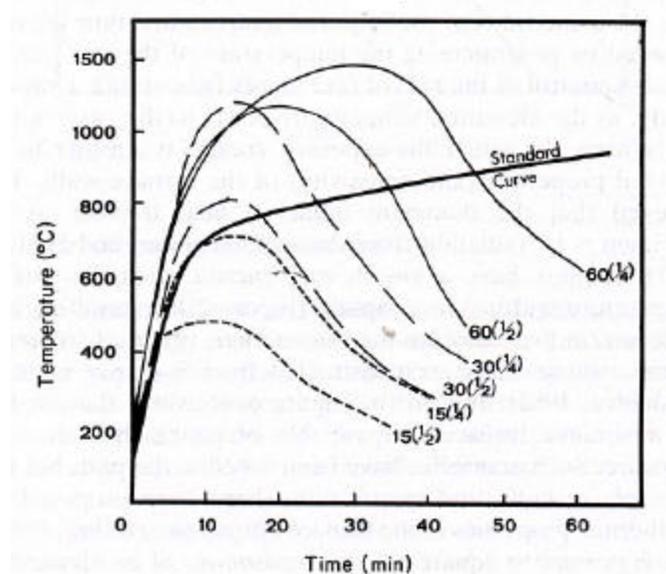
Fig. 6: Temperature history for compartment fires (burning hydrocarbons) for different fuel load, given in Kg/m², and ventilation expressed as % of one particular value of wall opening. Reproduced with permission from [2]

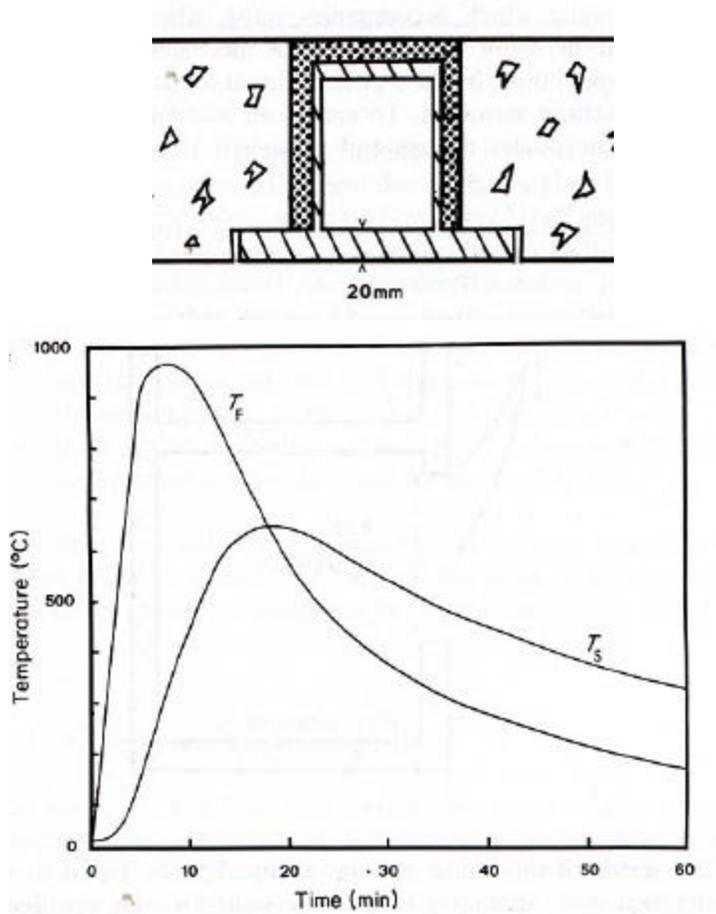
Fig. 7: Temperature history of the fire, measured at the ceiling steel beam. The fire load is 100 MJ/m^2 , and the opening factor is $0.08\text{ m}^{1/2}$, subscripts f and S correspond to fire, and steel. Reproduced with permission from [2].

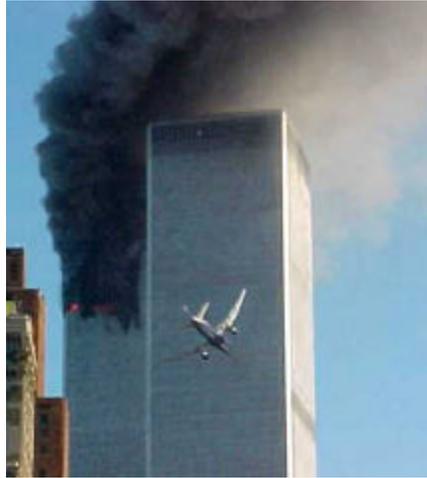
Figure 2: Boeing 767 aircraft approaching the South Tower (www)

On September 11, the first Boeing 767-200 aircraft hit the North Tower at 8:46am, near the center of the North face at about the 96th floor. The South Tower was hit at 9:03am by another Boeing 767-200 aircraft near the southeast corner of the building at about the 80th floor (Figure 2). In both cases, the planes appeared to have sliced into the buildings and exploded immediately after penetration. Smoke clouds discharged heavily from the impact face as well as the side faces of the buildings. In both cases, destruction looked local, and appeared at first not to have challenged the structural stability. People tried to escape from the impact area, while some were unfortunately trapped in the floors above the impact zones due to damaged egress routes and/or raging fuel fire.

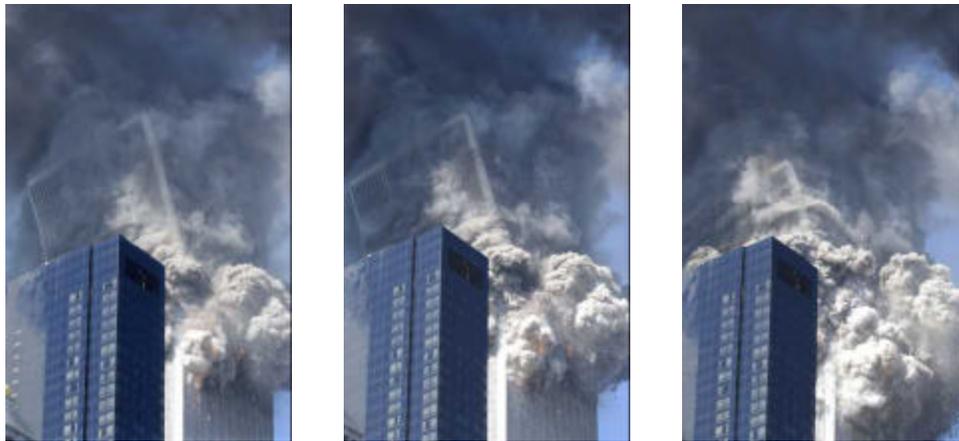
Figure 3: Progressive collapse of the South Tower (Photos from AP)

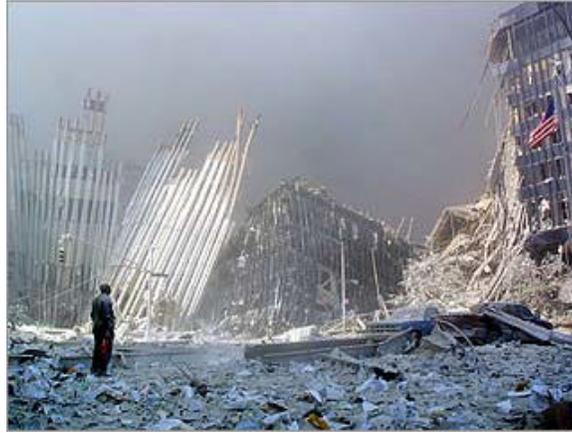
Figure 4: Collapsed tower with perimeter columns still linked at the bottom floors (www)

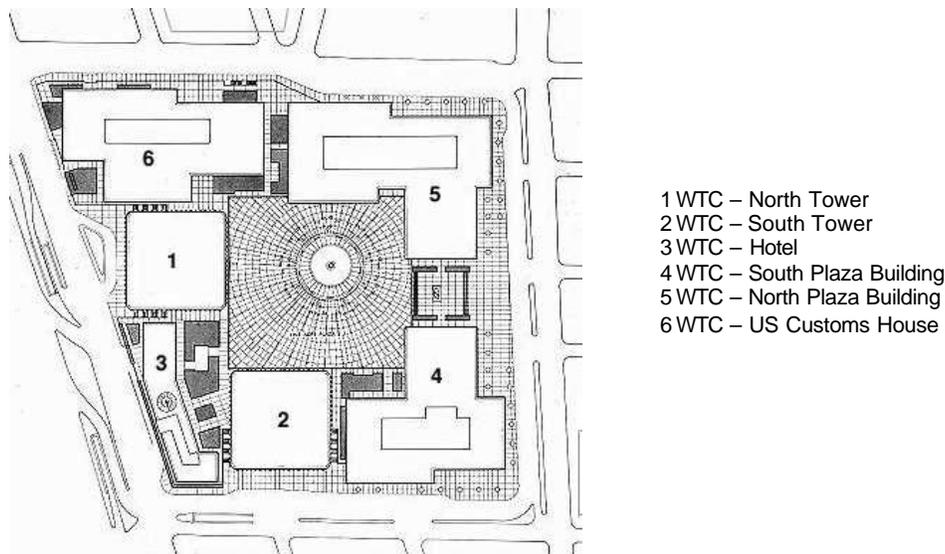
Figure 5: Plan of the World Trade Center complex (www)

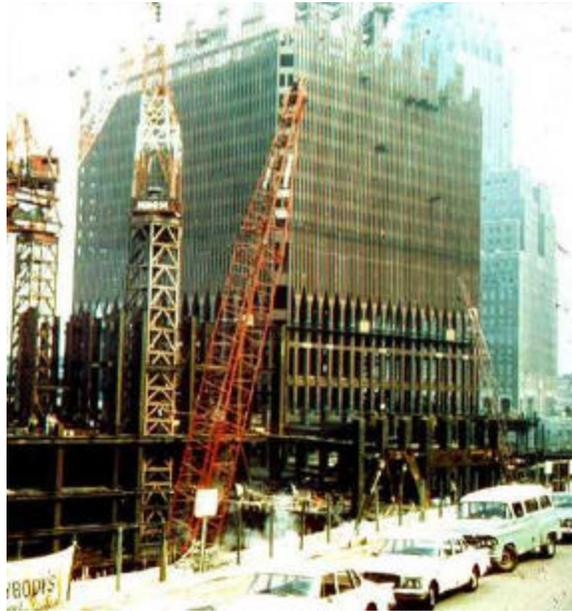
Figure 6: Towers under construction (www)

The complex was designed by Minoru Yamasaki and Associates of Troy, Michigan, and Emerith Roth and Sons of New York. The structural engineers were John Skilling and Leslie Robertson of Wortington, Skilling, Helle, and Jackson. The site excavation had begun in 1966 and construction of the towers started two years later. The first tower (WTC-1) was completed in 1970 and the second tower (WTC-2) was completed in 1972. Figure 6 shows one of the towers under construction.

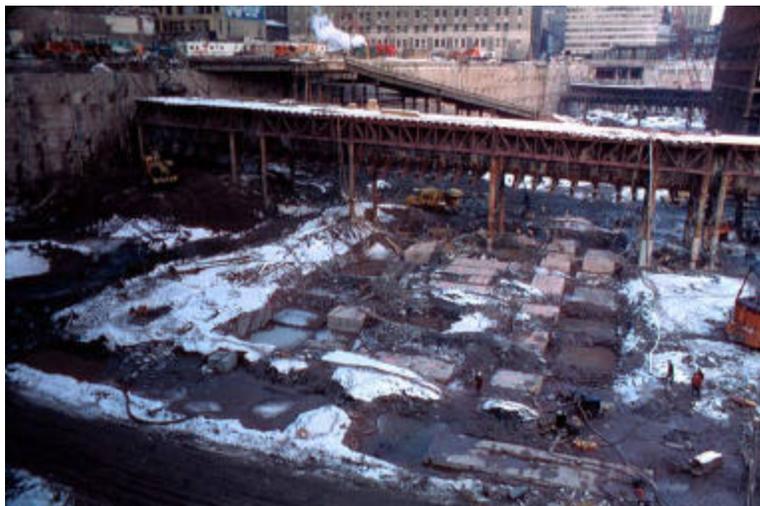
Figure 7: View of the bathtub (www)

The WTC buildings were supported by gigantic foundations. They rested on bedrock 21m (70ft) below ground. In the area that contained the twin towers, more than a million cubic yards of earth and rock were removed to place a basement that was 299m × 155m × 21m (980ft × 510ft × 70ft). The basement housed a commuter rail station, a 2000 car parking area, mechanical equipment rooms, and storage. Prior to excavation, underground walls were built all the way down and into the bedrock to withstand the external water and earth pressure, and

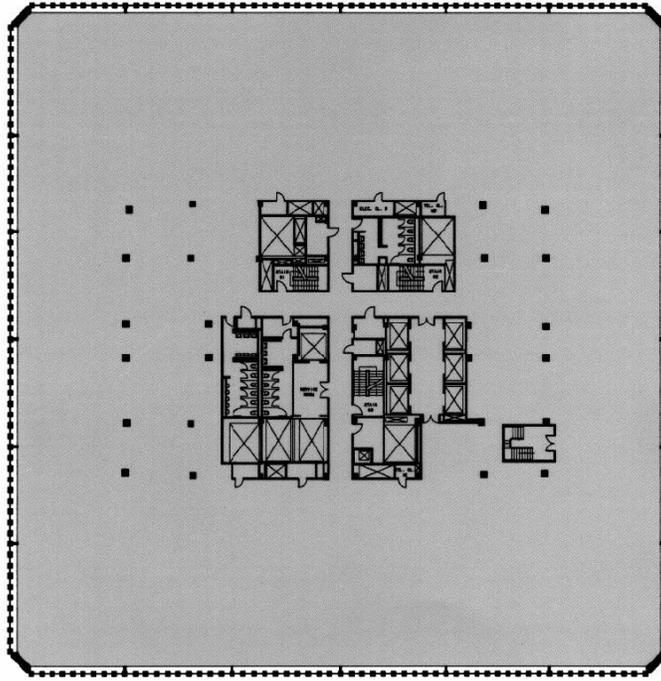
Figure 8: Typical floor plan (Hart et al., 1985)

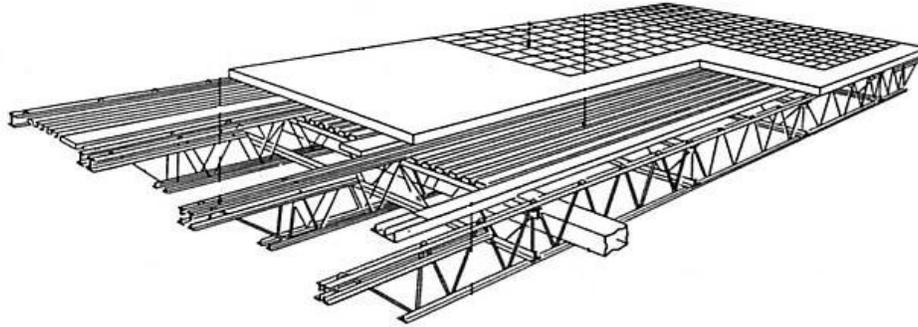
Figure 10: Conceptual view of floor system (Hart et al., 1985)

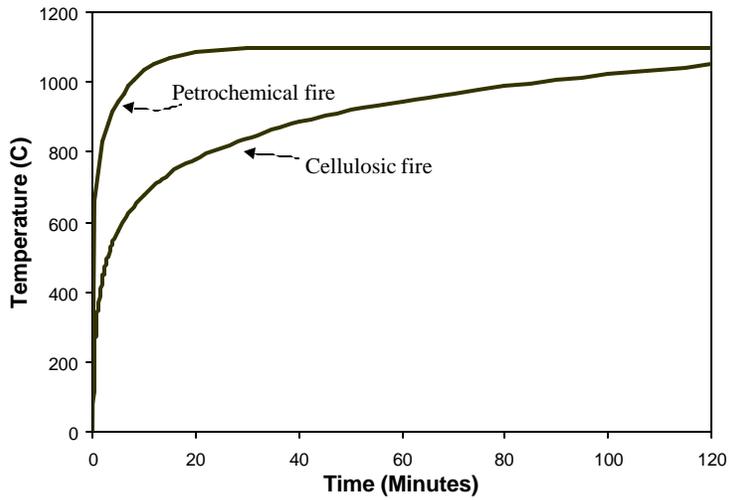
Figure 12: Fire curves (ISO, 1975)

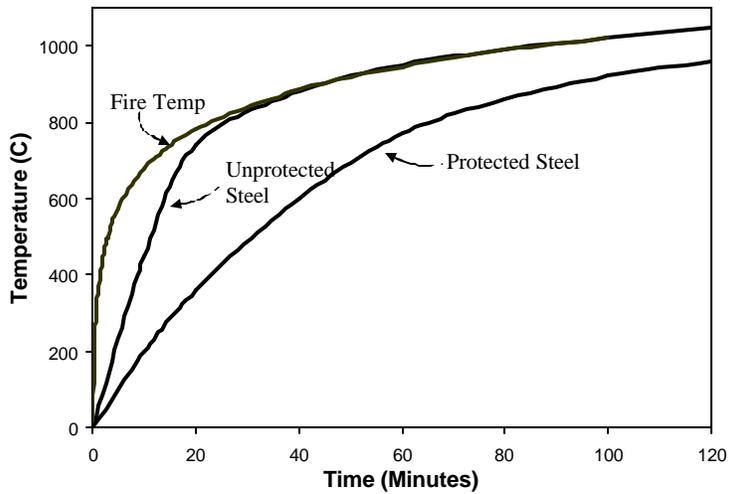
Figure 13: Temperatures for protected and unprotected beams exposed to fire (Buchanan, 2001)
