The Towers Lost and Beyond

A collection of essays on the WTC by researchers at the
Massachusetts Institute of Technology

Table of Contents

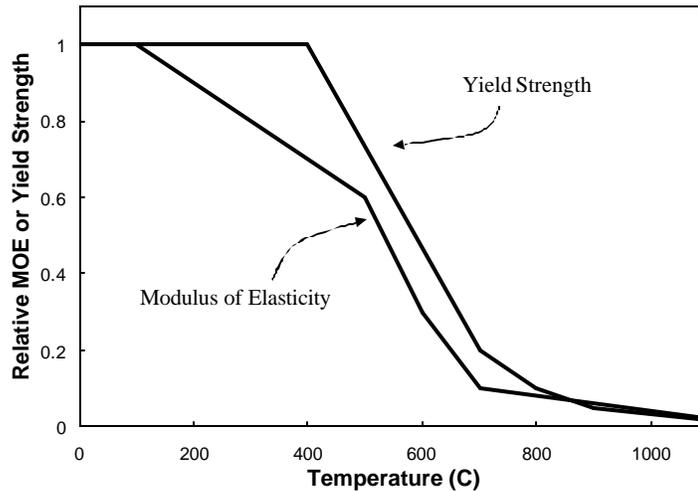
Figure 14: Reduction in yield strength and modulus of elasticity of steel as a function of temperature (EC3, 1995)

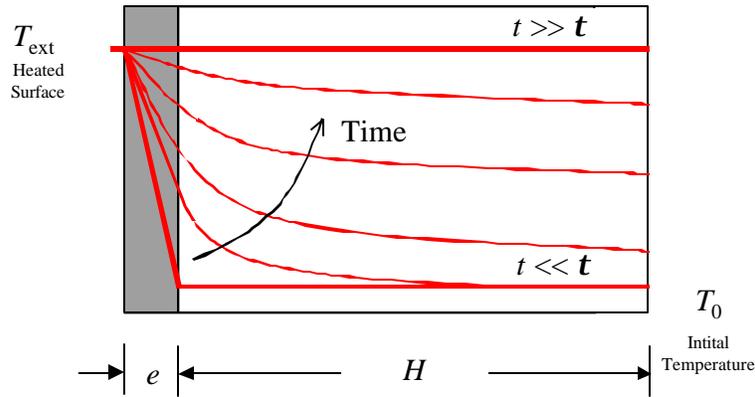
Figure 15: Temperature Profiles Through a Cross Section with a Fire Proofing Layer

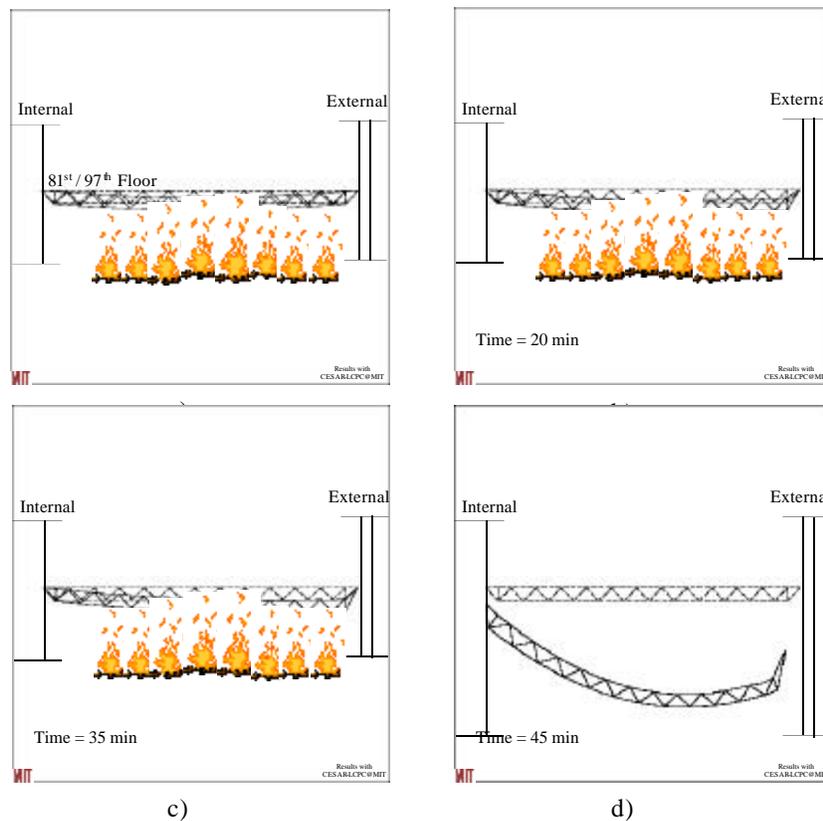
Figure 16: Finite element simulation of the floor collapse from end joints

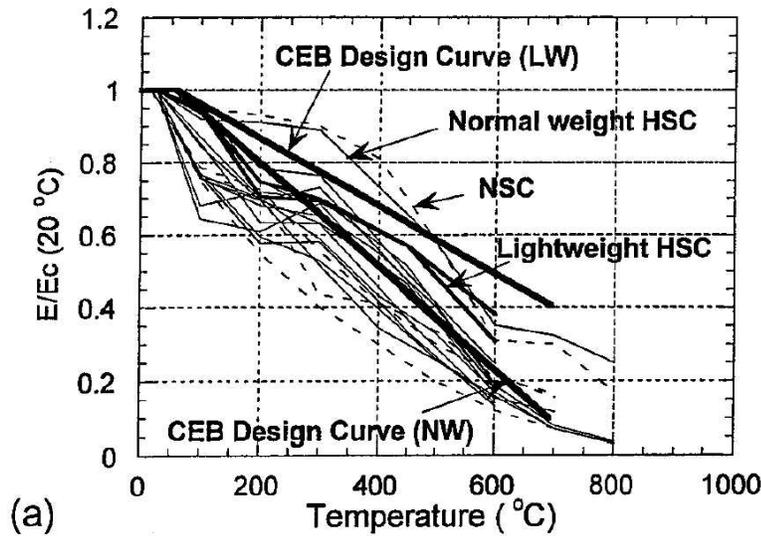
Figure 17: Thermal damage of concrete: loss of stiffness at high temperature (from the compilation of data by Phan, 1997)

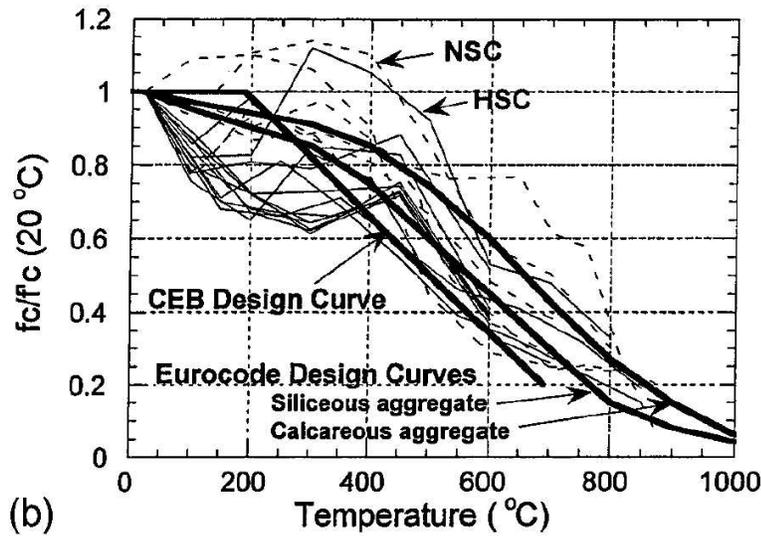
Figure 18: Thermal softening of concrete: loss of strength at high temperature (from the compilation of data by Phan, 1997)

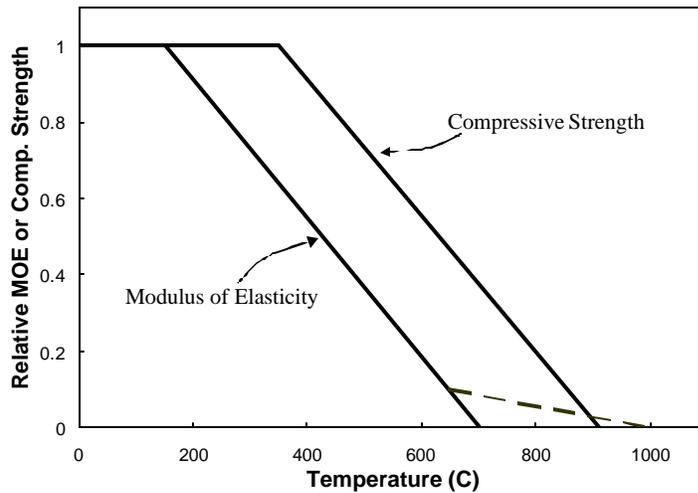
Figure 18: Idealized curves for thermal damage and thermal softening of concrete at high temperature (BSI, 1985)

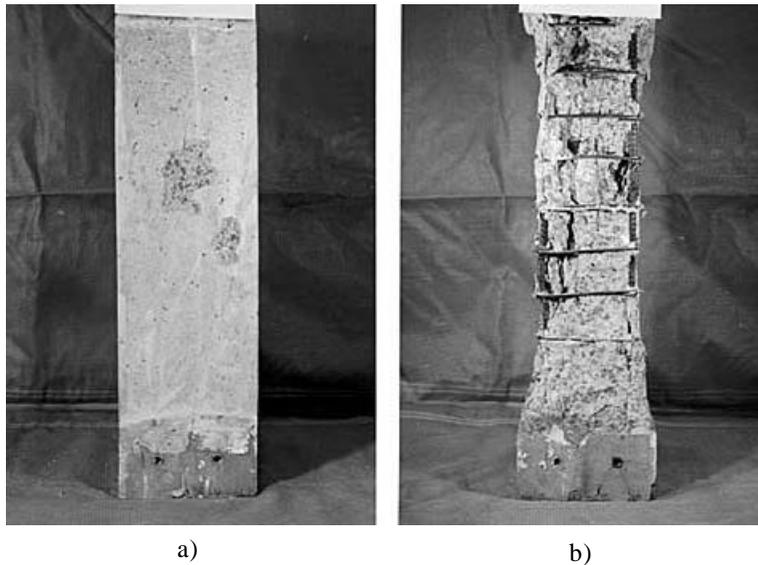
Figure 19: Effect of heat on concrete after 2 hours of exposure to 1000°C Fire
 (a) Fiber reinforced concrete and (b) Ordinary reinforced concrete
 (Takenaka Co, 2000)

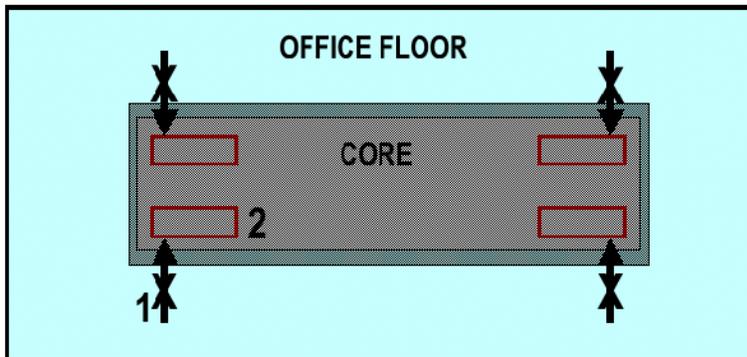
Figure 3: Compromised building egress within zones A and B

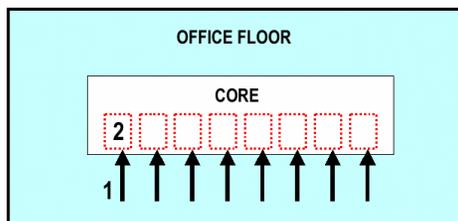
Figure 5: Elevator Shaft Egress Strategy

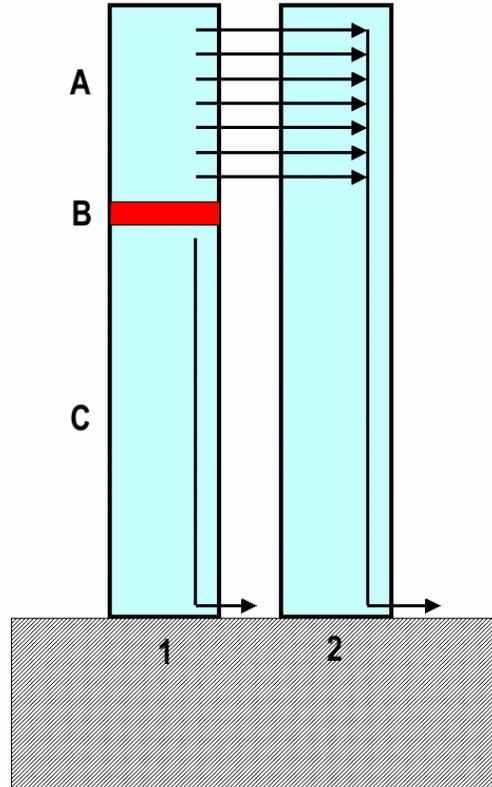
Figure 10: Egress path through an adjacent building

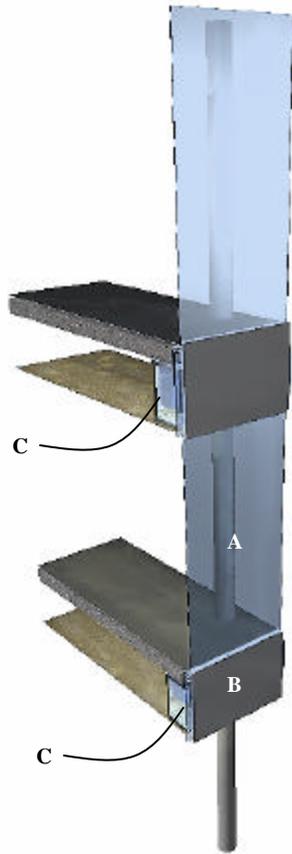
Figure 11: Section of curtainwall with integral perimeter wall escape mechanism.

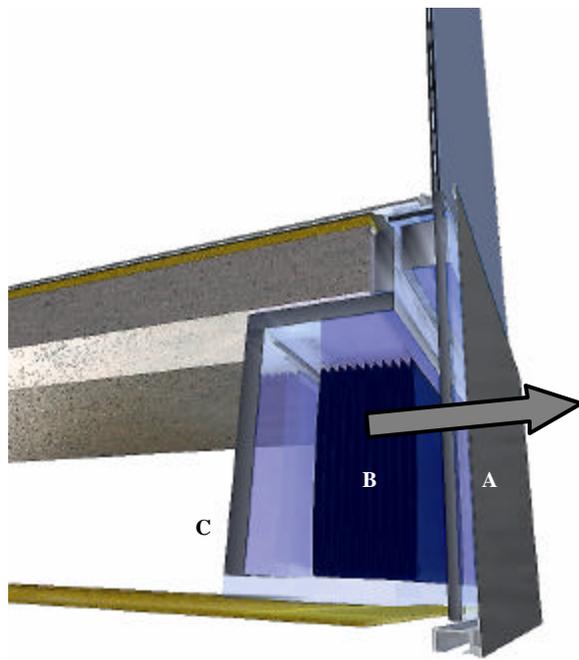
Figure 12: Detail at spandrel panel

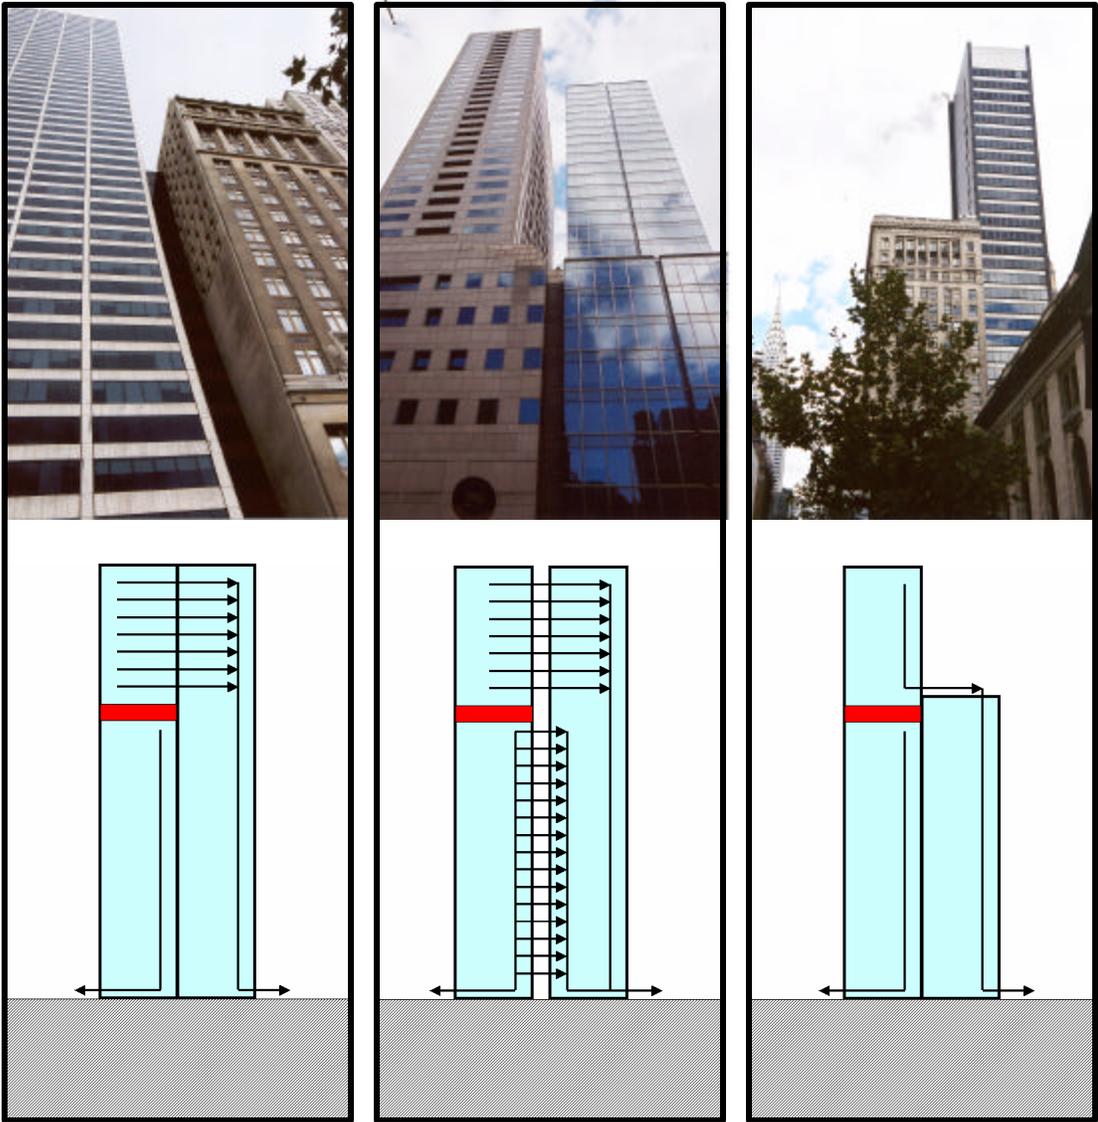
Figure 13A: Adjacent Building Egress

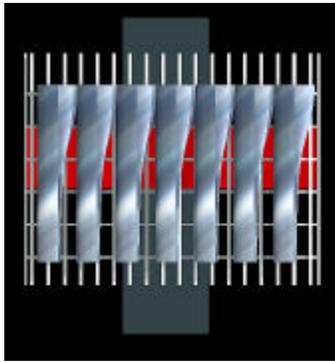
Figure 14: Elevation showing egress chutes deployed

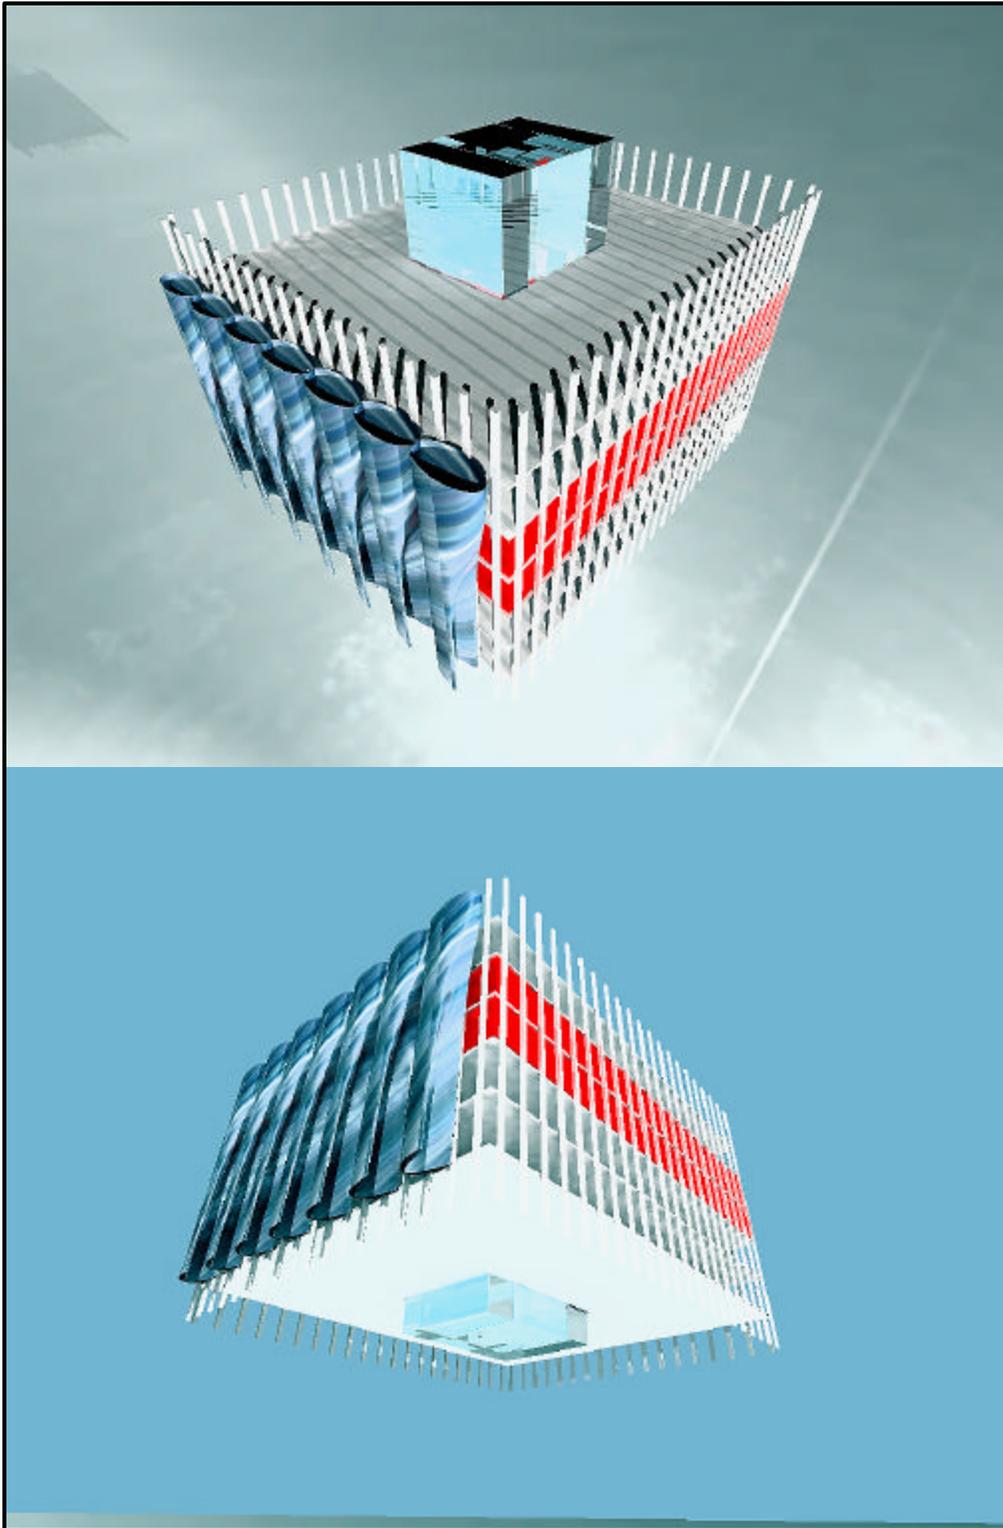
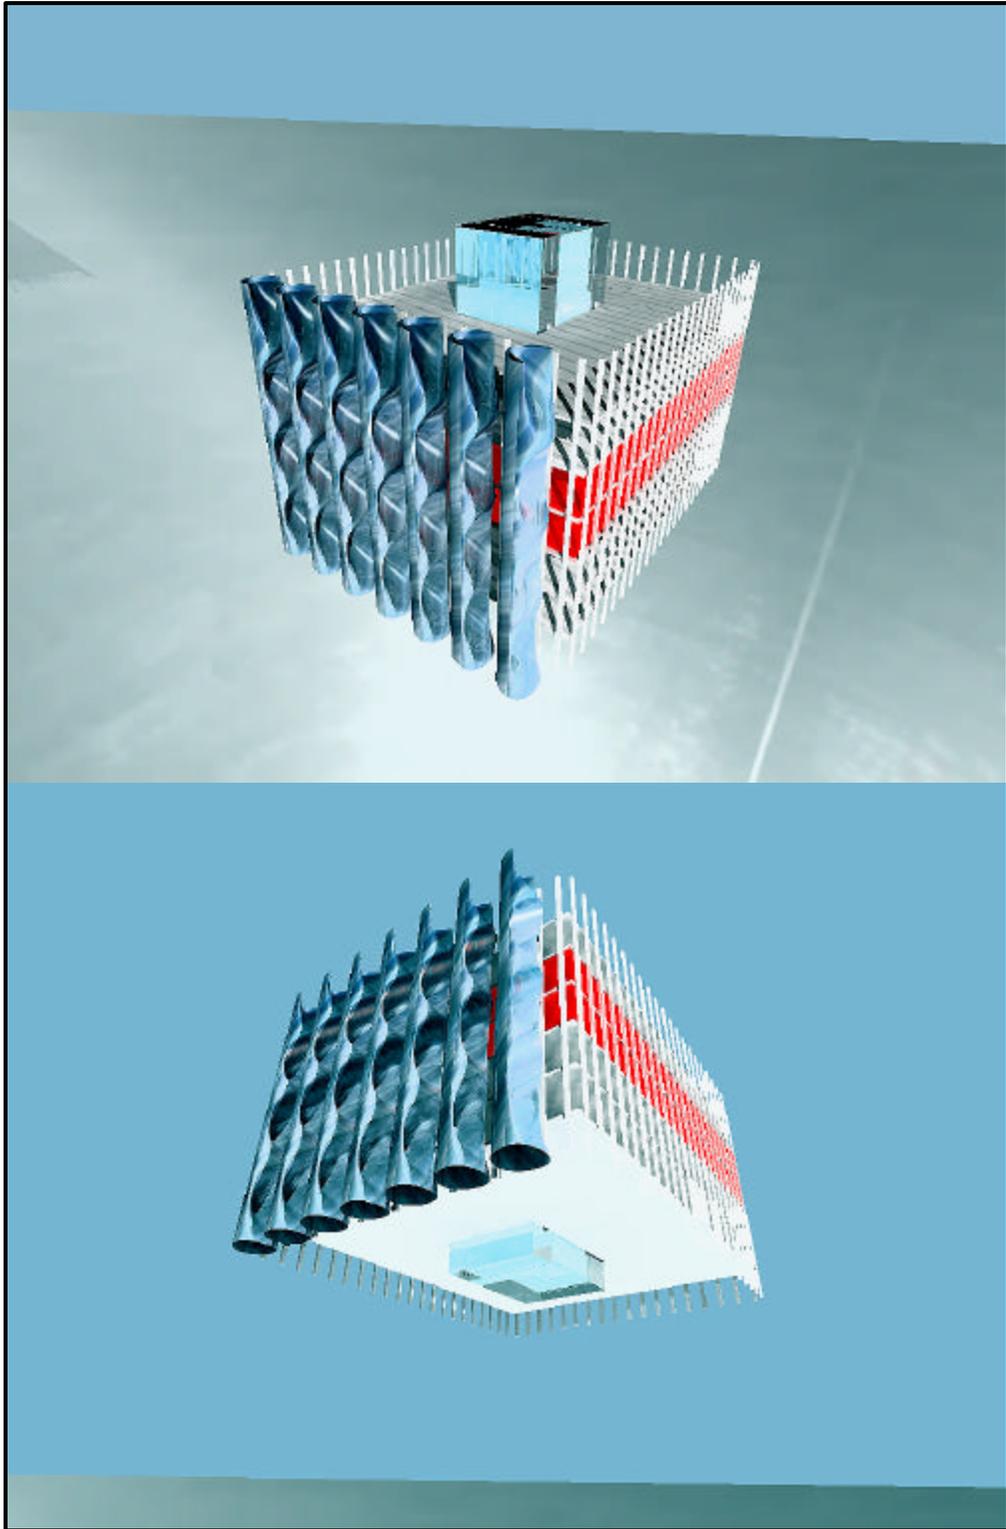
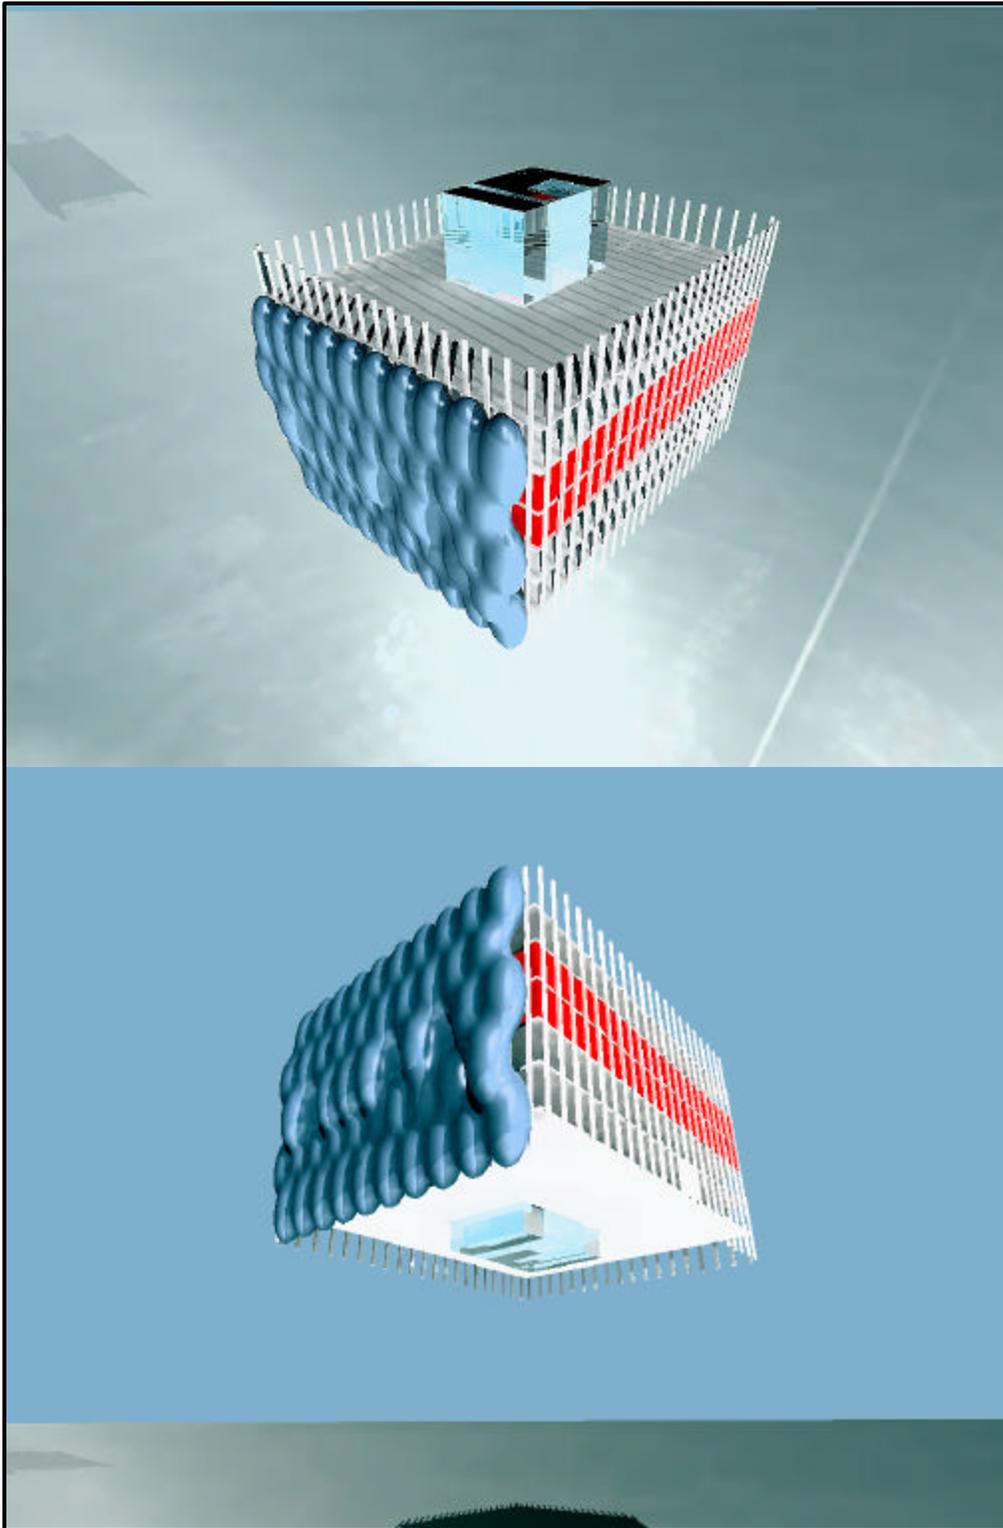
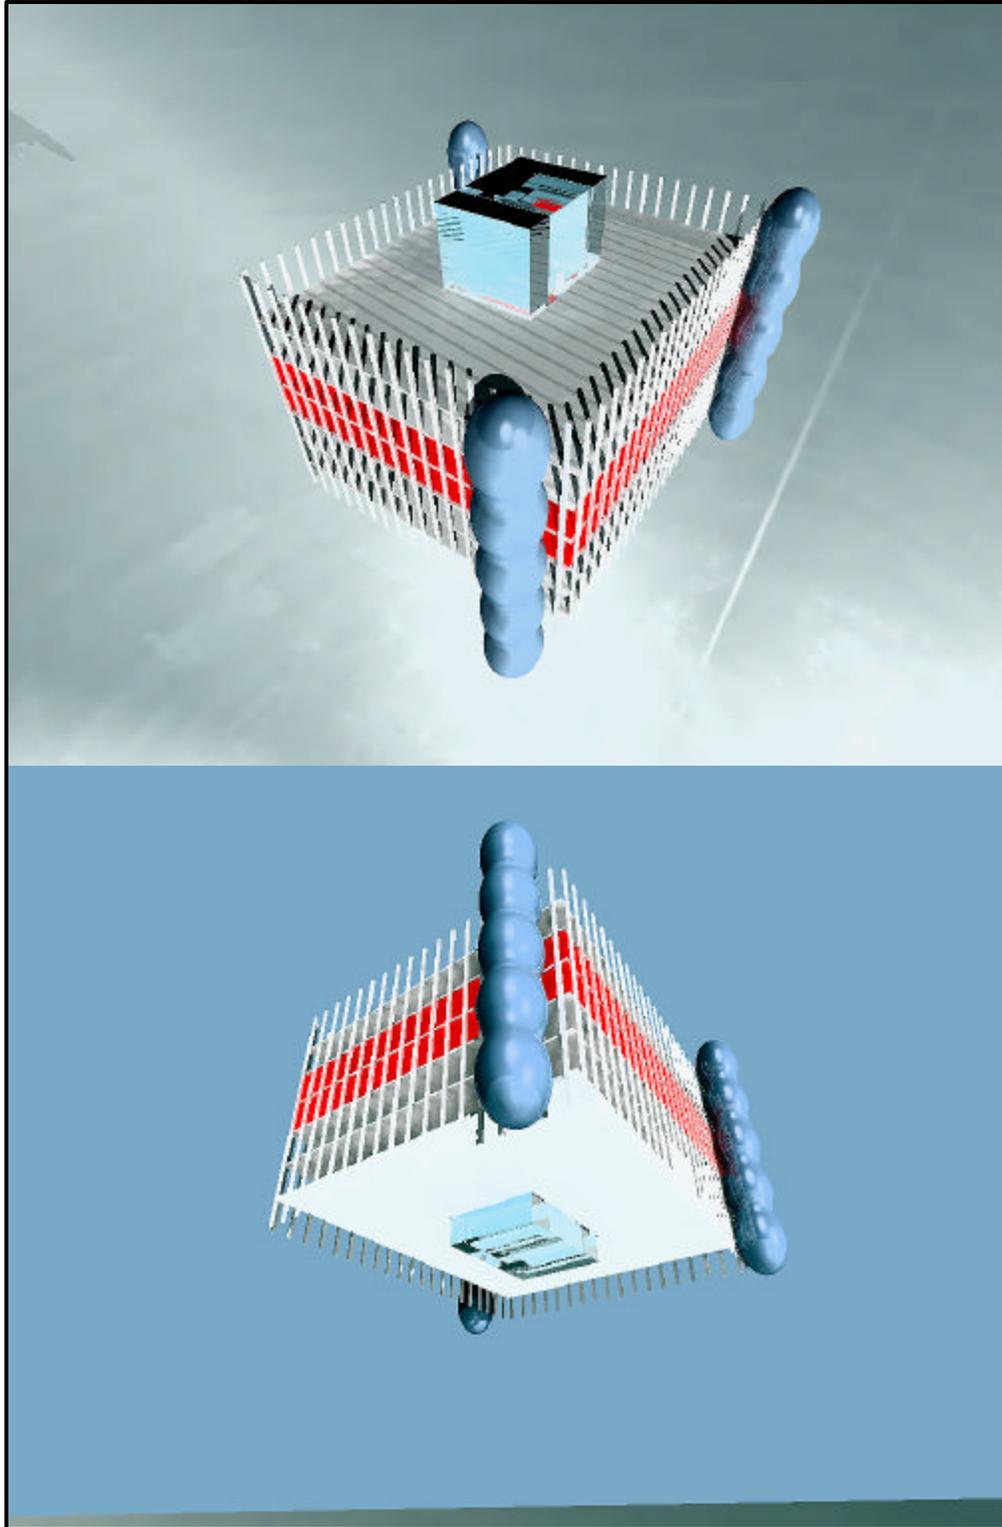
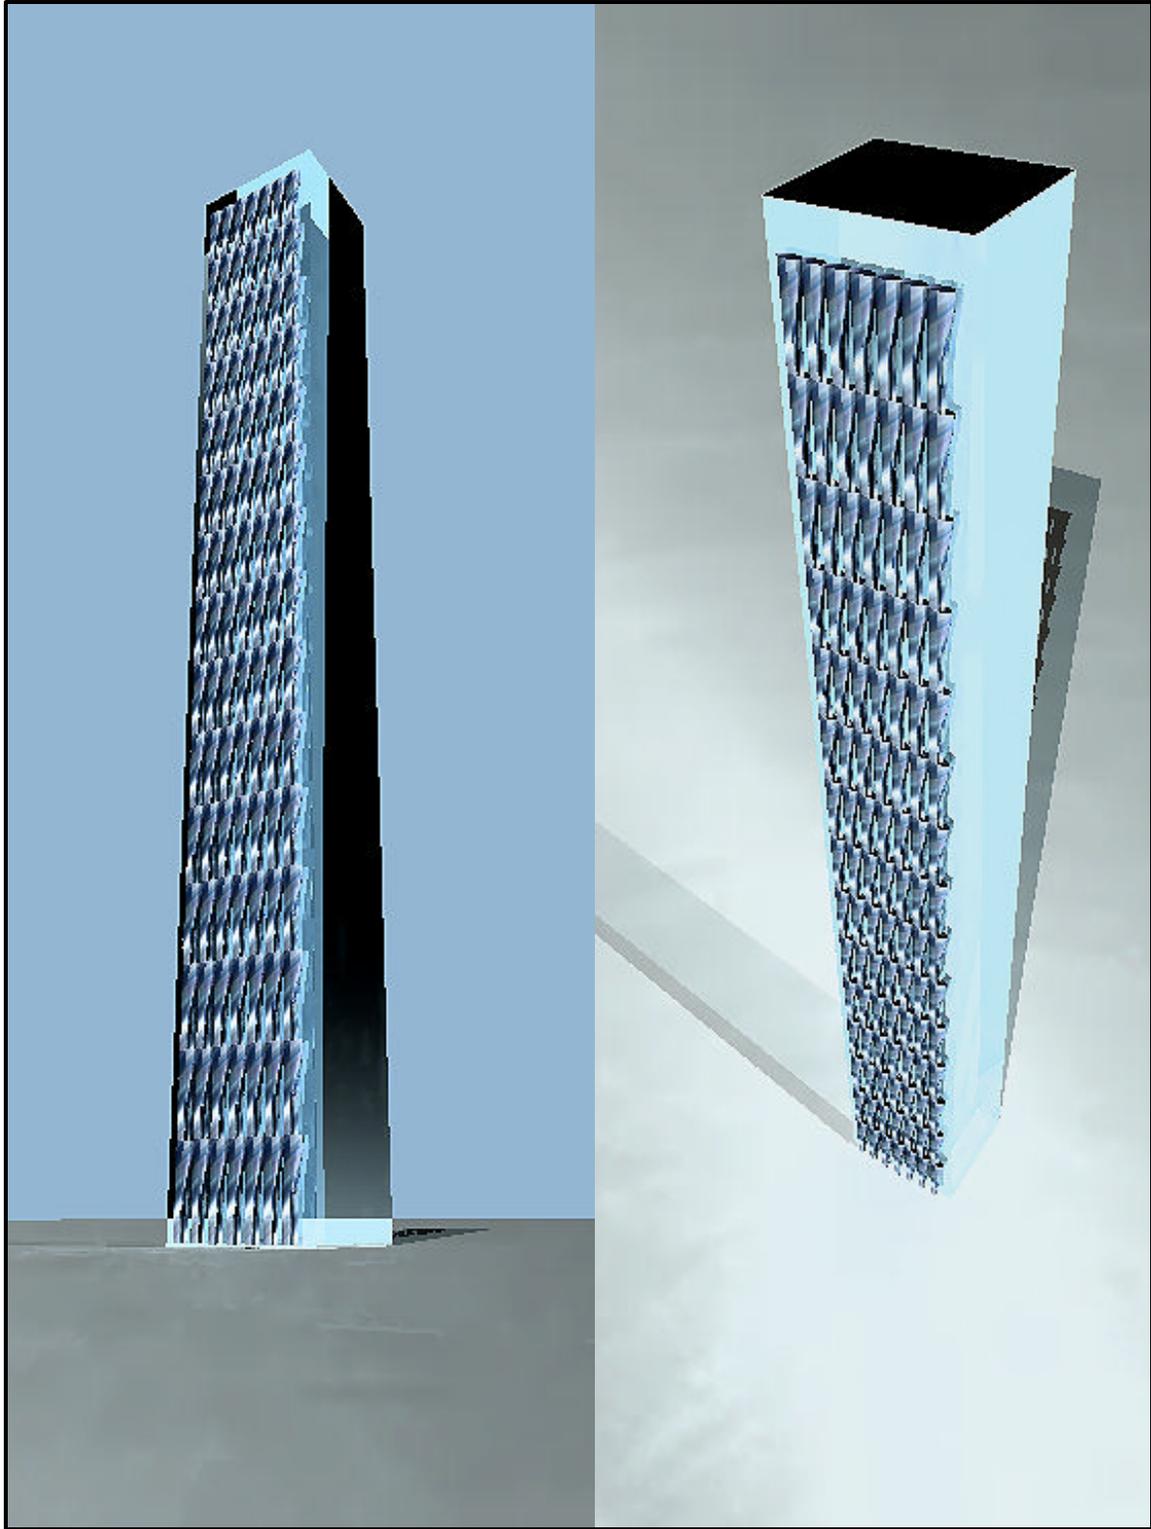
Figure 16: Deployed fire-resistant textile egress chute.

Figure 17: Deployed fire-resistant textile egress chute.

Figure 18: Deployed fire-resistant textile egress chute.

Figure 19: Deployed fire-resistant textile egress chute.

Figure 20: Deployed fire-resistant textile egress chute.
