Structural Health Monitoring for Bell 407 Tail Boom

Ashish Purekar, Kunal Kothari
Techno-Sciences, Inc.
Beltsville, Maryland

Presented at the American Helicopter Society 65th Annual Forum, Grapevine, Texas, May 27-29, 2009. Copyright © 2009 by the American Helicopter Society International, Inc. All rights reserved.

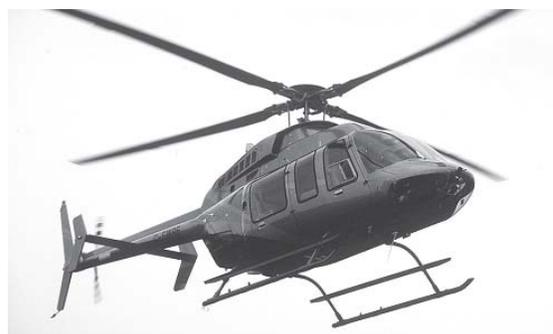
Figure 1: Bell 407

Helicopters are attractive platforms for application of SHM technologies [6] due to the environment in which they operate where severe vibration loads and varying mission profiles can induce damage in the structure. The Bell 407 tail boom, pictured in Figure 1, was chosen as the specific Primary Structural Element (PSE) to demonstrate in-situ SHM technologies due to fatigue and ballistic related damage. While the Bell 407 is a civilian system, it is similar in design to the US Army OH-58 Kiowa. The structural health monitoring technologies can, however, be transitioned to any military or civilian platform.

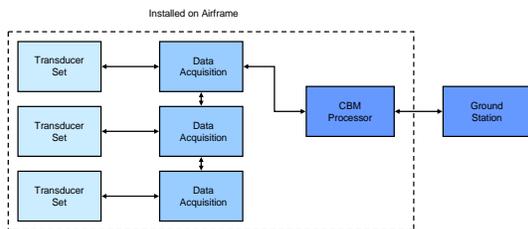
Figure 2: Transducer network configuration

Hardware components of this SHM system consist of mounted transducers, data acquisition, and processing units. A diagram of a conceptual transducer network for SHM is shown in Figure 2. Transducers are mounted to structural components of interest and designed to evaluate damage conditions. A link to a ground station unit enables data archiving and implementation of fleet-wide health monitoring and maintenance coordination.

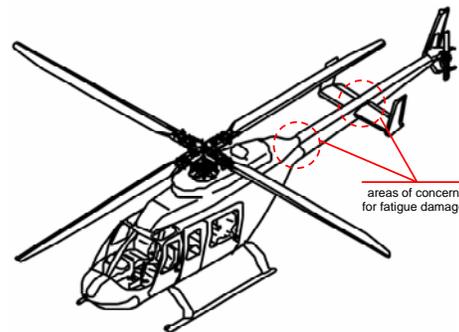
Figure 3: Fatigue hot spots on Bell 407

Fatigue damage is caused by stress concentrations and cyclic loads. While there are several fatigue sensitive locations on the aircraft, the Bell 407 tail boom structure was chosen to demonstrate the sensor technology. The two main areas of interest for damage detection on the Bell 407 tail boom are identified as the inter-costal members used to mount the tail boom to the airframe and the area around the horizontal stabilizer, both circled in Figure 3. Vibratory loads from the helicopter downwash and tail rotor vibrations induce stresses around the cut-out for the horizontal stabilizer. Stress concentrations in these regions lead to fatigue cracking between rivets at the interface of the horizontal stabilizer and the tail boom.

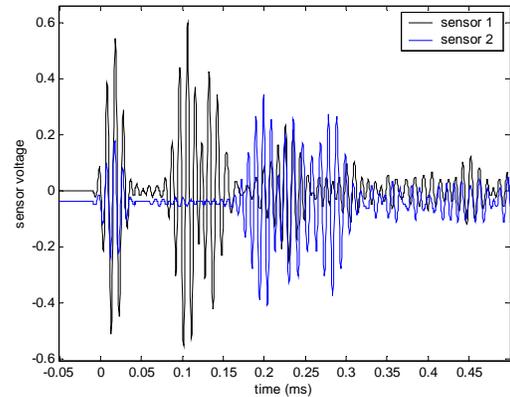
Figure 5: Transient response at 100 kHz excitation

High frequency tone burst signals from 40 kHz to 200 kHz were introduced into the structure by the excitation element and the sensors were used to monitor the passage of the A0 Lamb waves as they propagated outward. The transient sensor response was gathered at each test frequency. A plot of the transient response from 100 kHz excitation is shown in Figure 5. The initial response shows EMI noise followed by the passage of the A0 Lamb mode as it travels down the tail boom through each of the sensors. Subsequent waveforms correspond to reflections from boundaries and edges in the test section. The group speed was determined at each of the test frequencies and compared to models of wave propagation for thin flat panels. The Kirchoff bending mode [12], based on a simplified model of a thin panel, does not allow for shear deformation through the thickness. The A0 Lamb mode model is based on a higher order theory [13]. The comparison between the theories and experimental results are shown in Figure 6. The results show the two models start diverging as the frequency increases above 50 kHz excitation. Additionally, the A0 Lamb mode model follows experimental trends more closely than the Kirchoff model. The model produces group speed predictions approximately 10% higher than experimentally observed. This could be due small differences in materials properties, skin thickness, and sensor placement.

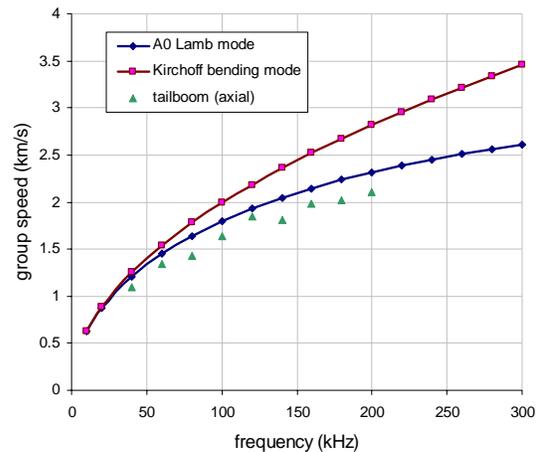
Figure 6: Comparison between theory and experiment

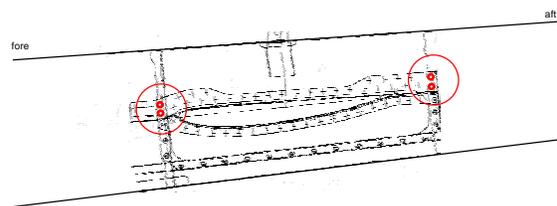
Figure 7: Fatigue cracking hot spots

The area of the Bell 407 tail boom most prone to fatigue damage is directly fore and aft of the horizontal stabilizer. History has shown crack initiation at the fastener positions shown in Figure 7.

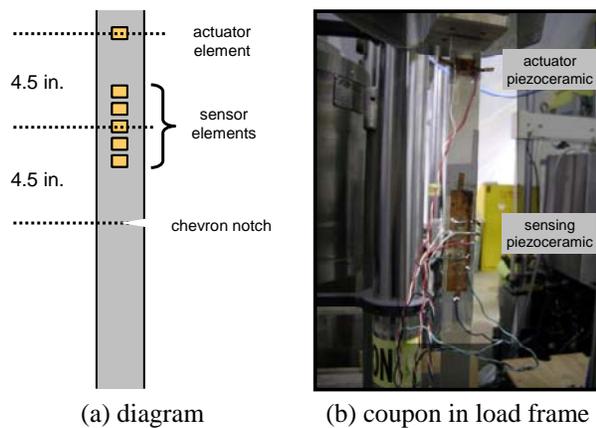
Figure 8: Coupon specimen for fatigue crack detection

24 in. long. A diagram of the coupon specimen is shown in Figure 8. A chevron notch that had a depth of approximately 0.164 in. and a span of 0.05 in. was cut into the coupon. Mechanical loading was applied using a MTS test frame with tension-tension loading from 100 MPa to 195 MPa at 1 Hz frequency. One piezoelectric transducer was used as an actuator and five transducers were placed between the actuator element and the notch. Each transducer was a 0.25 in. diameter PZT-5A piezoceramic element. Data was acquired every 600-800 cycles after crack initiation was observed. Data was acquired for two cases, (1) a crack open case where a tensile load of approximately 100 lbs was used and (2) a crack closed case where the bottom grip on the MTS machine was released.

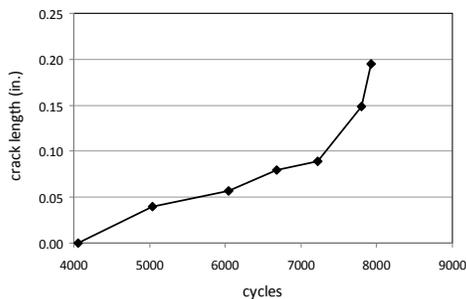
Figure 9: Growth of crack with loading cycles

Fatigue testing of the coupon specimen produced stable crack growth up to a length of approximately 0.2 in. The curve in Figure 9 shows the growth in the crack with the number of cycles. The set of images in Figure 10 show the growth in the crack as the number of cycles increased. After a 0.20 in. crack depth was observed and subsequently loaded, the specimen critically failed.

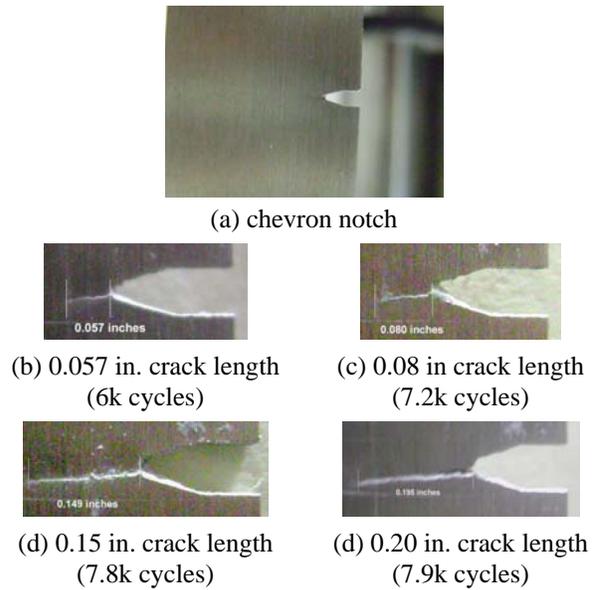
Figure 10: Crack propagation in coupon specimen

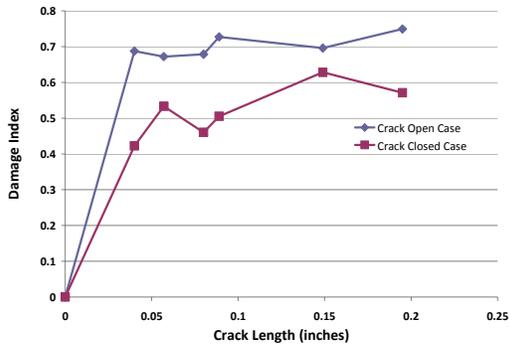
Figure 11: Monitoring of crack growth

The actuator transducer was excited using a 5 cycle tone burst of 60 kHz, 80 kHz, and 100 kHz. The transient data was captured by the sensor elements. The transient time histories were windowed based on the expected flight time of the interrogating signal from the actuator to the notch and back to the center of the sensor. The transient data was captured and signal processing algorithms were used to compare the signals in the undamaged and baseline cases. The data reduction step produced damage indices, which are used as a diagnostic metric. Damage indices were computed based on the time domain response and averaged across all sensor elements and frequencies. The damage indices are plotted for both the crack open and crack closed cases (Figure 11). In both cases, the damage index is shown to rise as the crack length increases. The damage index levels for the open crack were higher than the closed crack cases. The test results showed that the guided wave damage detection technique is capable of detecting and tracking fatigue crack growth.

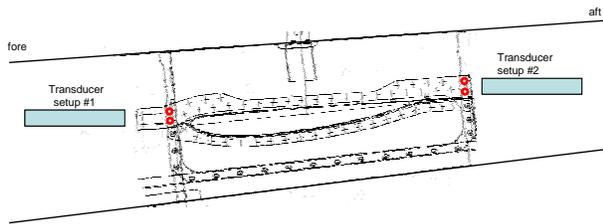
Figure 12: Transducer layout for fatigue monitoring

The proposed transducer layout is shown in Figure 12 for the regions to the fore and aft of the horizontal stabilizer. This arrangement enables monitoring of the two hot spot regions in the tail boom section prone to fatigue damage.

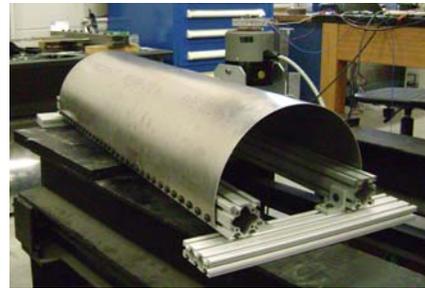
(a) tail boom skin section

Figure 13: Setup for tail boom skin damage detection

A test specimen was constructed to simulate the skin components of the Bell 407 tail boom (Figure 13a). The length of the test specimen was 33 in. with a diameter of 15 in. and thickness of 0.04 in. An aluminum panel was rolled and mounted on a frame with bolts. One line of bolts was fixed to the side of the curved panel. The distance between each bolt was 1 in. which matches the distance between rivets used in the Bell 407 tail boom construction. The specimen was instrumented with in-situ piezoelectric transducers for interrogation during simulated ballistic event. A total of eight transducers were bonded to the structure (Figure 13b); four on each side with a spacing of 10 in. between the transducers and 4 in. from the bolt locations.

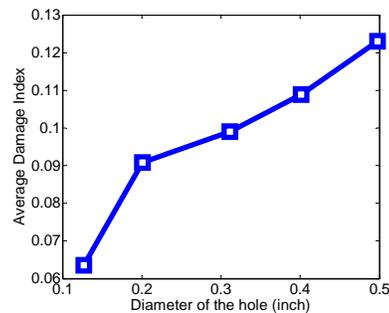
Figure 17: Growth of damage index with damage size

The paths corresponding to these damage indices are shown in Figure 16. The general location of the damaged region was determined based on the evaluation of the damage indices and correlation with transducer layout. In this manner a set of distributed transducers form a network of paths which are able to identify an approximate the location of the damage. The results were similar when considering damage of various sizes. The average of the maximum damage indices in each direction was determined and plotted versus damage size (Figure 17). Additional testing is still required to validate the correlation between damage size and damage index.

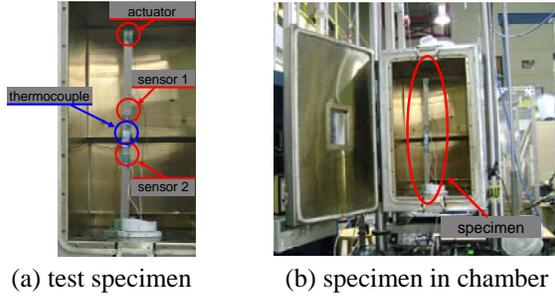
Figure 22: Test setup to evaluate temperature effects

An experimental setup was used to determine the effect of temperature on the response of the piezoelectric elements. The experimental specimen with mounted transducers is shown in Figure 22a. The specimen was placed in a heating/cooling chamber as

shown in Figure 22b. Thermocouples were mounted to the specimen to get the material temperature. Data was gathered for temperatures ranging from -60°F to 200°F .

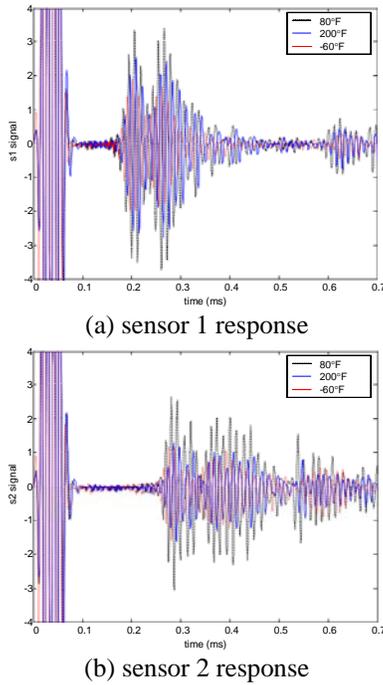
Figure 23: Sensor response for 80 kHz excitation (80°F , 200°F , and -60°F)

The recorded responses for sensors 1 and 2 at 80°F , 200°F , and -60°F for 80 kHz excitation is shown in Figure 23. It is apparent from the sensor signals that the amplitudes of the signals have shifted due to temperature.

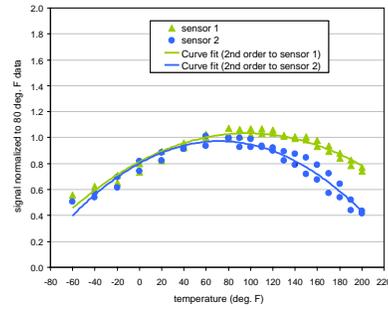
Figure 24: Normalized ϕ for 80 kHz excitation

Curve fits were performed for each of the normalized ϕ curves and the results for 80 kHz are shown in Figure 24. This process was repeated for all of the tested frequencies. The analysis resulted in the following temperature compensation equation:

$$\bar{\phi} = aT^2 + bT + c$$

where a, b, and c correspond to the curvature, slope, and offset of the curve. In the above relation, T is defined in terms of $^{\circ}\text{F}$. For 80 kHz case, the values of a, b, c were determined to be $-2.82\text{E-}05$, 0.004646 , and 0.808072 , respectively.

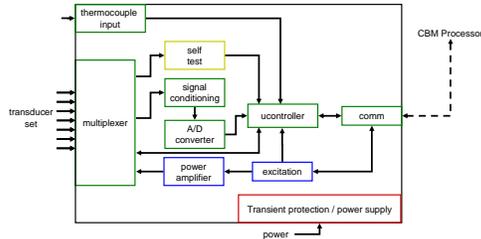
Figure 25: Conceptual design of testing system

A prototype system was designed to provide an on-board structural diagnostics capability. This system was tailored for an Acousto-Ultrasonic pitch-catch transducer network. The system consists of a data acquisition unit, excitation circuitry, microcontroller unit, multiplexer, thermocouple unit, and a communications subsystem that interfaces with a HUMS processor (Figure 25). The prototype system has the ability to perform additional data reduction functions with the addition of digital signal processors

to off-load the HUMS processor. This prototype system will be used in the technology demonstration on the Bell 407 tail boom. A small form factor unit has been designed to be used with 32 piezoelectric transducers. The unit has a designed footprint of approximately 36 sq. in. and a weight of approximately 3 lbs.
