NRCC-49203

Laboratory Demonstration of Solar Driven Inward Vapour Diffusion in A Wall Assembly

Institute for Research In Construction

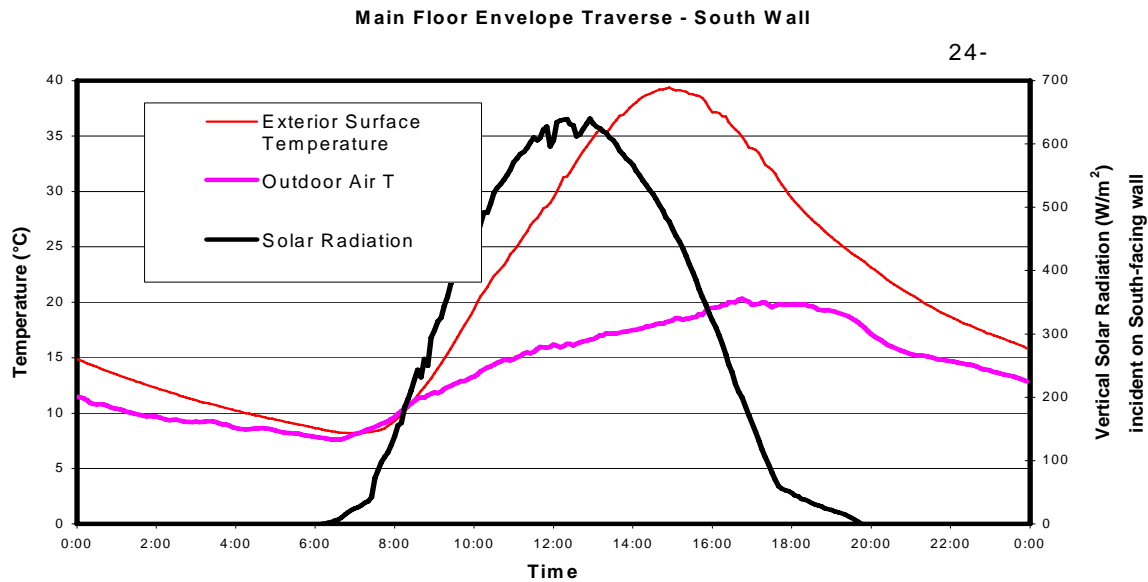
Figure 1 – Effect of solar radiation on the surface temperature of a south-facing brick veneer wall

It can be seen that the air temperature peaks at 20 °C whereas the surface temperature of the brick peaks at close to 40 °C. Had the wall been soaked in a driving rain on the previous night, the brick would obviously have undergone drying on that sunny day. But what would have happened to the vapour that had been generated during that process? Some of it would have definitely gone to the exterior air. At the same time a vapour diffusion process towards the interior of the built environment would also have been possible as indicated by the field measurements of Saïd et al. (2003) and Wilson (1965). This would have been especially true when the brick got warmer, thereby increasing the temperature and local vapour pressure within the brick. The indoor vapour pressure at that stage would have been significantly lower than that in the brick and a “solar driven” vapour diffusion process towards the interior could not have been ruled out. If the indoor was air conditioned, say to maintain 20 °C and 50 % RH, moisture could have condensed interstitially. This phenomenon may result in harmful moisture accumulation within the wall

Calculations of exterior surface temperature that have been previously reported in literature (Hutcheon, 1983) provide some indication of the substantial increases in surface temperature when exterior walls are exposed to direct solar radiation. The sun provides radiation at building surfaces at a rate that varies with time of year, time of day, orientation of the surface, clarity of the sky, surroundings and surface absorptance. This is illustrated in **Figure 1**, as measured in a field experiment undertaken at the Institute for Research in Construction (Ottawa, Canada) on a sunny day in August 2004. The results show that the rise in exterior surface temperature above air temperature in summer is 20 °C for a south-facing brick veneer wall at noon local time.

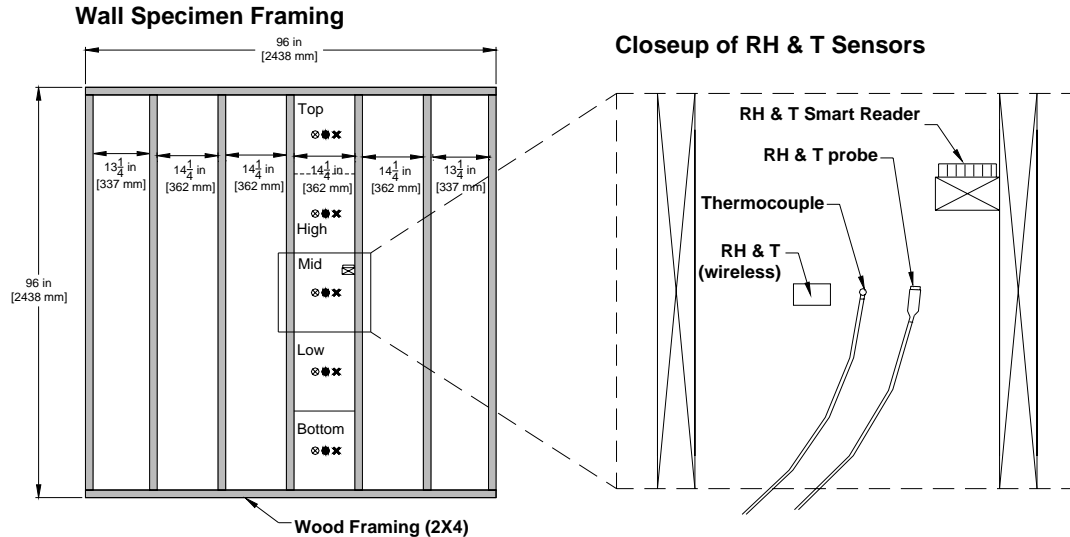
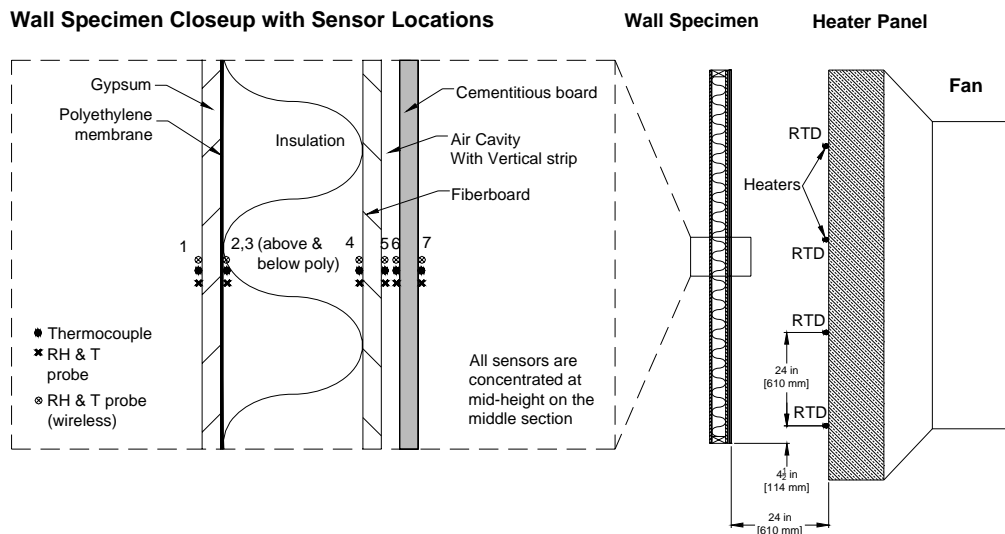
EEEF WALL SPECIMEN - FRONT VIEW

EEEF WALL SPECIMEN - SIDE SECTION VIEW

Figure 2 – Wall specimen configuration Simulated solar radiative heating effects imparted

A schematic of the wall configuration is provided in Figure 2 and depicts the various components of the experimental set evaluated in this preliminary full-scale test. The experimental set consisted of evaluating the hygrothermal properties of a wood- frame wall assembly consisting of various layers of which the exterior cladding was a single sheet of cementitious board, followed by: an asphalt impregnated fiberboard sheathing, insulation placed in the cavities between the studs of the assembly, a single sheet of polyethylene installed as vapour barrier and gypsum board (dry wall) used as interior finish. The assembly was subjected to simulated rain through a series

Relative humidity sensors, RTDs (Resistance Temperature Detectors) and thermocouples were used to measure relative humidity and temperatures at different levels and on each layer of the wall assembly. Each of these sensors was located at mid-section of each layer of the wall assembly (Figure 2). Readings were taken every 2 minutes and averaged every 10 minutes. The weight of each component of the wall was taken before and after the experiments, from which both the initial and final moisture contents for individual components could be determined.

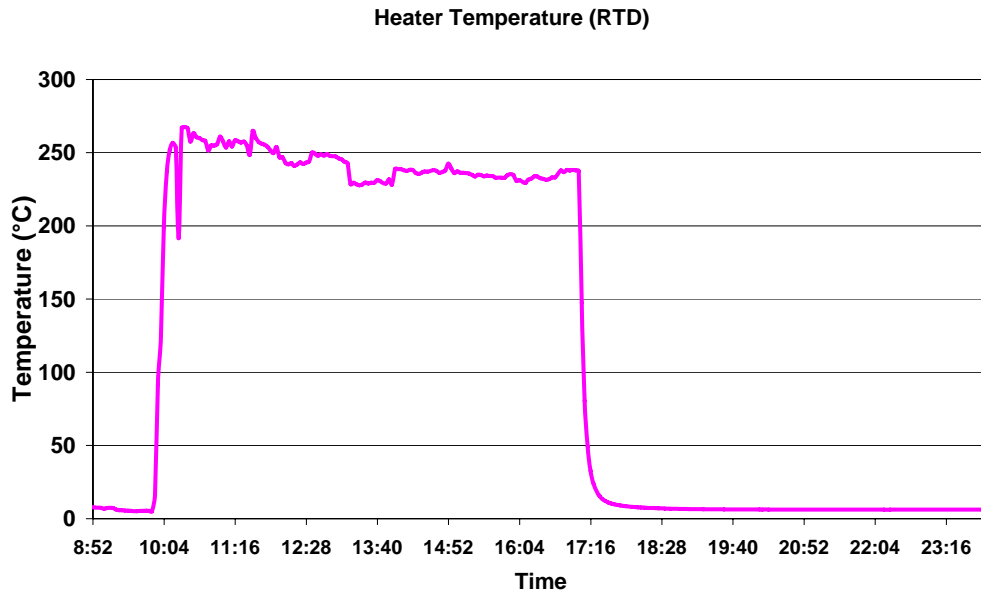
Figure 3- Temperature profile of the heater

In this paper, a select set of results is presented that illustrate the hygrothermal response of the wall assembly described above. The phenomenon of inward moisture drive is demonstrated in this straightforward test. Figure 3 shows the temperature profile of the infrared heater during the test period. From 8:50 to almost 10:00 AM the heater was turned off. During that time, the water spray is activated, and the pre-conditioning of the wall is initiated.

At 10:00 AM the heaters were turned on, and after 20 minutes the temperature of the heater reached 260 °C and thereafter was maintained at an average of 245 °C during 7 hours. The criterion for stopping the heater was for the surface temperature of the cladding (i.e. cementitious board) to reach 13 °C above the ambient temperature of the chamber.

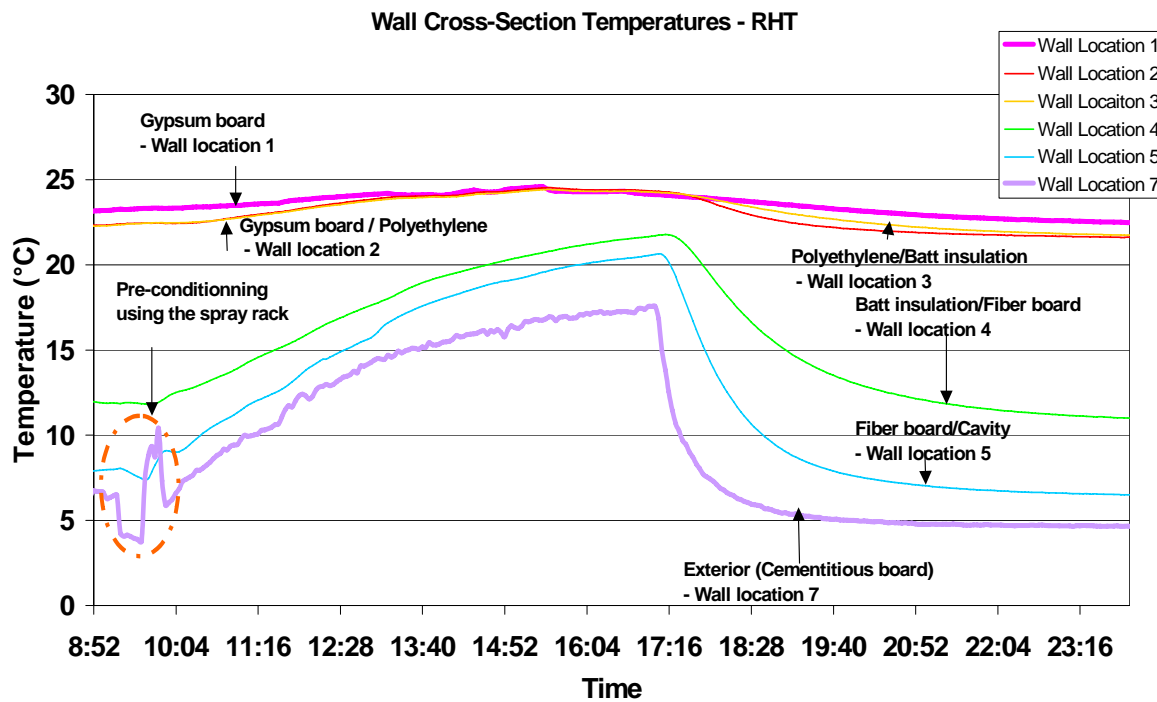
Figure 4- Cross section temperature profiles versus the time of the experiment
11th Canadian Conference on Building Science and Technology
Banff, Alberta, 2007

Figure 4 provides temperature profiles of the different components (layers) as a function of the test period across a section of the assembly. As is apparent from the temperature-time plots, the wall conditioning period occurs between 8:50 and 10:00 AM. During this time, the cladding surface temperature increased from 4 to 11 °C. The warming effects is due to the water spray as it was greater than that of the initial laboratory chamber temperature thus resulting in an increase in surface temperature of the cementitious board of almost 7 °C. The pre-conditioning stopped at 9:50 AM and thereafter, the surface temperature of the cementitious board decreased from 11 °C to almost 6 °C after 10 minutes given that the chamber was at 5 °C. The heaters were turned on at 10:00 AM. This effect is directly shown in the figure since there is a corresponding increase in surface temperature of the cementitious board and the temperatures of the sheathing and

insulation. The heaters were on for almost 7 hours; over this period, the surface temperature of the cementitious board reached a maximum of 17.5 °C, i.e., 13 °C above the ambient temperature of the chamber thus ensuring that the solar effect criterion was fulfilled. The heaters were then turned off; the temperature profiles of the outer part of the wall (i.e. cementitious board, sheathing and the insulation) follow the declining temperature trend for the heater.

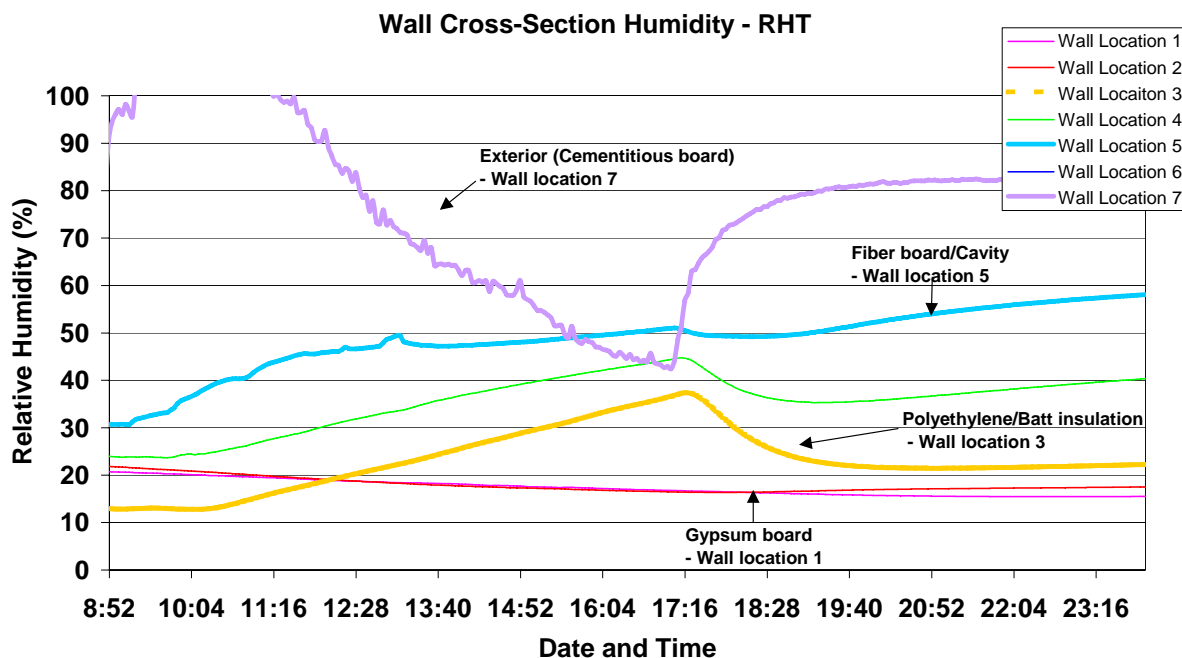
Figure 5- Cross section relative humidity profiles versus the time of the experiment

Figure 5 shows the relative humidity profiles during the test. We can see that during the pre-conditioning phase the relative humidity near the surface of the cement board (see Figure 4; Location 7) is 100 % and above and stayed until 11:30 AM. This was due to the water spray that saturates the sensors and the surface of the cement board is saturated as well. After that period, the heater had an effect on the surface.

This is similar to rain deposition on the wall, which is in part driven inward in the form of water vapour when the sun's radiation heats the surface of the moisture-laden cladding. (Surface evaporation would also take place in this drying process, but this component was not measured). It is quite evident in this graph that the surface relative humidity of the cement decreases whilst the relative humidity of the cavity increases as does the relative humidity of the insulation both sides (sheathing and the poly). The relative humidity of the cavity started at 30% and reached 52 % during the heating period. This graph shows the inward moisture drive brought about by the simulated radiative effects of the sun. Figure 6 shows the humidity ratio profiles of each component of the wall during the test.

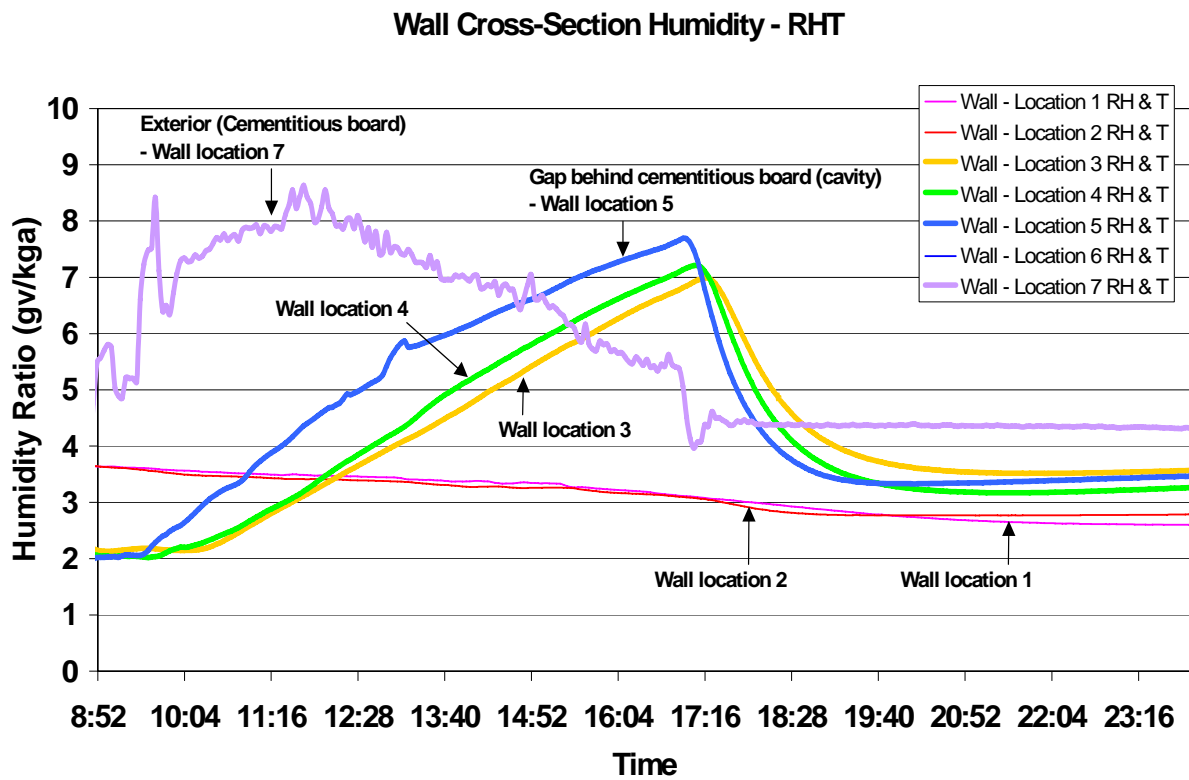
Figure 6- Cross section humidity ratio

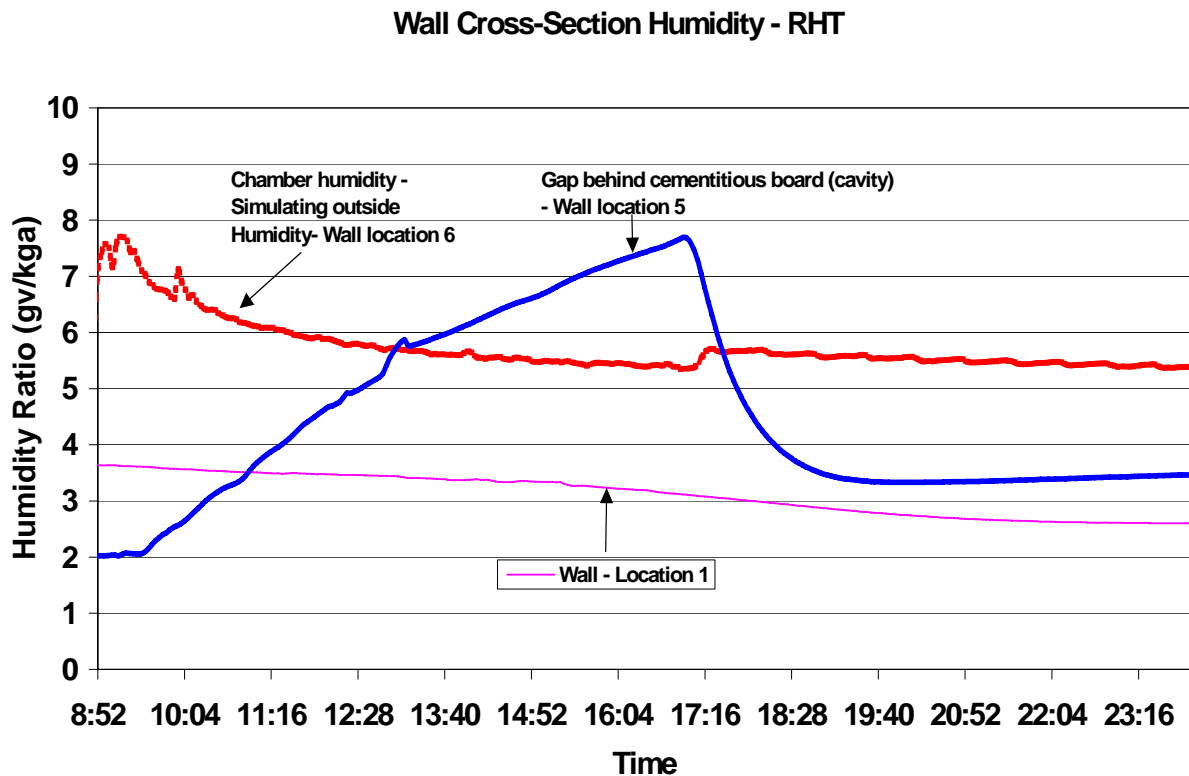
Figure 7- Wall cavity behind cement humidity ratio –Lab experiment

The humidity ratio of the outside air (i.e. chamber temperature) and the cavity behind the cement board are represented in Figure 7. It shows that the heater is on from 10:00 AM until 5:00 PM.

The moisture is driven into the cavity when the heater is on; this simulates for example an east-facing wall of a house exposed to the sun. The humidity ratio at 10:00 AM starts at 2 gv/kg reaching 7.5-gv/kg air at 5:00 PM. Thereafter, with no infrared heating, there is necessarily a reduction in humidity ratio, simulating, at this stage, a night sky radiation effect (4.5 gv/kg air). The inward moisture drive shown on this graph occurs between 1:00 PM and 5:00 PM, with the humidity ratio in the cavity being above that of the outside ratio.

The examples provided in this paper, though not involving the same assemblies (brick veneer in the field vs. unfinished fibre-cement cladding in the lab) and not directly comparable, nonetheless illustrate the order of magnitude and duration of heat driven inward vapour drive of two different assemblies. Figure 7, which is laboratory test, and Figure 9, which is field test, showed us that we could mimic in the lab similar orders of magnitude of changes in terms of absolute humidity ratios in envelope cavities during the phenomenon of inward vapour drive.

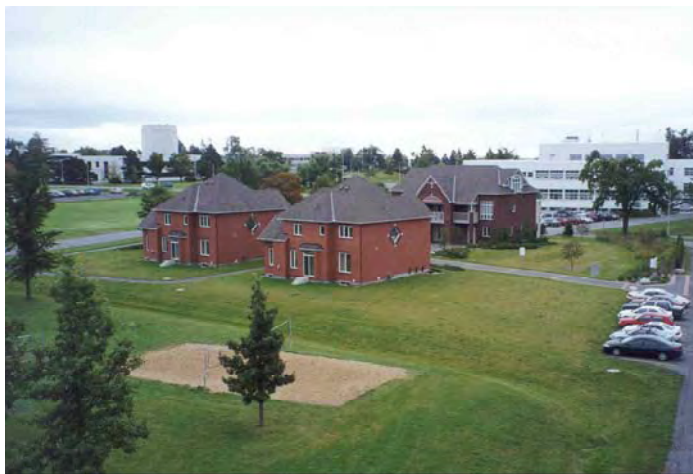
Figure 8- Canadian Center for Housing Technology

There is a good similarity between this laboratory experiment and a field test conducted at the Canadian Center for Housing Technology (CCHT) (see Figure 8). Figure 9 provides a plot of the humidity ratio over a period of a day (24 August) for an East-facing brick veneer wall of the CCHT test facility. Humidity profiles are taken for the outside surface of the wall and in the space behind the brick veneer cladding at the second floor level. It can be seen that the sun does not shine directly on the east wall for a long period of time (i.e. humidity ratio declines from 0 to ca. 7:15 AM).

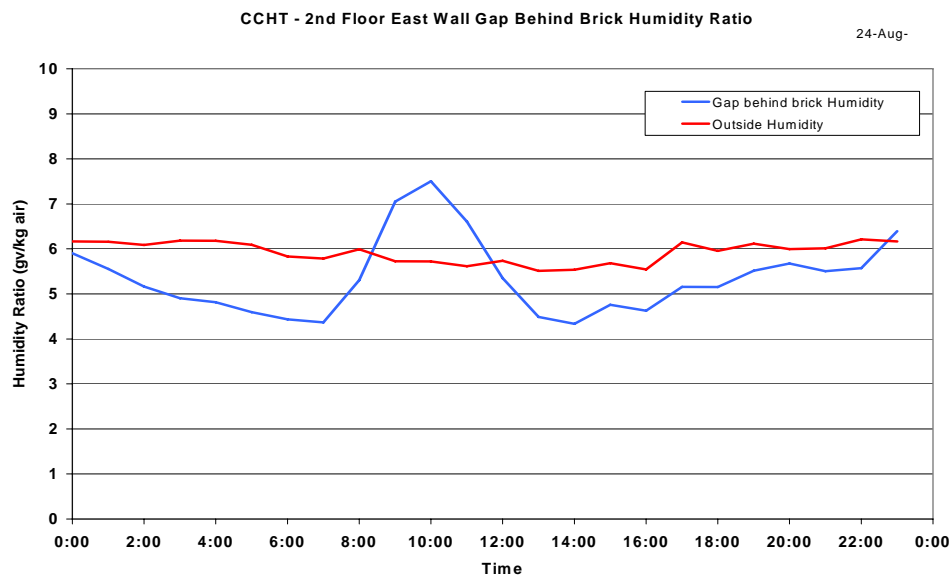
Figure 9- East wall gap behind brick humidity ratio at CCHT

The moisture is driven into the cavity when the sun heats the East wall from about 8:00 AM to 1:00 PM. The humidity ratio starts at 4.5 and reaches 7 gv/kg air at 10:00 AM and then back to no

solar radiation effect (4.5 gv/kg air). The inward moisture drive is shown on this graph between 9:00 AM and 12:00 PM, given that the ratio in the cavity is above the ratio given at the outside of the wall.

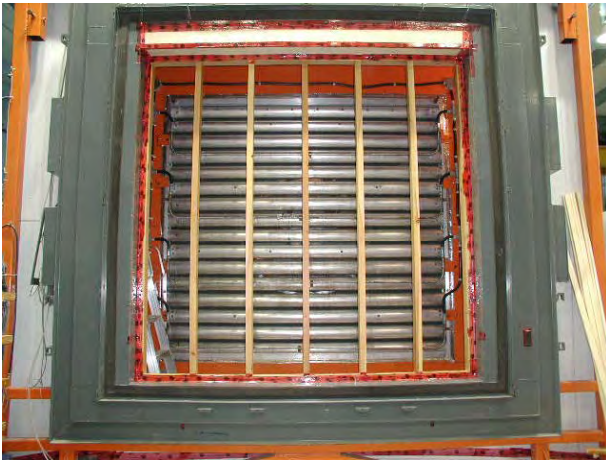
Figure 10- Installation of the wood-stud frame in EEEF

of water nozzles that sprayed a controlled and calibrated quantity of water onto the wall. Simulated solar radiative heating effects imparted on the cladding surface were achieved through a set of infrared heating coils located in proximity to the cladding surface. The different steps of the experiment are illustrated in Figures 10-17.

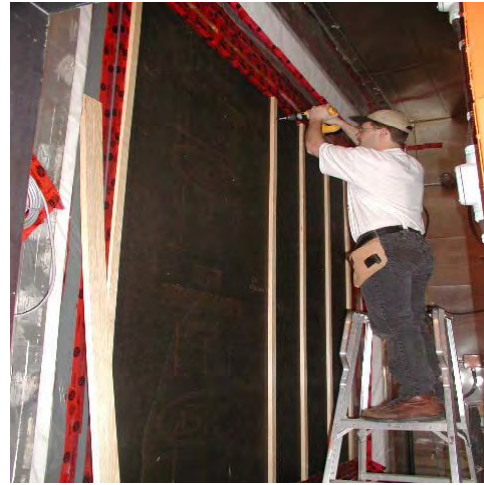
Figure 11 - Installation of strapping for cavity behind cladding

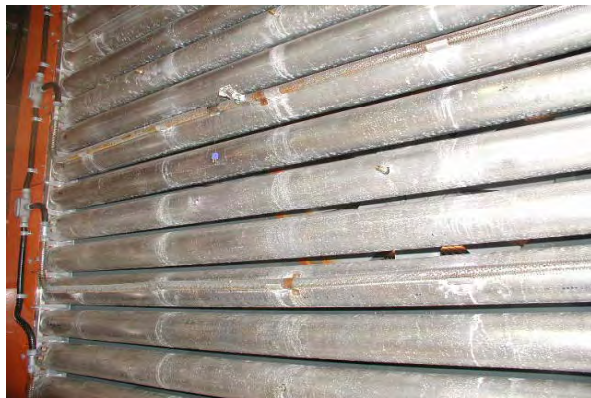
Figure 12 - Spray rack and infrared heating system

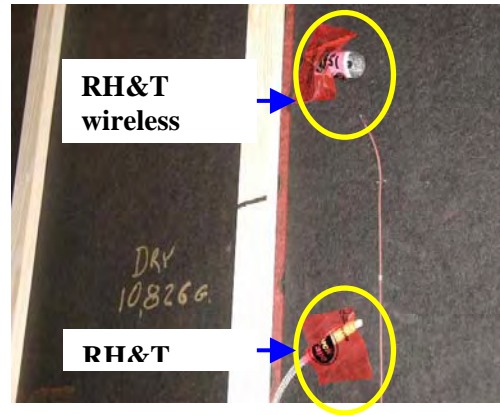
Figure 13 - Installation of RH&T probes in the cavity (Location 5)

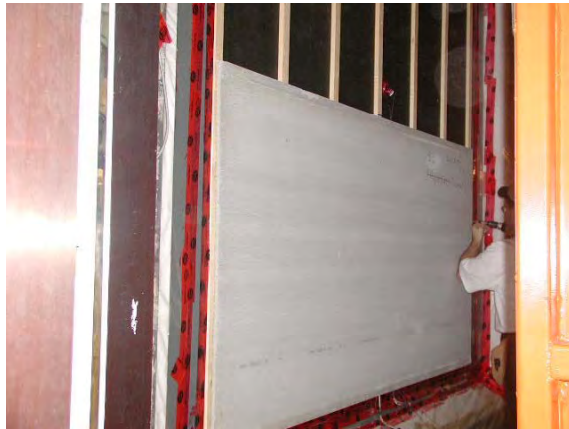
Figure 14 - Installation of cement board (Location 7)

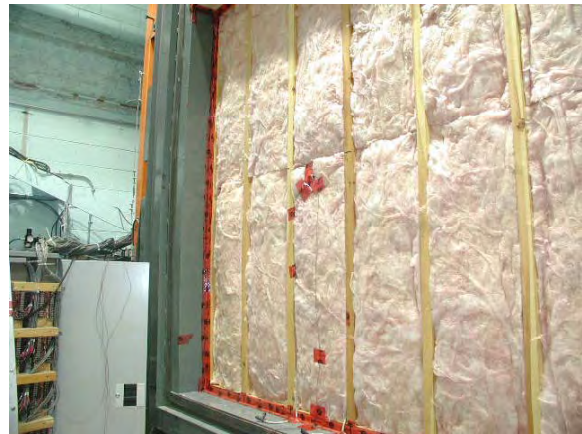
Figure 15 - Installation of insulation in stud-cavity

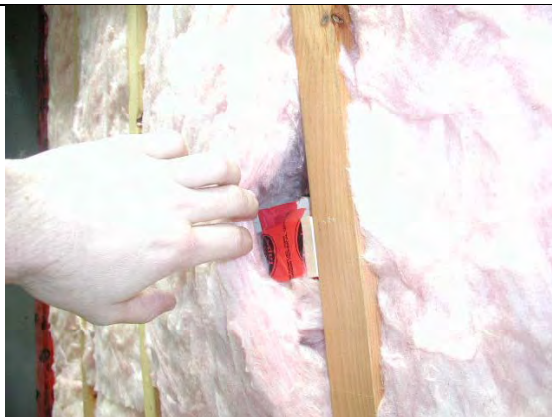
Figure 20 - Installation of ACR sensor in stud cavity

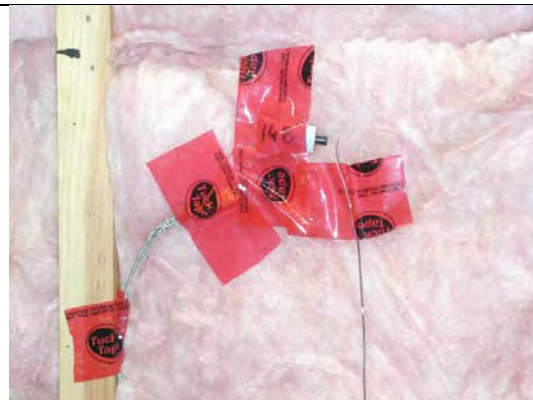
Figure 17 - Close-up of sensors located on polyethylene membrane (inside) – Location 3
