Kanchan Arsenic Filter Trouble Shooting Manual

By Maclyn O'Donnell

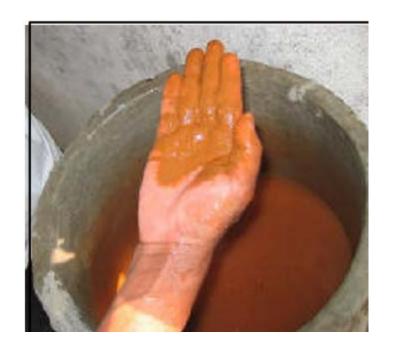
Top sand layer will clog. It is normal. It is because of the accumulation of dirt, dust, iron particles, and/or other contaminant particles.

- Filter maintenance. Clean the top layer of sand. If doesn't work, then
- Check clogging in the diffuser basin. Take the basin out and pour water into the basin. If basin clogs, then remove and wash iron nails and brick chip to clean out the dirt. Also wash the basin and clear out any holes that has been blocked by iron sludge/ dirt. If doesn't work, then
- Remove all sand and gravel. Check for blockage in the pipe. Sieve sand and gravel. Re-install gravel and sand. Keep in mind that that there should be always water in the filter before adding gravel and/or sand to avoid trapped air bubbles. If doesn't work, then
- Contact ENPHO. This is interesting. We also want to know why.

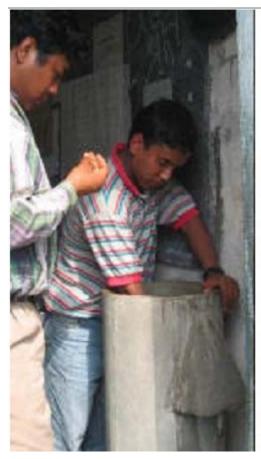
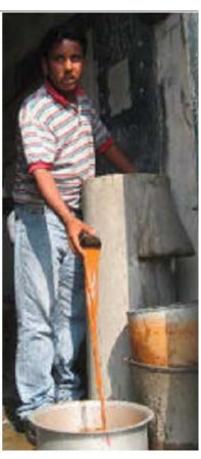
Filter maintenance
 (i.e. cleaning the top
 layer of sand) can
 often return the flow
 rate to normal

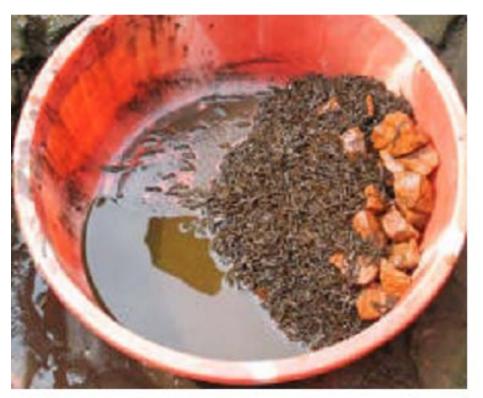
Iron nails and/or brick chips can be very dirty. They must be washed to remove dirt and sand particles before placing into the diffuser basin

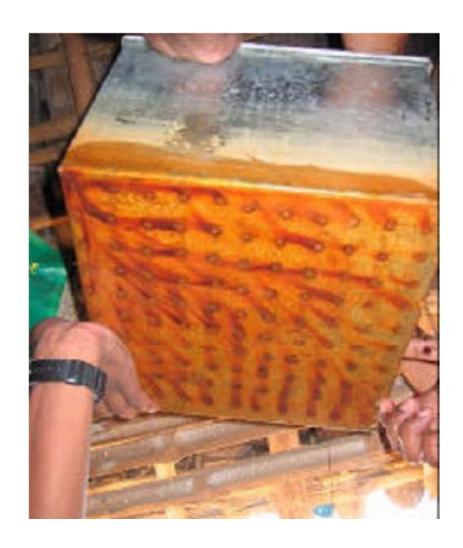
Remove the diffuser basin to check for clogging in the basin

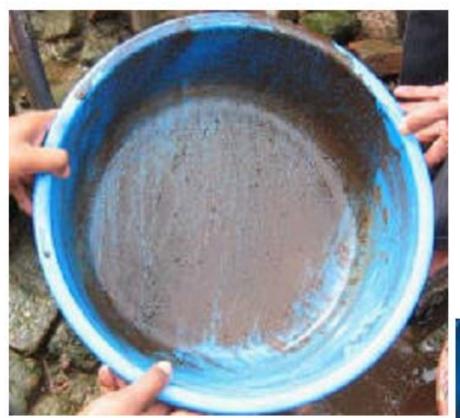
Iron nails and/or brick chips were not washed prior to installation. Dirt from nails and/or brick clogs the holes in the diffuser basin.

Holes too small will get clogged easily. Holes too large will allow iron nails to pass. Proper size is necessary.

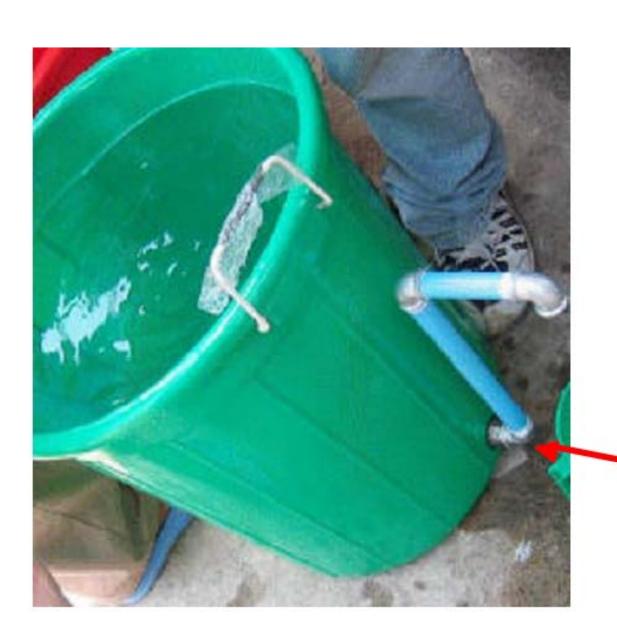
Leakage is commonly found here. Possible reasons may include:

- insufficient Teflon tape
- jammed rubber washer
- inadequate tightening

- If the leakage in on the outside pipe system, re-seal with Teflon tape and/or glue. If not, then
- Check leakage at the bottom of the Gem505 container. There may be a crack. Seal with glue. Put the filter on a very flat surface with a 3cm layer of sand. If not, then
- Remove all sand and gravel. Check for seal for the entire piping system. Re-seal if necessary. The tank nipple rings may be jammed. Replace entire pipe or fitting parts if necessary. If doesn't work, then
- Replacement of the plastic Gem505 container may be needed.

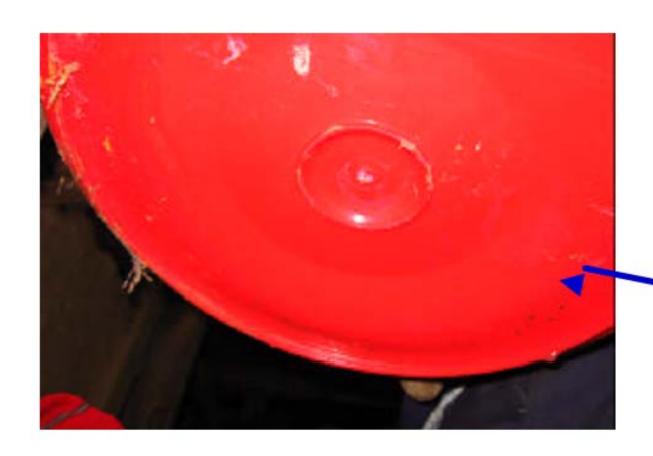
Due to the pressure of the sand and water, the bottom of the Gem505 container may crack.

To prevent this problem, the filter must be placed on a very flat surface with a 3cm thick layer of sand.

This will help support the pressure of the sand and water.

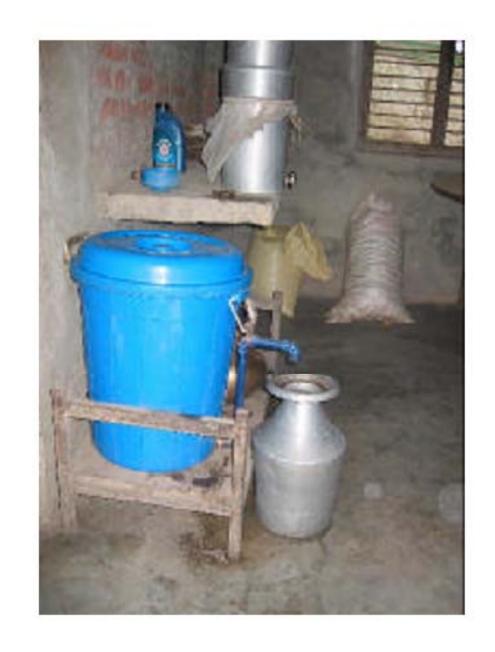
The filter should be placed indoors, away from the sun. Sun's UV ray will damage the plastic, making it fragile.

The filter should be placed on a flat, stable surface.

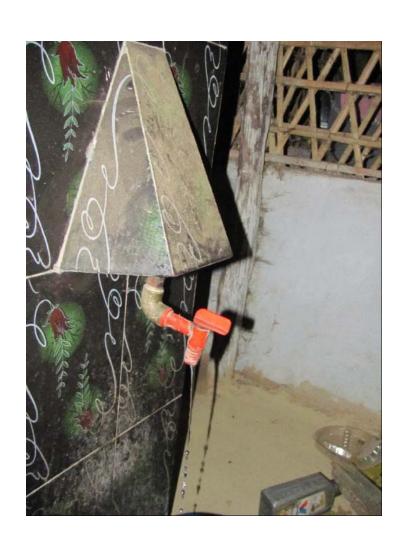
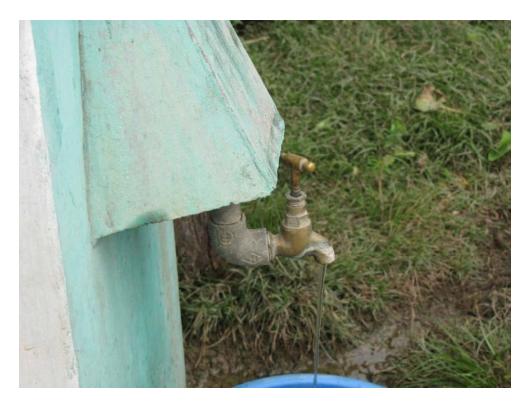
- Many consumers of the KAF like to install a tap into the outlet of the filter so they can have the filter give them water whenever they want it
- Unfortunately this will also increases the standing water level above the sand, which is designed to be 2-inches so that sufficient oxygen is present for the arsenic removal process.
- If seen remove the taps

These taps need to be removed to keep the filters performing well

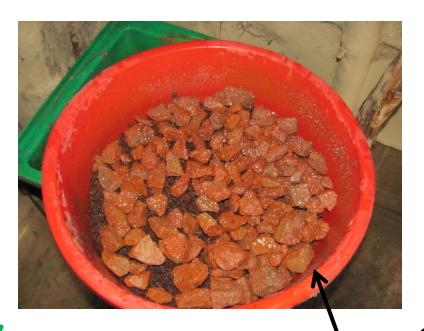
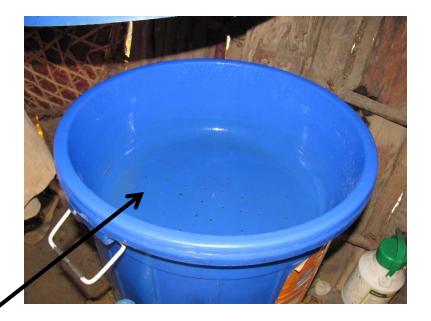
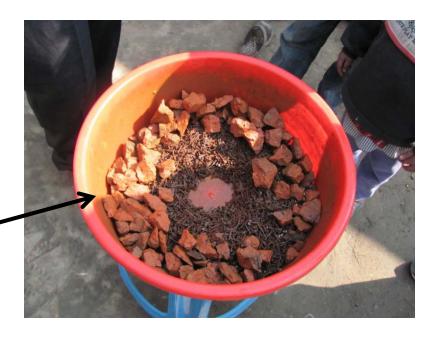
- Nails spread evenly and weight down sufficiently
- X No nails present
- X Nails not weighed down enough, poring caused the nails to clump on the sides of the filter

- If there is an absence of nails altogether then add nails, spread them evenly then weigh them down with stones or brick chips
- If there are large gaps in the iron layer then break up the present nails (usually the nails rust together over time) then spread them evenly and weigh them down with stones or brick chips.

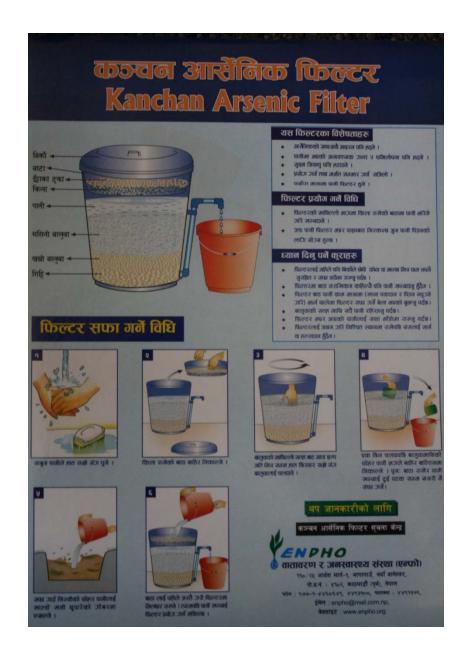
This is what the fact sheet should look like

- Every filter should have a sheet on it or near it that explains how to used the filter and some things which should not be done to the filter
- If this is missing from a plastic filter then, after asking the owner's permission, put a sticker version of the instruction sheet on the filter
- If the owner does not want a sticker on their filter or the filter is made of concrete then give the owner a copy of the instruction sheet and offer to hang it somewhere near the filter
- A owner may feel the instruction sheet is not visually appealing and thus do not want it hanging in their house. Because of this do not press having the sheet in somewhere that is constantly visible.
 Though, if a filter's owner does not want the sheet in a visible location make sure you explain the sheet to the owner.
