**MICROBIAL CONTAMINATION IN THE KATHMANDU VALLEY
DRINKING WATER SUPPLY AND BAGMATI RIVER**

MASTER OF ENGINEERING IN CIVIL AND ENVIRONMENTAL ENGINEERING

MASSACHUSETTS INSTITUTE OF TECHNOLOGY

JUNE, 2000

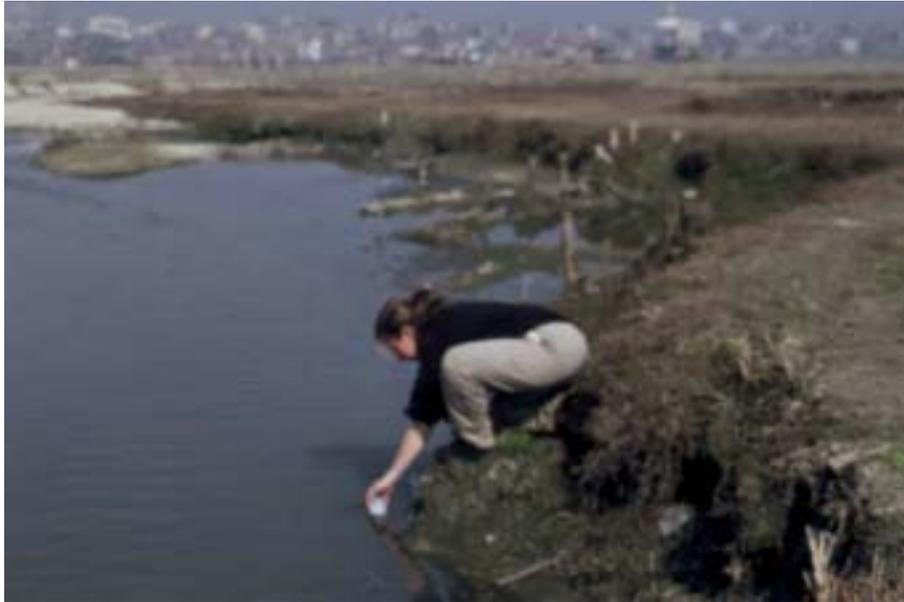
Figure 15: Picture of me sampling on the Bagmati River.

In an effort to see as much of the Bagmati River as possible the river was divided into six sections from Sundarijal to south of Chobhar. These sections included Sundarijal to Gokarna, Gokarna to Bouddha, Bouddha to Gaushala, Gaushala to the Sankhamul Ghat, the Sankhamul Ghat to Sundarigat, and finally Sundarigat to south of the Chobhar Gorge. All stretches were observed except Gaushala to Sankhamul Ghat. Walks along the Bagmati were taken during the morning and early afternoon of five days in Kathmandu. During these walks field notes were taken and samples were collected, see Figure 15.

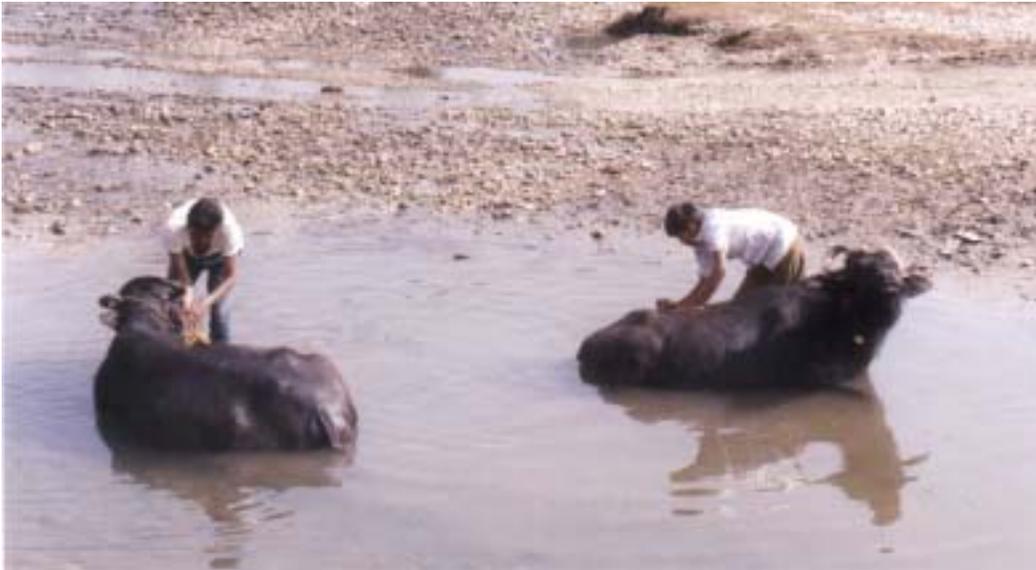
Figure 17: Picture of farmers washing water buffalo in the Bagmati.

After leaving Sundarijal, the Valley turned into a flat agricultural plain and the Bagmati lost much of its clarity. In many places the river was diverted into earthen irrigation channels and water was used to water crops. Some farmers were observed washing their clothes and animals in the river. Figure 17 shows two very happy water buffalo having

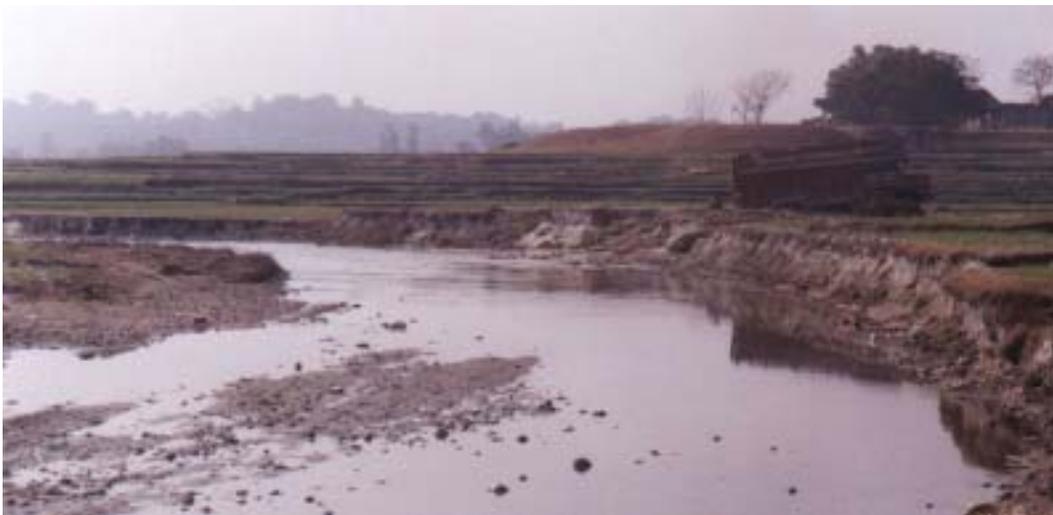
Figure 18: Picture of a truck removing gravel from the Bagmati.

their daily bath. Near here there were areas where gravel mining was taking place. In these area people dug gravel out of the riverbed. Then the gravel was put on trucks that drive up and down the river as shown in Figure 18.

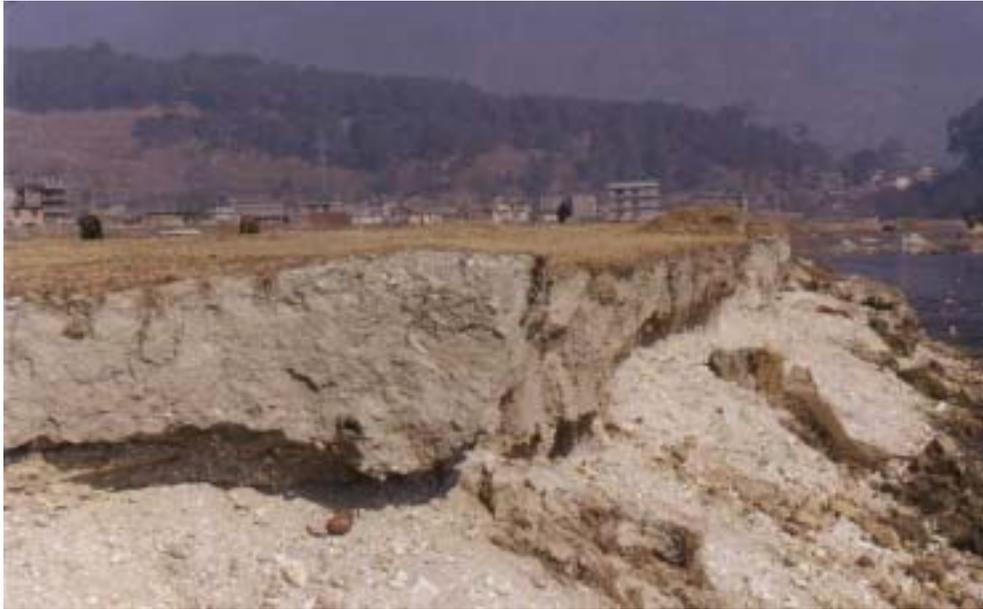
Figure 20: Picture of river bank erosion near Gokarna

The next sample was taken downstream of Gokarna, near Atarkhel. This spot was downstream of a small riffle where the water was turbid. In this stretch, the land adjoining the river is fairly agricultural with grazing areas for livestock and heavily eroded banks as seen in Figure 20. Near the riverbank was a small wool mill or carpet factory and a carding or weaving machine was heard. There was a reddish effluent coming from the mill. Houses lined the road about a quarter of a mile away; the population density appears moderate.

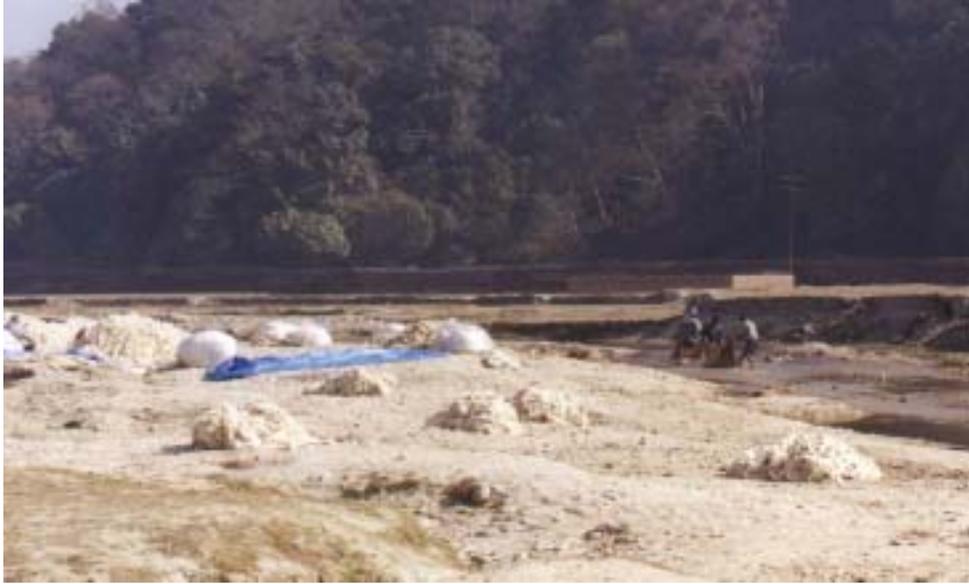
Figure 21: Picture of wool drying on river bank and laborers in river.

The third sample this day was taken just after the Jorpati Bridge. Among the garbage under the bridge was a dead dog, human feces, and a sewer outfall. Before the bridge there was a wool drying area and women washing clothes and bathing. Wool drying activities, such as those shown in Figure 21, were seen several times over the course of several days. This whole section was fairly barren and agricultural and the current remained strong with a low volume.

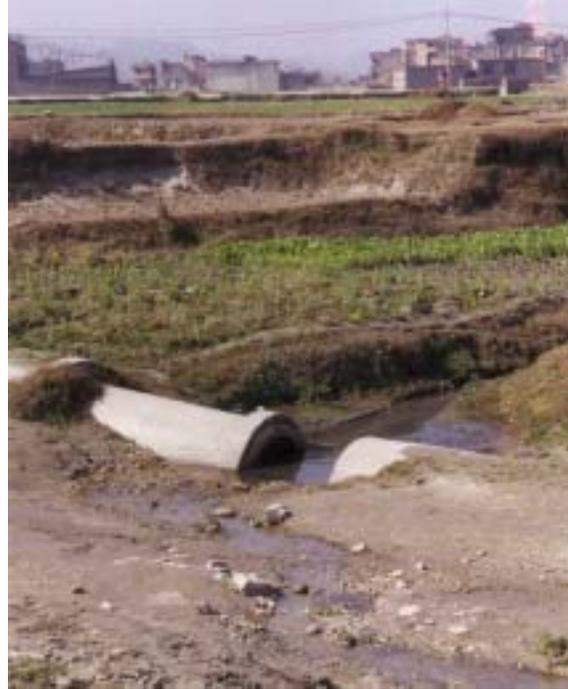
Figure 23: Picture of an open sewer in a field next to the Bagmati River.

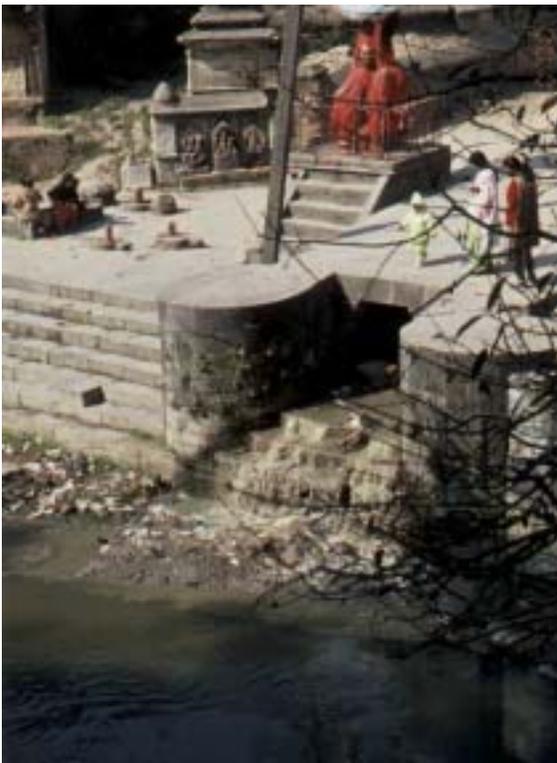
Figure 25: Picture of the sewage outfall at the Gujeshwari Temple.

The Gujeshwari Temple area was just downstream from construction and agricultural areas. The river was about 15 feet wide and 1 foot deep here with a swift current and looked and smelled like raw sewage. One sewage outfall at the Gujeshwari Temple was near an area of worship as shown in Figure 25. At the Pashupatinath Temple area there were people worshipping and performing cremations. The temple area is in a highly developed gorge, not a flood plain like much of the rest of the riverbank. The cremations necessitated that some people enter the river to worship and clear ashes as shown in Figure 26. Just downstream of the temples a laborer was mining gravel from the middle of the river using a small shovel as shown in Figure 27. Trash can be seen lining the banks in this picture.

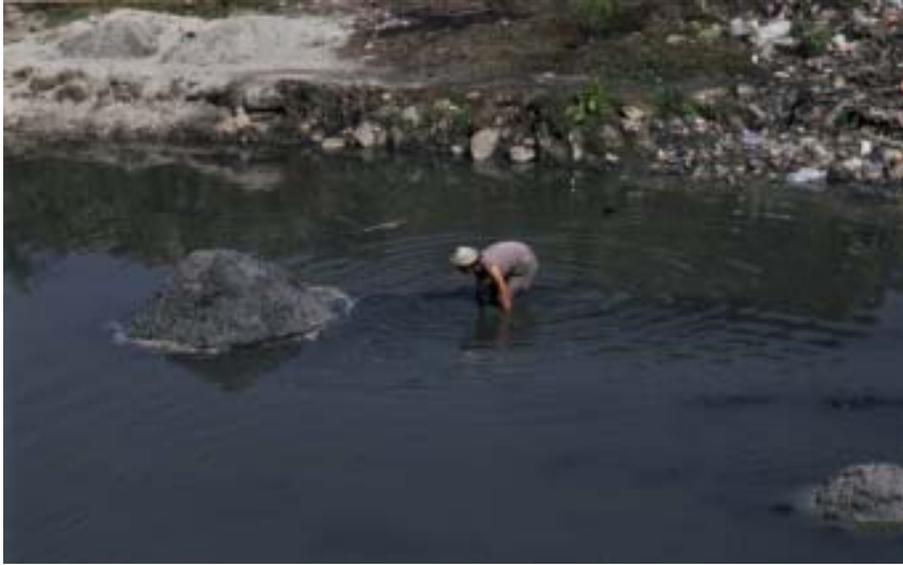
Figure 27: Picture of man digging gravel from the Bagmati.

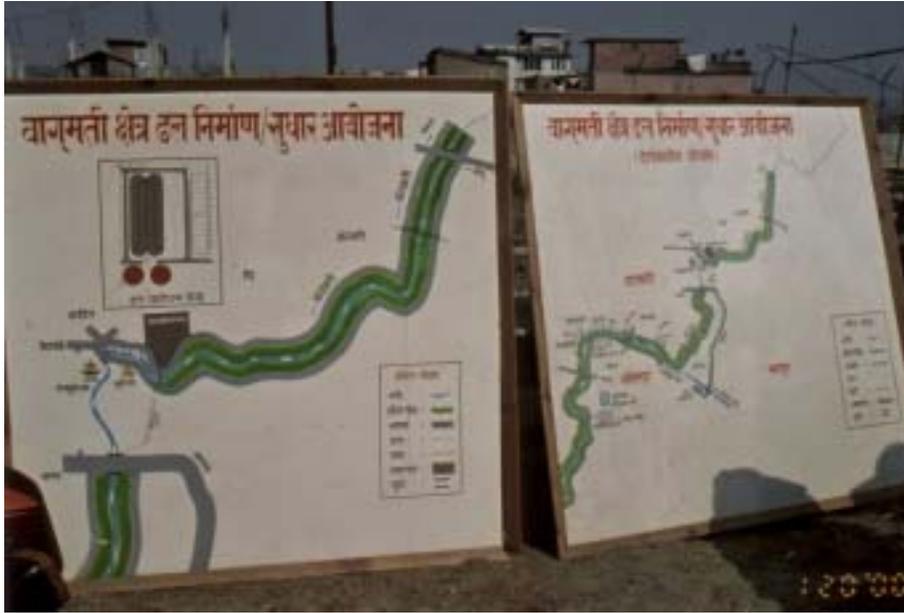
Figure 28: Picture of the sewage treatment plant plans.

The most interesting discovery of this day was a sewage treatment plant under construction. Engineers at this plant told us that the treatment plant would provide both primary and secondary treatment and showed us the diagram of these plans as shown in Figure 28. The plant was supposed to be finished in about a year, though construction had not begun yet. The treatment plant would supposedly reduce the BOD in the river from what they said was its current level of 300 mg/L to 25 mg/L. Engineers also informed us that they were going to build a by pass tunnel which would take the treated sewage past the Gujeshwari and Pashupatinath temples and discharge it downstream. The motivation for both the treatment plant plans and the bypass tunnel was religions. The river plays a central role in Hindu worship and Pashupatinath, right downstream of the treatment plant, was being actively used for religious purposes. Part of the worship

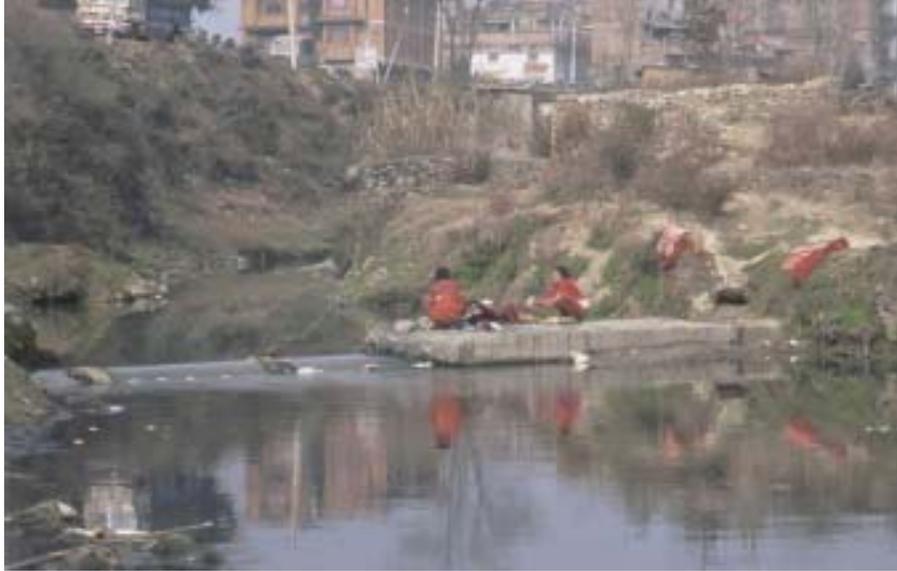
Figure 29: Picture of women washing clothes next to the River.

Even though there was minimal direct river uses, there were signs of indirect river uses. There were also many activities that people did right next to or near the river. These activities included several groups of women washing (see Figure 29), children playing soccer and retrieving a soccer ball from the river, several tent clusters right near the river bank, a small market selling meats (see Figure 30), a slaughter house, and several agricultural patches. In one area there was an area on the riverbank planted with trees.

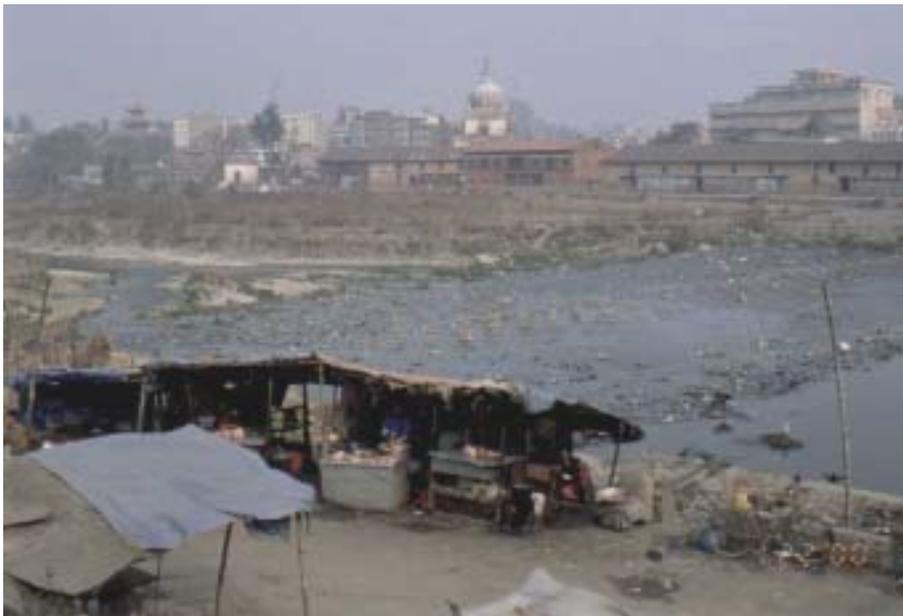
Figure 30: Picture of a meat market next the River.

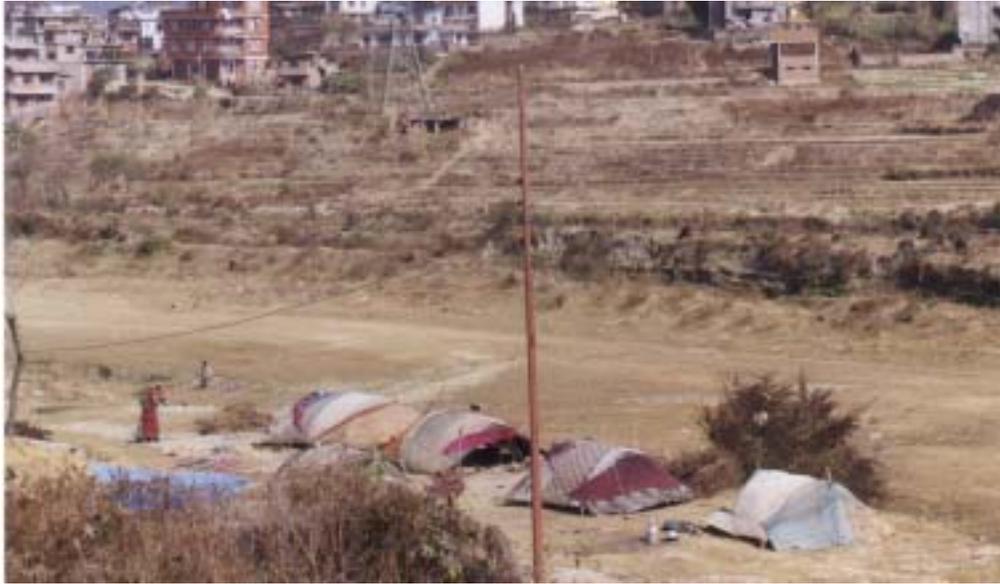
Figure 31: Picture of squatter tents along the river bank.

much less populated than the sections and around the city though there were a few squatter tents along the bank as shown in Figure 31. There was a lot of agricultural activity in the area but for the most part it was not right next to the river. Fewer piles of garbage lined the bank further south, however the river never lost its raw sewage look and smell. One sample was taken this day from Nakhu Khola, a small tributary to the Bagmati.
