Monitoring the long-term performance of the Peace Tower in Ottawa

NRCC-47706

Monitoring the Long-term Performance of the Peace Tower in Ottawa

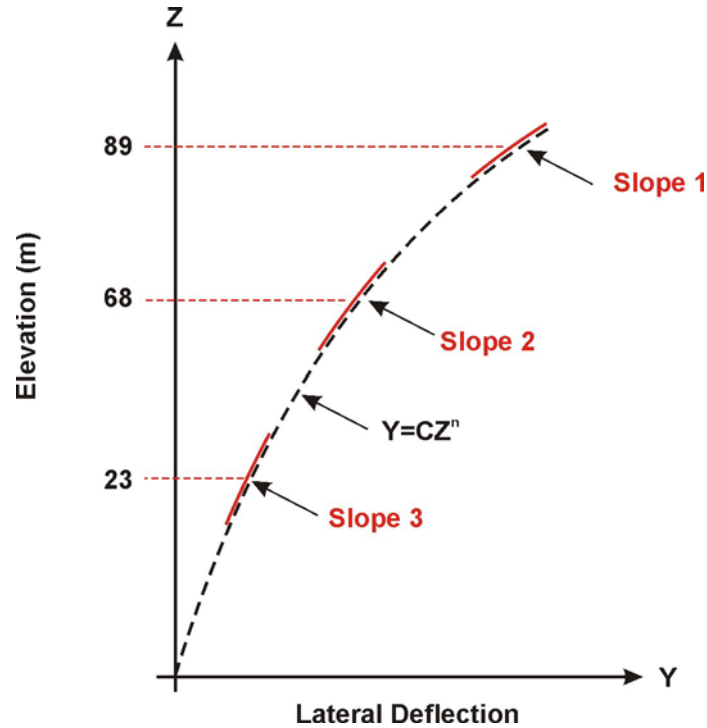
Fig. 6. Assumed shape of tower tilt and tilt-meter locations. Graph by Peter Richards

Tower tilt. The tower tilt is monitored at three elevations: 75, 223, and 292 feet (23, 68, and 89 meters). The angle changes measured are cyclical and very small (the maximum at the top is about 0.1

degree). The angle changes are caused by changes in temperature. A rough estimate of the lateral deflection was obtained by assuming a simple deflected shape based on the following equation and shown in Figure 6:
