## Monitoring as a tool for sustainable buildings

**NRCC-50436**

Said, M.N.A.; Paquette, J.; Lumsdon, C.

A version of this document is published in / Une version de ce document se trouve dans:  
2<sup>nd</sup> Canadian Conference on Effective Design of Structures, Hamilton, Ontario, May 20-23, 2008, pp. 115-131

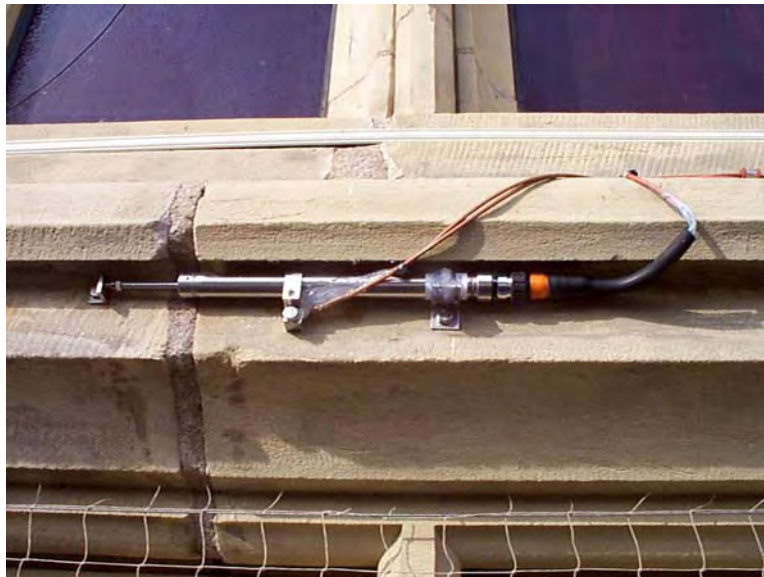
**Figure 3. A photo (PT991119) showing a displacement sensor tucked under a windowsill to monitor movement across a repaired crack.**

Displacement sensors, Figure 3, are used to monitor movement between adjacent walls with dissimilar construction and movement across existing or repaired cracks. The latter determines whether a crack opening is stable or changing. In special monitoring programs such as the Peace Tower, vibration sensors may be installed to monitor dynamic movement of the building envelope due to seismic events, blasting, wind, etc.

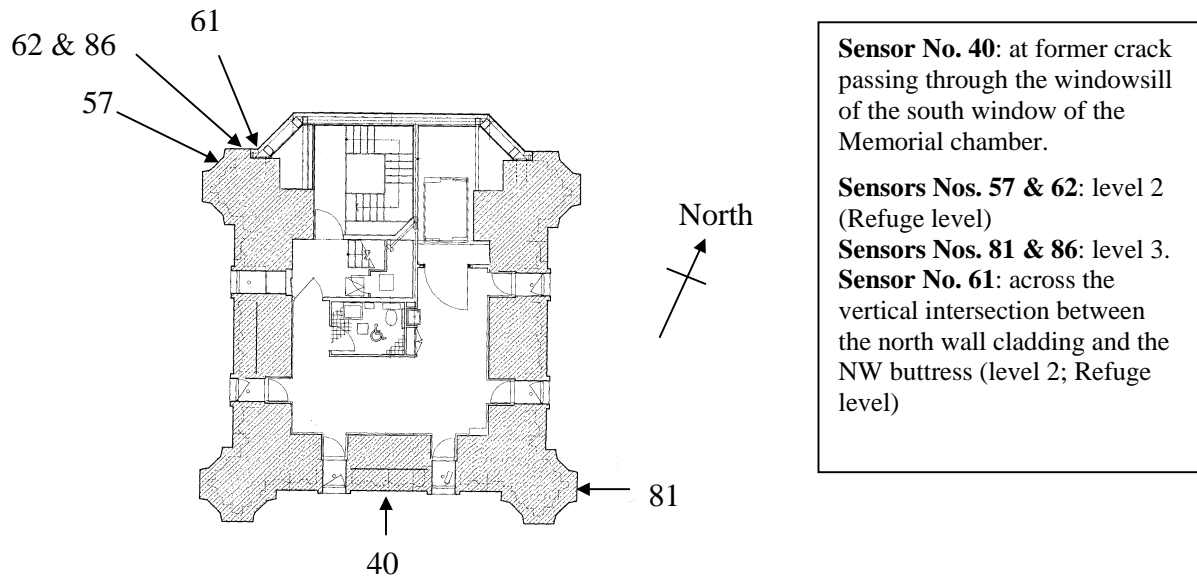
**Figure 11. Locations of the six displacement sensors.**

*Structure displacement:* Five displacement sensors were placed across former cracks to determine whether cracking would re-occur. A 6<sup>th</sup> displacement sensor was placed

horizontally across the vertical intersection between the north veneer wall and the NW buttress in order to monitor expected movement at the interface of the two claddings. Figure 11 shows the location of the six displacement sensors.

*Crack displacement:* The displacement sensor (# 40 in Figure 11) located in the south façade under a windowsill at level 1D changed its normal behaviour in July 2005 (see Figure 12). The displacement showed a gradual contraction leveling off to approximately -1.2 mm. The permanent contraction means that there was no restraint to shrinkage movement probably due to loss of pointing mortar. Figure 3 shows the condition of the mortar joint in November 1999 and Figure 13 shows its condition in September 2007. The displacement at this location is expected and probably was there since the tower's construction. A finite element analysis [7] indicated that horizontal tension stresses are induced at this location under pure gravity load. Frost damage was probably an aiding factor in the loss of the pointing mortar once it lost adhesion to the stones. The south façade has been experiencing high number of freeze-thaw cycles (see Figure 7). The crack at this location provides a high potential path for water entry into the wall because snow usually accumulates right above it.
