THE MECHANICS OF LANDSLIDES IN LEDA CLAY

W. J. EDEN AND R. J. MITCHELL

RESEARCH PAPER NO. 441
OF THE
DIVISION OF BUILDING RESEARCH

The mechanics of landslides in Leda clay¹

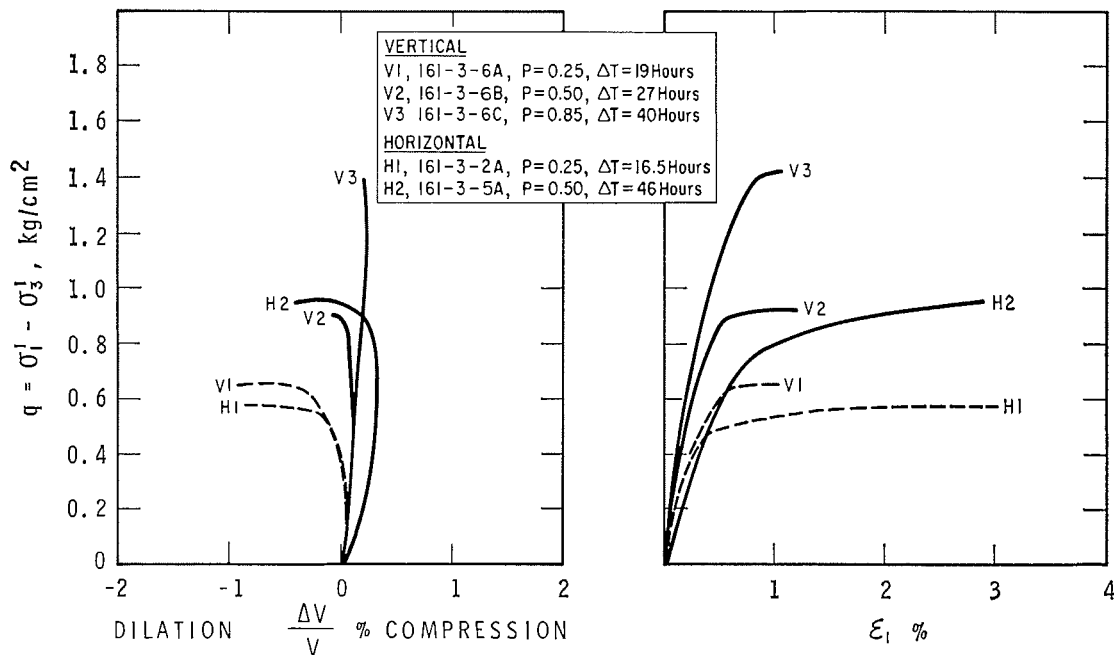
Stress-strain curves from several of the constant p tests are plotted in Figs. 2 and 3. Figure 2 shows a comparison between the behavior of vertical and horizontal specimens. Figure 3 shows the behavior of large diameter

specimens and the behavior of specimens in strain controlled tests. All the specimens tested developed a shear plane at (or near) the maxi-

mum deviatoric stress with these planes intersecting the physical horizontal direction at angles between 45 and 63° . The angle of shear

FIG. 2. Shear behavior of Leda clay under low confining pressures.

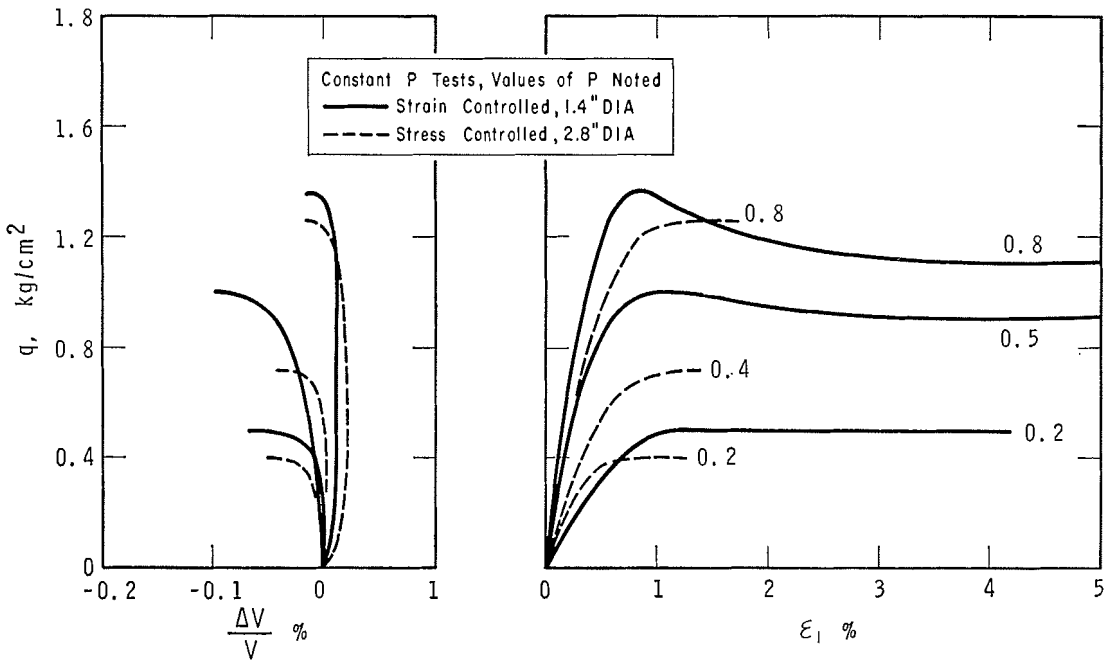
FIG. 3. Additional triaxial test data.

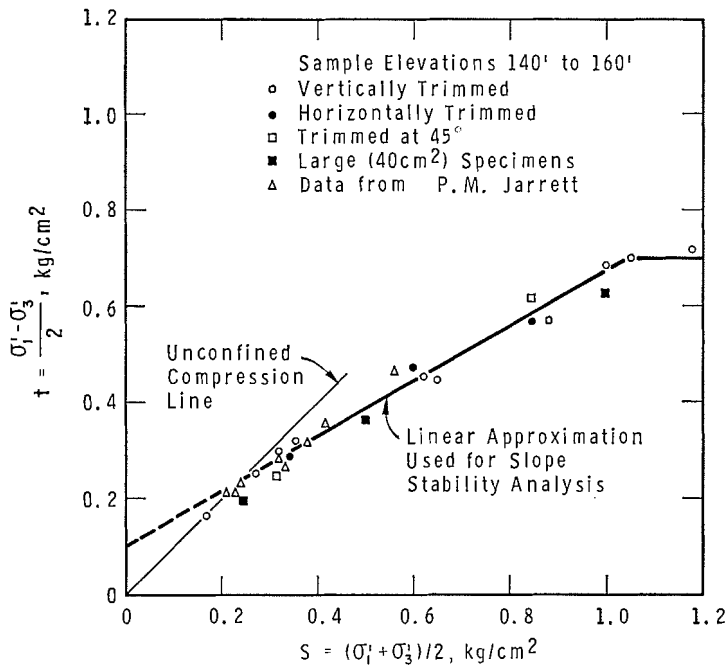
decreased as the mean normal stress at failure increased. Failure points (maximum deviatoric stress) for all tests are plotted in Fig. 4 with respect to the commonly used plane stress parameters

Test specimens of 10 cm² nominal area appear to be large enough to eliminate any significant size effect. At higher stress levels, such as shown on the horizontal portion of the envelope in Fig. 4 orientation and rates of testing might have an influence.

FIG. 4. Strength of Leda clay from the Rockcliffe site.

the trial circle numbers). A failure envelope ($c' = 0.12 \text{ kg/cm}^2$, $\Phi' = 33^\circ$) was chosen to approximate the triaxial test data in Fig. 4. The circles with centers at c_3 , c_4 , and c_7 in Fig. 7a yield stress points 3, 4, and 7 which lie on this failure line. As the circle with center c_3 was calculated to be critical for $\Phi' = 33^\circ$ the analysis indicates that the slope would be at a condition of limiting equilibrium when fully saturated under a hydrostatic groundwater condition.

The failure points plotted in Fig. 4 indicate a curved failure condition. In isolation those points contributed by P. M. Jarrett² give a planar strength criterion $c' = 0.08 \text{ kg/cm}^2$, $\Phi' = 45^\circ$ as compared to the values $c' = 0.12 \text{ kg/cm}^2$, $\Phi' = 33^\circ$ obtained by the authors. When used in the stability analysis both sets of strength parameters yield a safety factor close to unity. This somewhat surprising result occurs because these strength parameters define two planar failure criteria that intersect close to the value of the average normal stress on the critical circles. The absolute values of the strength parameters appear to be less important than ascertaining that the strength tests and stability analysis involve comparable normal stresses.

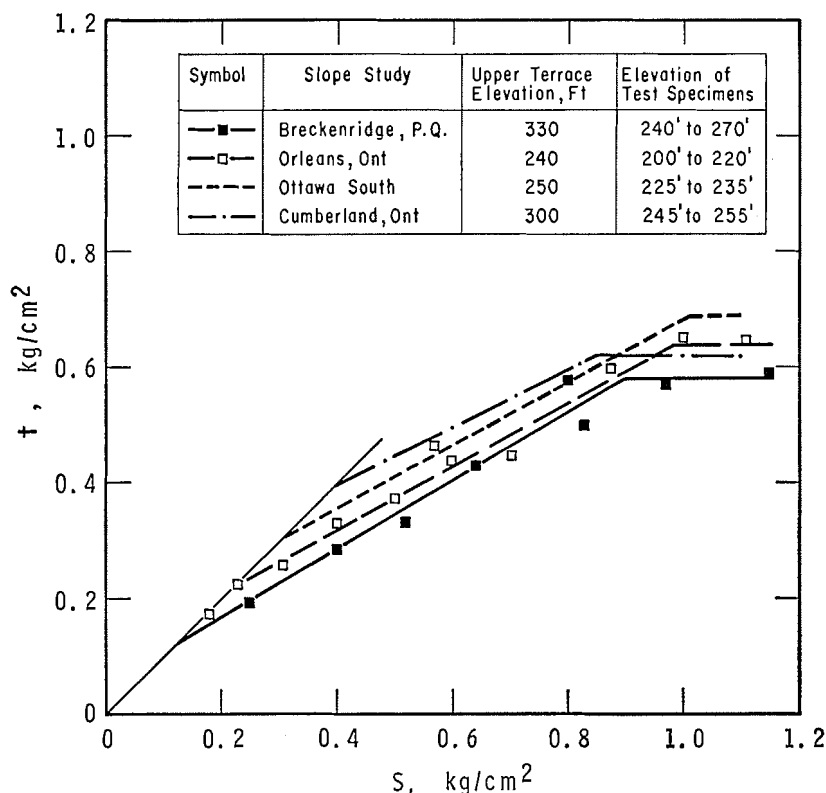
Failure points for specimens from the Breckenridge and Orleans landslide sites are plotted in Fig. 5. These points are approximated by linear failure envelopes for use in the slope

stability analysis. Failure envelopes obtained for Leda clay from other sites near Ottawa are also drawn to show that the low stress frictional

behavior occurs extensively and is not dependent on the elevation of the clay terrace.

FIG. 5. Failure envelopes for Leda clay from various sites.
