EXPERIENCES WITH GROUND WATER ON CONSTRUCTION

ROBERT F. LEGGET

REPRINTED FROM
PROCEEDINGS OF THE AMERICAN SOCIETY OF CIVIL ENGINEERS
JOURNAL OF THE SOIL MECHANICS AND FOUNDATIONS DIVISION
VOL. 88, NO. SM2, APRIL 1962, P. 1-17

TECHNICAL PAPER NO. 138

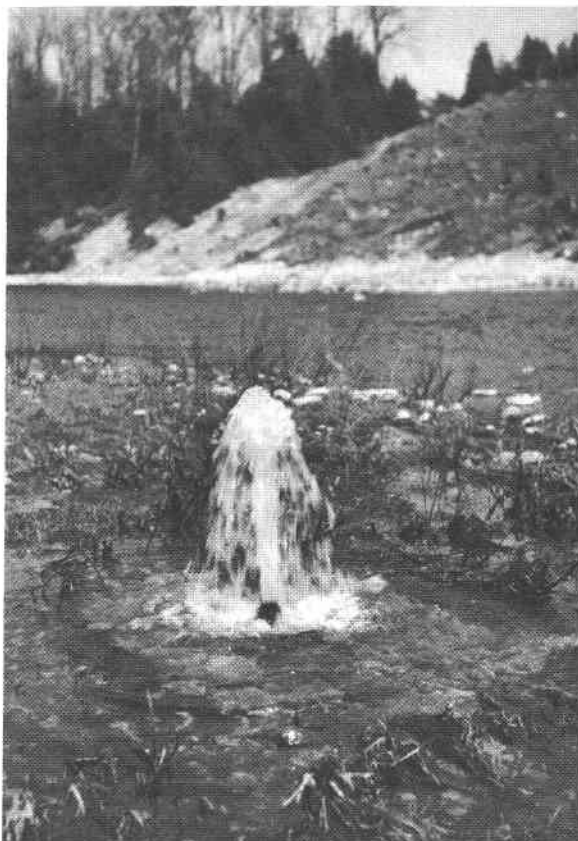
FIG. 1.—WATER UNDER ARTESIAN PRESSURE

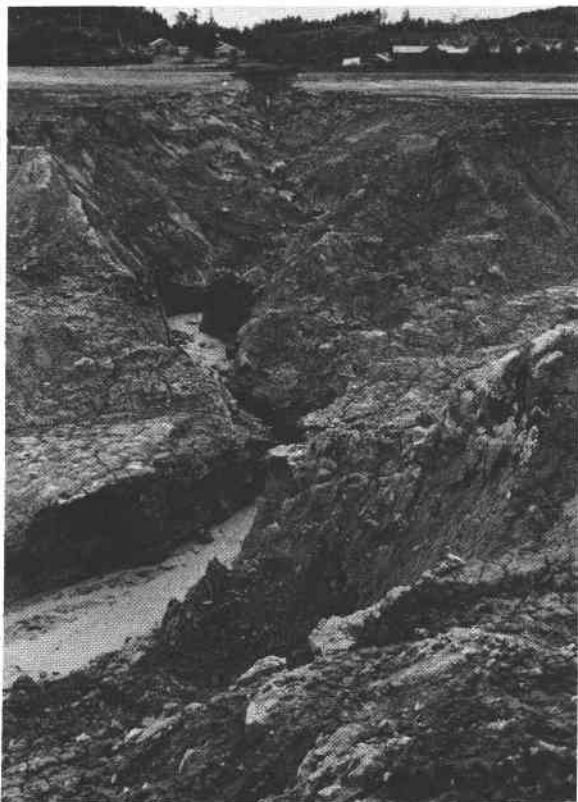
FIG. 2.—GULLYING IN DRIED-OUT BED

In the course of six weeks, this small flow of water, originating not far from the original shore line as an accumulation of seeping ground water, eroded a gully (Fig. 2). Before the necessary diversion work was completed, at the end of the sixth week, this gully was 36 ft deep and over 60 ft wide. The eroded soil was varved clay, with reasonable strength and a stiff consistency. Erosion to the extent noted in such material was one of the most graphic evidences that the writer has ever seen of the necessity for con-

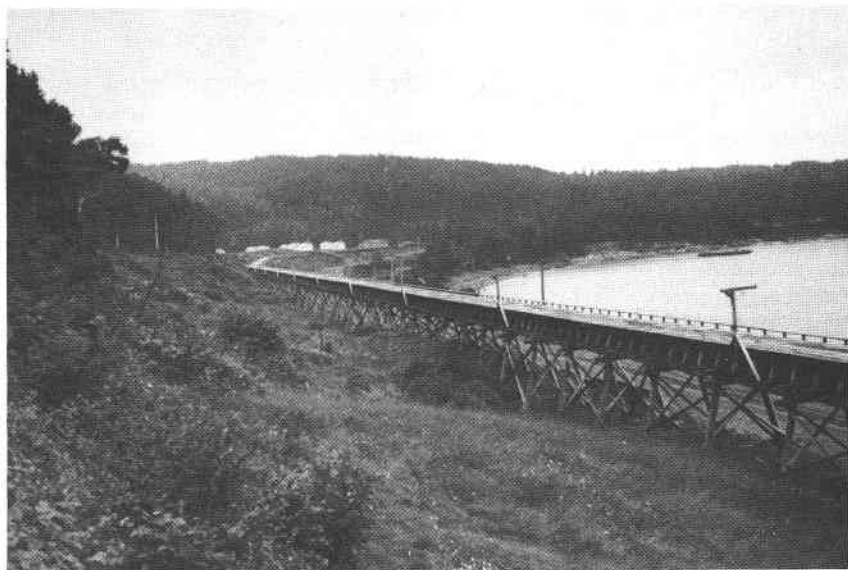
FIG. 6.—GENERAL VIEW OF THE FORESTVILLE LOG FLUME, QUEBEC

has been completely stabilized by the simple drainage system described. A general view of the Forestville log flume is shown in Fig. 6.
