Status at DORIS Hall

Works from August till October

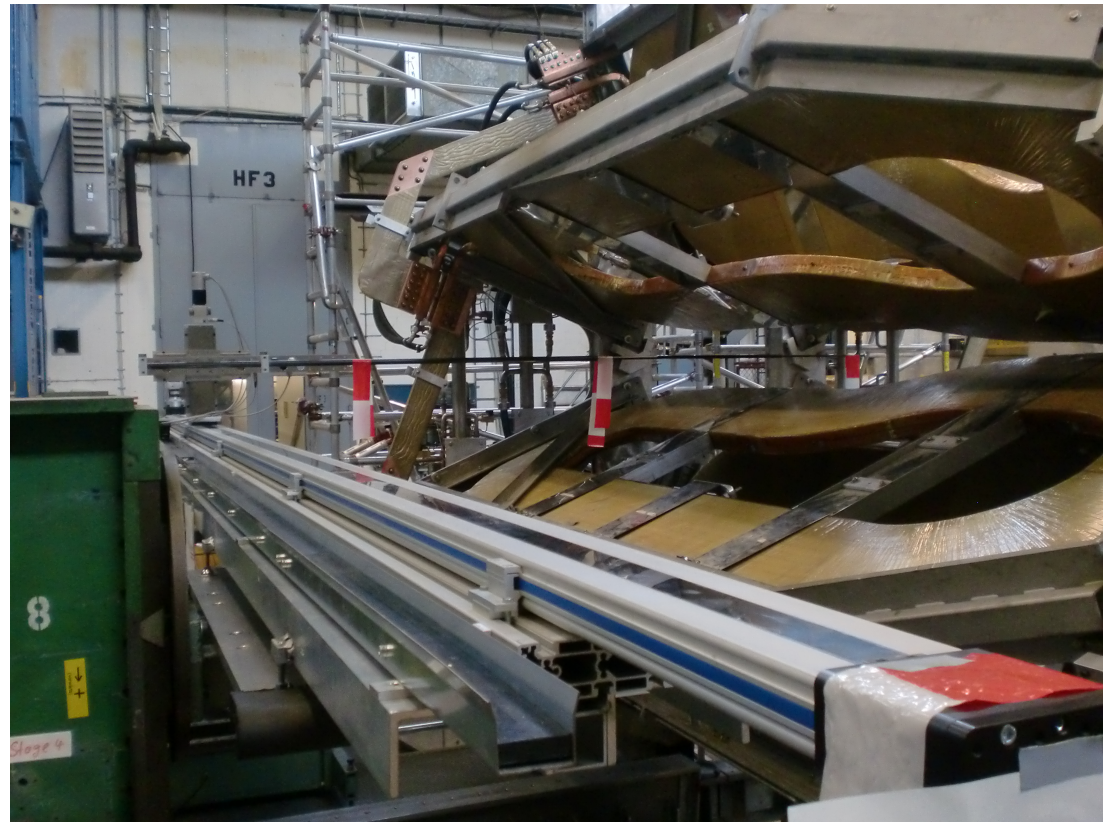
- Power cable connections done, but to be rerouted at the top connections between the two halves. Work starts Wednesday
- Magnet field measuring machine set up
- Temperatur sensors at coils and flow sensors for cooling water installed and cabled
- Try to get first power in the coils within next 10 days
- Pipes for gas supply partly installed

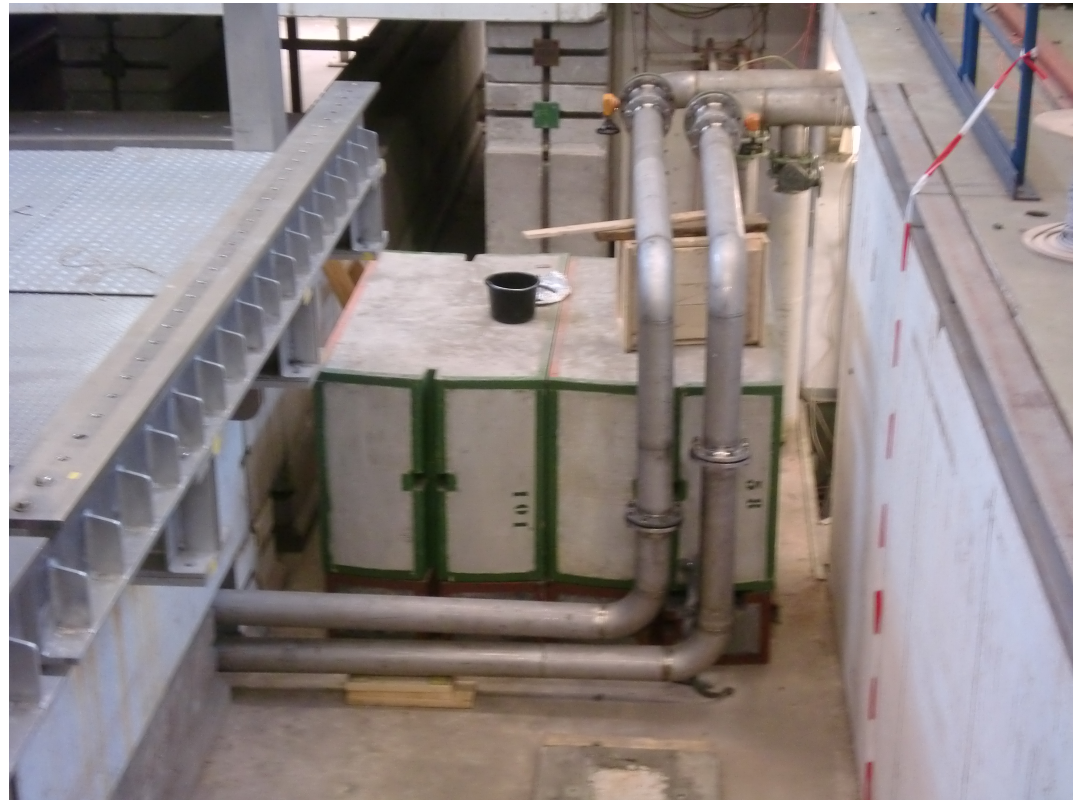
- First shielding blocs installed
- MHF lab on ringoutside modified to give way for our shielding
- This week we moved of 10 pcs. 12 m concrete roof bars into Hall 4
- Further shielding design underway
- Quadrupole- and vacuum system support design still underway
